TEST REPORT

Fire resistance test in accordance with AS1530.4-2014 of various control joint in a 116mm thick non-loadbearing fire rated plasterboard wall protected by HB Fuller Fulaflex FR sealant.

56967300.1

20 September 2018

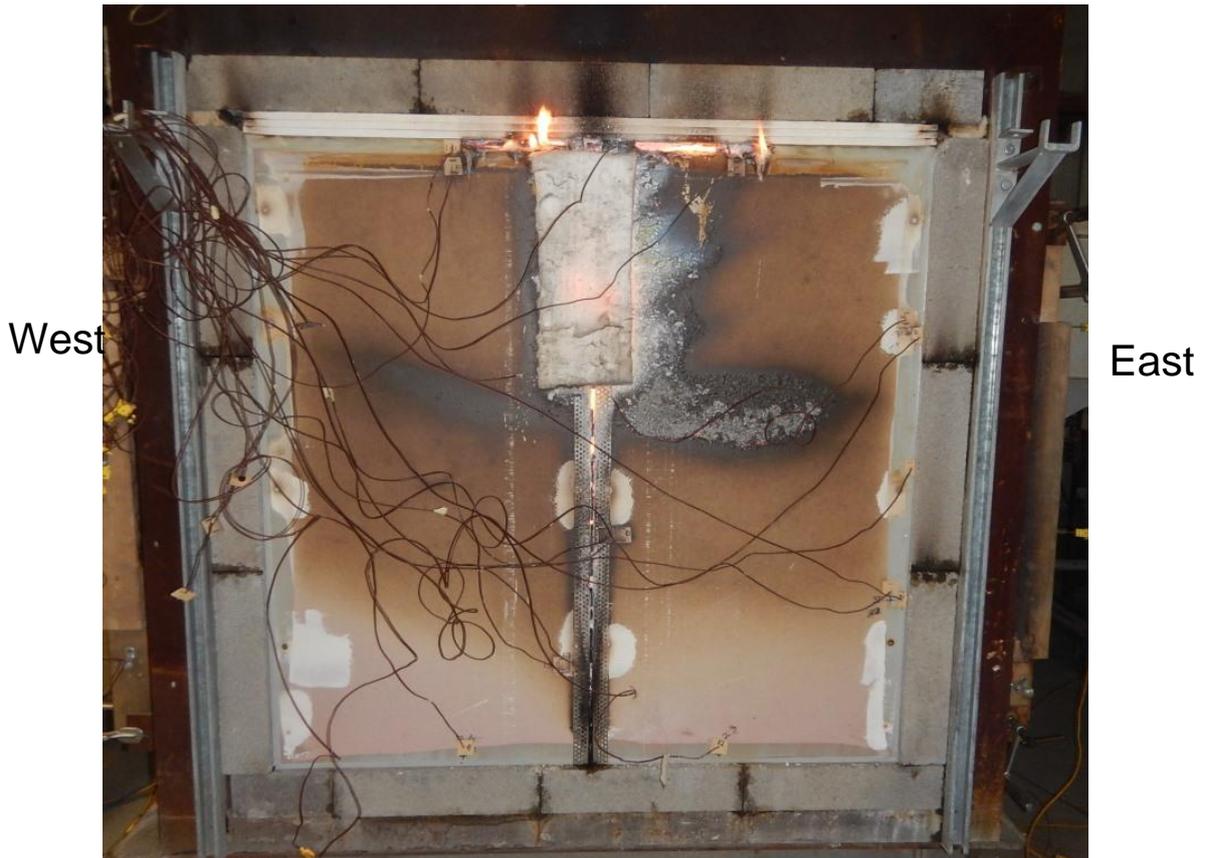
Figure A6.3: Unexposed face of specimen at the end of the test.

Service	Criteria	Result
A	Structural Adequacy	Not applicable
	Integrity	Failure at 171 minutes
	Insulation	Failure at 133 minutes
	FRL	-/120/120
B	Structural Adequacy	Not applicable
	Integrity	No failure at 181 minutes
	Insulation	Failure at 167 minutes
	FRL	-/180/120
C	Structural Adequacy	Not applicable
	Integrity	No failure at 181 minutes
	Insulation	Failure at 173 minutes
	FRL	-/180/120
D	Structural Adequacy	Not applicable
	Integrity	No failure at 181 minutes
	Insulation	No failure at 181 minutes
	FRL	-/180/180

Time		Observations
min	sec	
Service A		
00	00	Fire resistance test commenced and the average initial temperature of the specimen was approximately 20°C.
30	00	The specimen had continued to maintain integrity and insulation in accordance with AS 1530.4-2014
60	00	The specimen had continued to maintain integrity and insulation in accordance with AS 1530.4-2014
90	00	The specimen had continued to maintain integrity and insulation in accordance with AS 1530.4-2014
115	52	Smoke emission had become evident at the mid-height of the control joint
120	00	The specimen had continued to maintain integrity and insulation in accordance with AS 1530.4-2014
126	11	Discoloration appeared on the smoke emission area. Hole had formed on the sealant.
126	42	Smoke emission had appeared on the other location of the control joint
131	25	The sealant had expanded on the top section of the control joint
132	50	The expanded sealant had partially close one of the holes

133	25	TC 015 on the Rondo P35 control joint, 25mm away from the control joint recorded a temperature of 201°C. Failure of insulation in accordance with AS 1530.4-2014 clause 2.13.3(b), where the maximum temperature of Thermocouple TC 015 exceeded the initial temperature by more than 180°C.
142	20	The width of the control joint on the top side had increased
150	50	A 30 second cotton pad test was carried out in accordance with AS 1530.4-2014. No glowing or flaming had become evident
160	50	A 30 second cotton pad test was carried out in accordance with AS 1530.4-2014. No glowing or flaming had become evident
171	00	A 30 second cotton pad test was carried out on top section of the control joint resulting in flaming of the cotton pad. Failure of integrity of the specimen in accordance with AS 1530.4-2014, clause 2.13.2.2, where ignition of the cotton had occurred.
Service B		
00	00	Fire resistance test commenced and the average initial temperature of the specimen was approximately 20°C.
