**FIRE RESISTANCE TEST IN ACCORDANCE
WITH AS1530.4-1997, SECTIONS 2, 4 AND 10
AND AS4072.1-1992 AS APPROPRIATE ON
FIRESOUND GREY TRIAL ACRYLIC SEALANT
PROTECTING FOUR (4-OFF) JOINTS
IN A CONCRETE FLOOR SLAB**

HB Fuller Australia Company Pty Ltd,
16-20 Red Gum Drive
Dandenong South
VIC 3175

A1.1.7 Details of the test construction are shown schematically on Drawing No. 40869-TS-01.

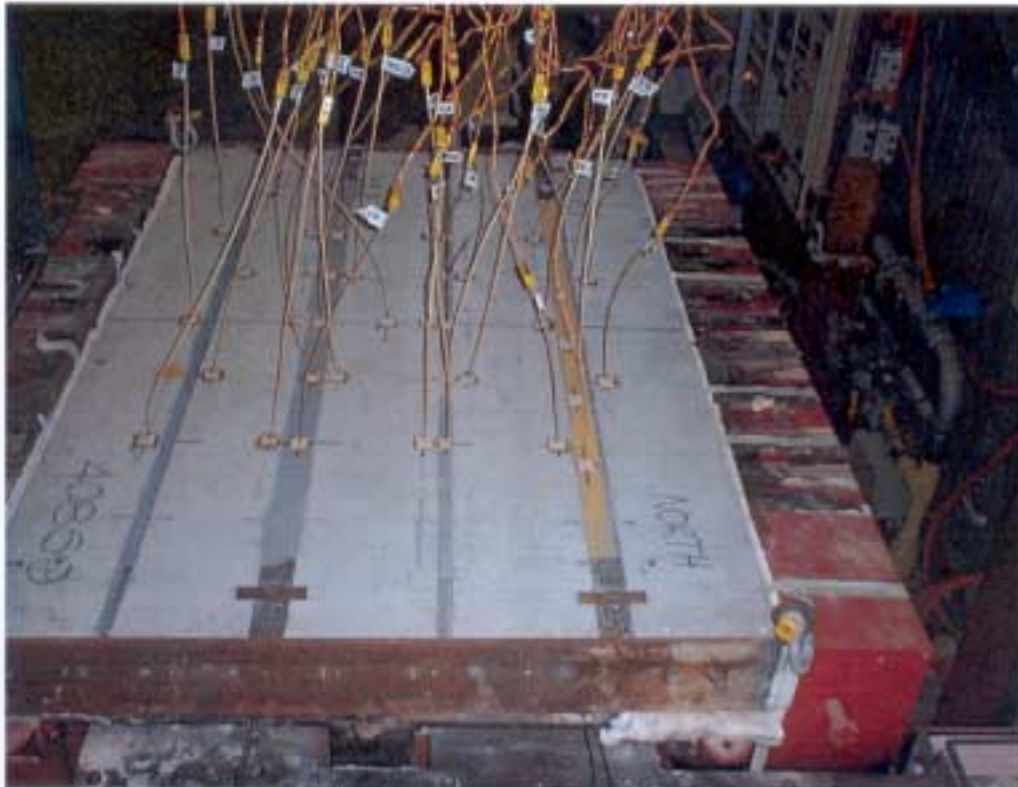
Plate 1: Unexposed face before commencement of the fire resistance test

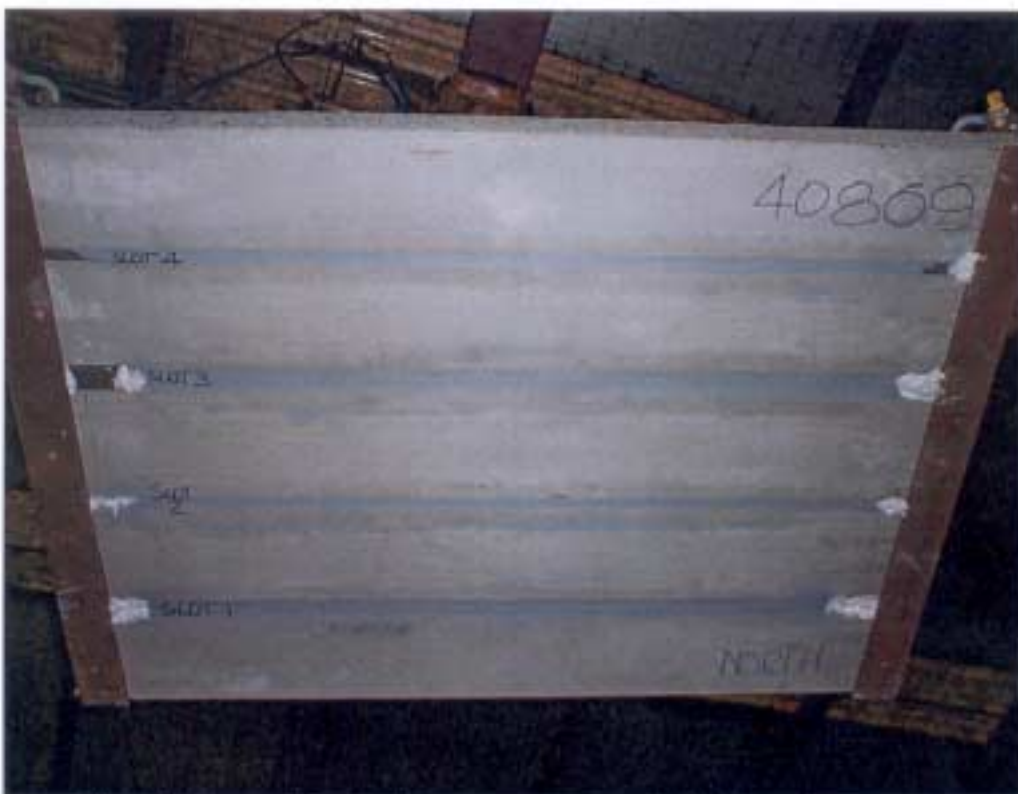
Plate 2: Exposed face before commencement of the fire resistance test

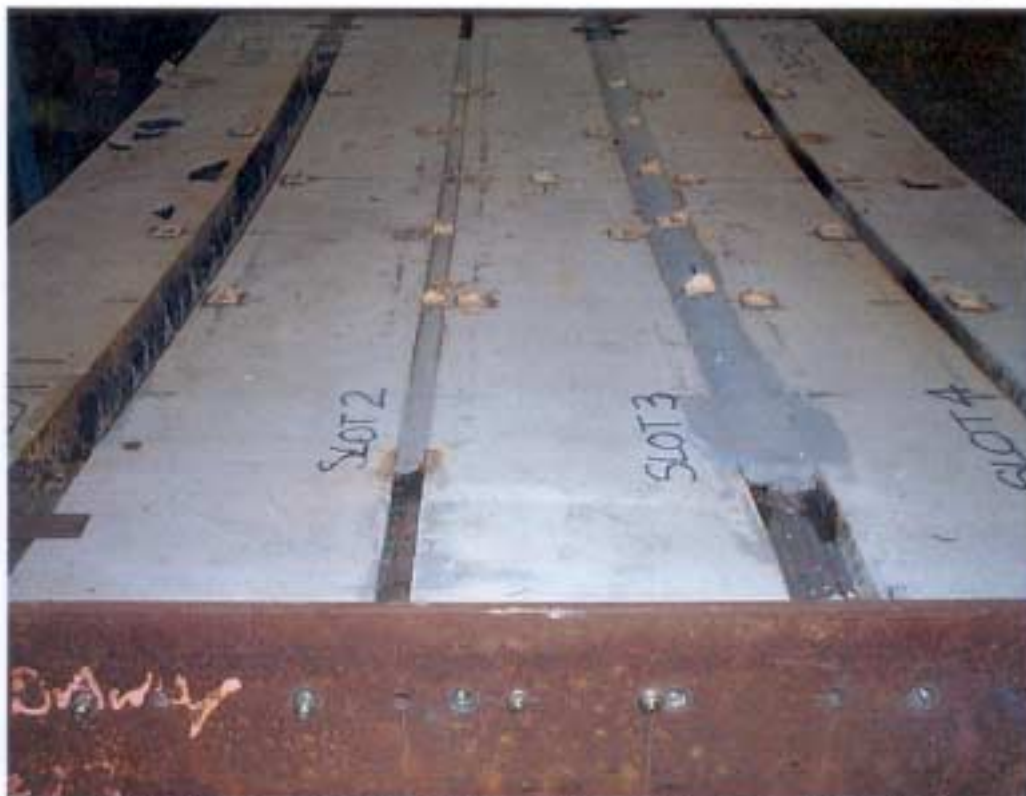
Time		Test Observations 40869
Min	Sec	
120	00	All Control joints were intact with no through gaps evident. The mastic material along Control joints 2 and 3 was changing shape from concave to convex. The change in shape was uniform along the full length (1200mm) of the sealant material. This barrelling was about 5mm for Control joint 3 and about 3mm for Control joint 2. There were no splits in the material.
135	00	The barrelling of the material of Control joint 3 had increased to about 10mm above the surface of the concrete and about 5mm for Control joint 2. The sealant material in Control joint 4 was glowing bright red along the full length but there were no through gaps evident. The sealant material in Control joint 1 was still grey in colour except for a couple of short lengths of red lines about 300mm from the cast end of this control joint.
150	00	The barrelling of the material of Control joint 3 was now about 20mm above the concrete surface whereas Control joint 2 was still about 5mm. Control joint 4 continued to glow bright red in colour but there were no through gaps evident. The surface of Control joint 1 was still grey in colour. There were no splits in the sealant material of Control joints 2 and 3 and this material was still firmly in contact with the edges of the concrete sections.

158	00	The material in Control joint 3 was beginning to lose contact along the interface with the concrete slab.
165	00	No further changes were observed.
180	00	No further changes were observed. All control joints were free from cracks or gaps. The barrelling appeared to have stabilized at about 5mm for Control joint 2 and 25-30mm for Control joint 3. Downwards deflection of the slab over a segment of 1300mm at the centre was 25mm.
210	00	No further changes have occurred. All control joints were still fully intact and free of cracks or gaps. The colour of Control joint 1 was still basically grey.
220	00	No further changes had occurred.
230	00	No further changes had occurred.
235	00	No further changes had occurred.
240	00	No further changes had occurred. All control joints were intact with no gaps or cracks visible.
241	00	The furnace was shut down and the fire resistance test was terminated at the request of the test sponsor.

Plate 3: Unexposed face after completion of the fire resistance test

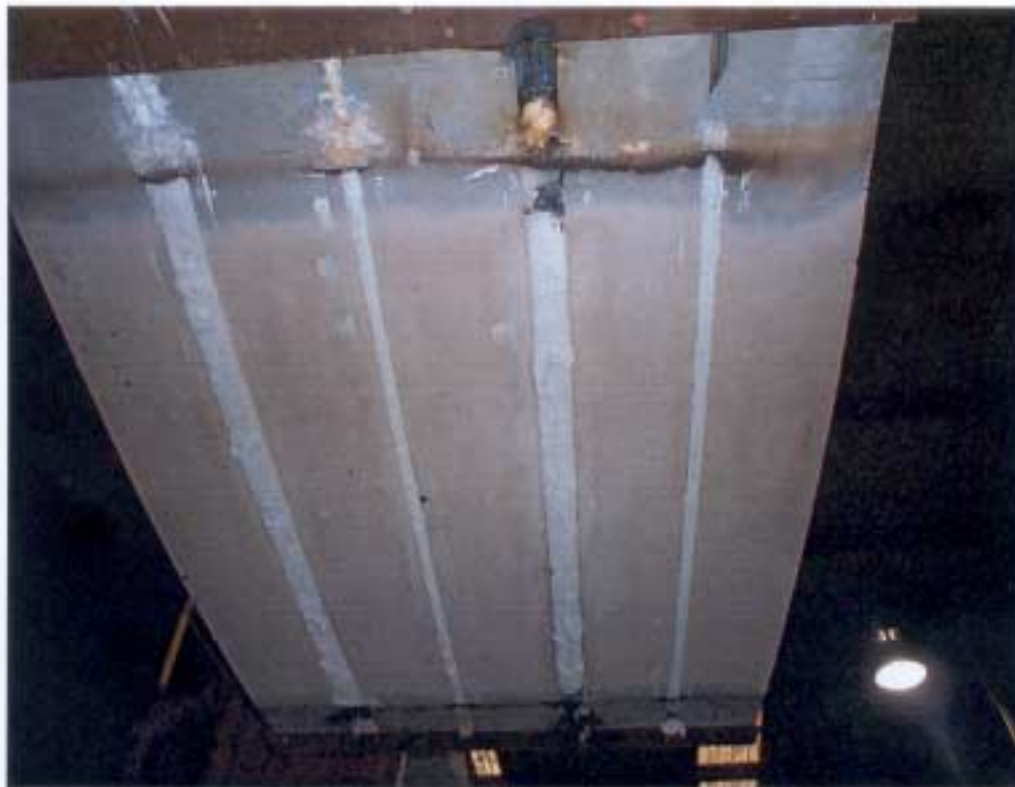
- (i) The mastic material was still in place in each of the control joints with no gaps evident in any of the joints either in the material or the edges.

- (ii) Some of the material had flaked off during the test and had fallen onto the floor of the furnace.
- (iii) Barrelling of the mastic material had occurred along each control joint about 25 to 30mm for Control joints 1 and 3 and about 6mm for Control joints 2 and 4. About half of this portion of material was still in place with the remaining portion fallen off during the test. The barrelling effect had been caused by the material intumescenting.

- (iv) The exposed face of the concrete had covered with craze cracking together with transverse full depth cracking across the concrete segments at or about the midspan of the specimen.

- (v) Spalling of the concrete had occurred at one spot at about the centre of Control joint 2 south edge.

Plate 4: Exposed face after completion of the fire resistance test
