H.B. FULLER AUSTRALIA PTY LTD

# FIRE RESISTANCE TEST REPORT

Test standard: Sections 2 and 10 of AS 1530.4:2014  
Reference Standard: AS 4072.1-2005 AMDT 1 (Rec:2016)  
Test sponsor: H.B. Fuller Australia Pty Ltd  
Products: HB Fuller Fulaflex FR sealant  
Job number: FRT56967300  
Revision: R1.1 Test date: 20 September 2018

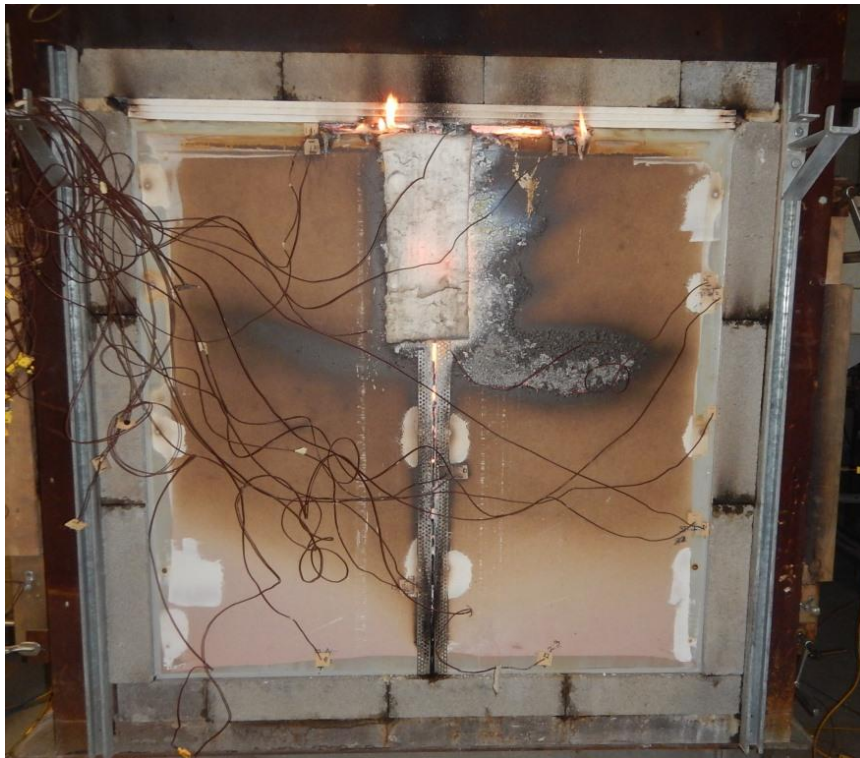
Figure 19 Unexposed face of the specimen at the end of the test

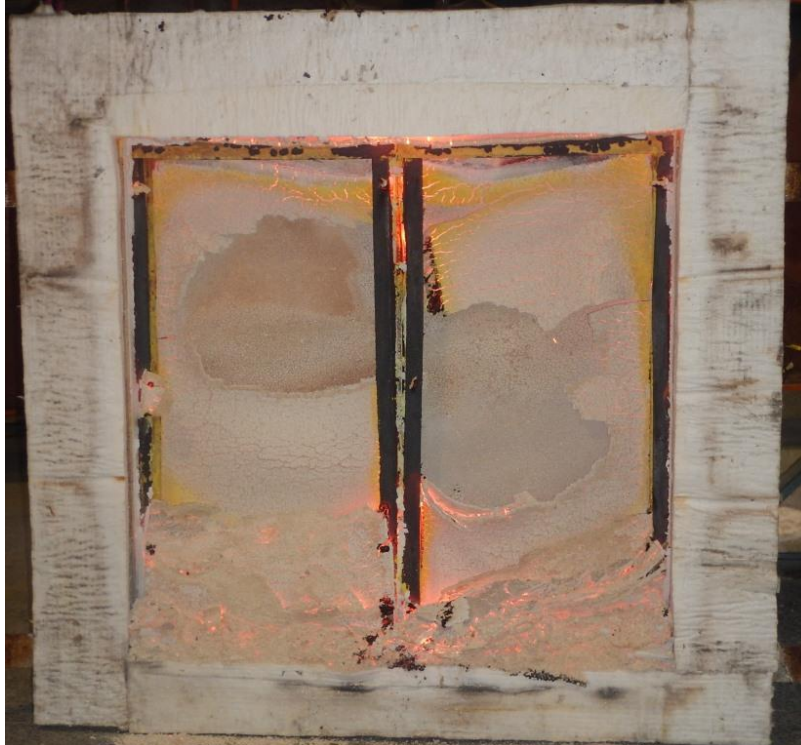
Figure 20 Exposed face of the specimen at the end of the test
