Fire resistance test report

Test standard: Sections 2 and 10 of AS 1530.4:2014 Test sponsor: H.B. Fuller Australia Pty. Ltd. Product: H.B. Fuller Firesound[™] Job number: FRT210084 Test date: 11 May 2021 Revision: R1.1

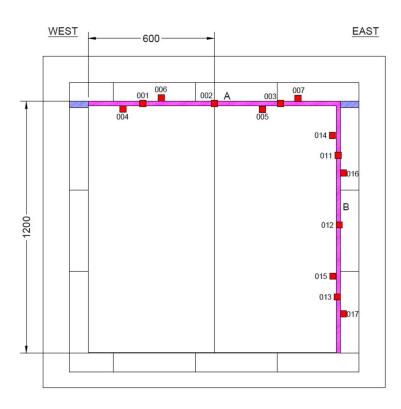
Control joint	T/C no.	Description
А	001	On the control joint, at the west quarter point, 250 mm from the mid-width.
	002	On the control joint at the mid-width.
	003	On the control joint, at the east quarter point, 250 mm from the mid-width.
	004	On the Hebel®, 125 mm west from TC 001.
	005	On the Hebel®, 125 mm east of TC 002.
	006	On the block, 125 mm east from TC 001.
	007	On the block, 125 mm east of TC 002.
В	011	On the control joint, at the upper quarter point, 250 mm from the mid-height.
	012	On the control joint at the mid-height.
	013	On the control joint, at the lower quarter point, 250 mm from the mid-height.
	014	On the Hebel®, 125 mm above TC 011.
	015	On the Hebel®, 125 mm below TC 012.
	016	On the block, 125 mm below TC 011.
	017	On the block, 125 mm below TC 013.

• The unexposed side specimen temperatures were measured by type K thermocouples with wire diameters less than 0.5 mm soldered to 12 mm diameter × 0.2 mm thick copper discs covered by 30 mm × 30 mm ×2.0 mm thick inorganic insulating pads.
	The thermocouples positions are shown in Figure 7 in Appendix D.
	 A roving thermocouple was available to measure temperatures at positions that appeared hotter than the positions monitored by the fixed thermocouples.

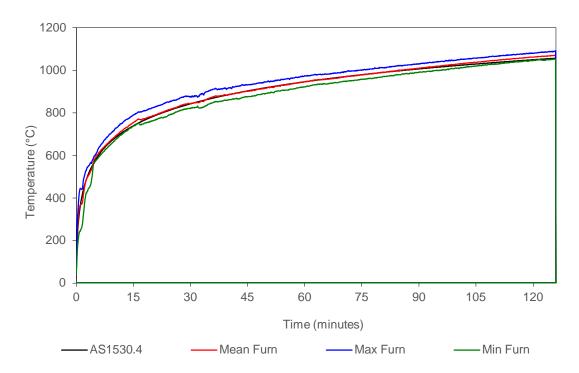
Figure 8 Furnace thermocouple temperature vs time

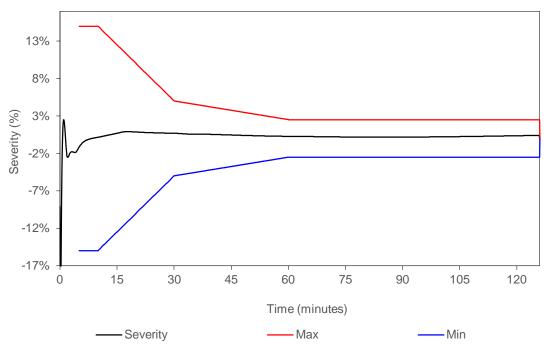
Figure 9 Furnace severity vs time

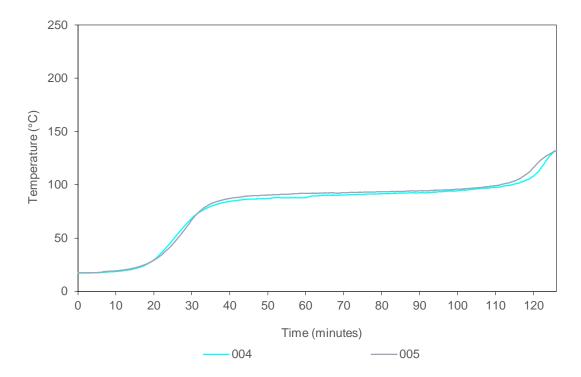
Figure 11 Upper horizontal control joint A on the wall temperature vs time.

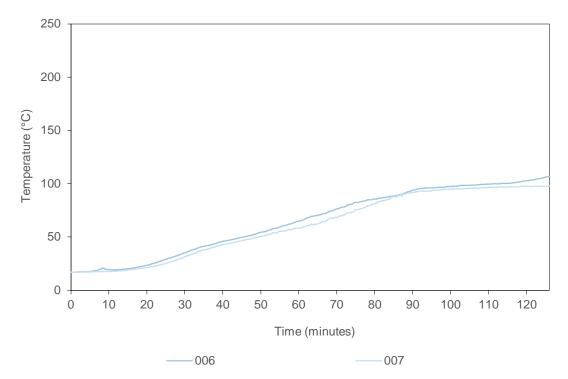
Figure 12 Upper horizontal control joint A on the concrete blocks temperature vs time.

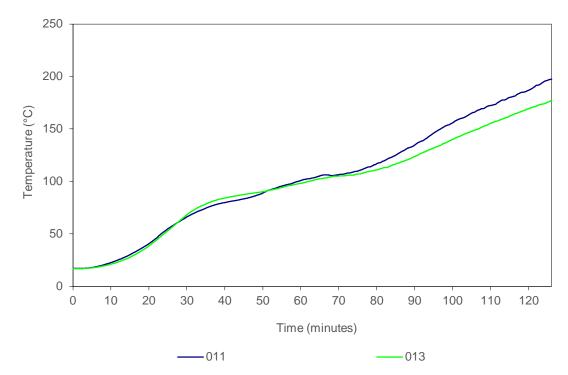
Figure 13East vertical control joint B on the sealant temperature vs time.Note: TC012 was located directly over a crack and the data has been omitted.

62	00	Sealant was expanding out.						
90	00	The test specimen continued to maintain integrity and insulation in accordance with AS 1530.4:2014.						
119	45	The roving thermocouple applied next to TC012 recorded a temperature of 173 °C.						
120	00	The test specimen continued to maintain integrity and insulation in accordance with AS 1530.4:2014.						
123	30	The roving thermocouple applied next to TC012 recorded a temperature of 187 °C.

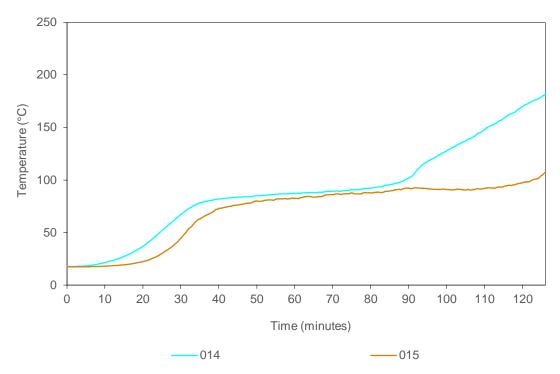
Figure 14 East vertical control joint B on the wall temperature vs time.

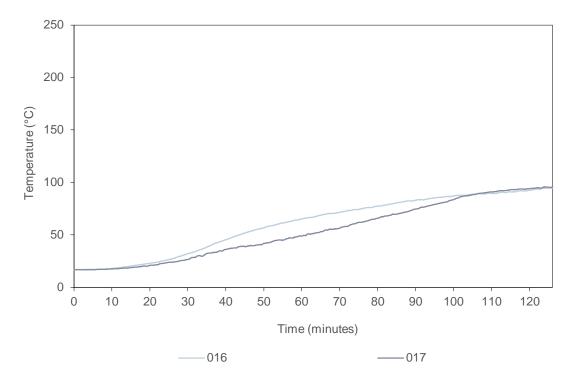
Figure 15 East vertical control joint B on the concrete blocks temperature vs time.

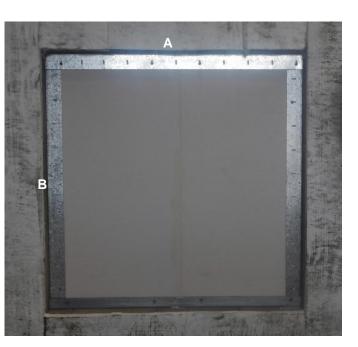
Figure 16 Exposed face of the specimen before the start of the test

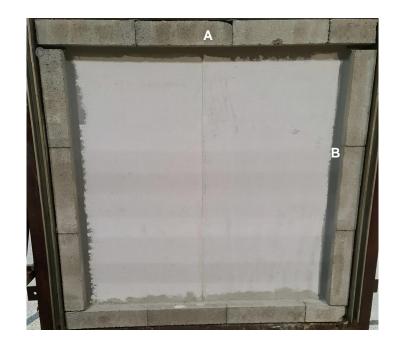
Figure 17 Unexposed face of the specimen before the start of the test

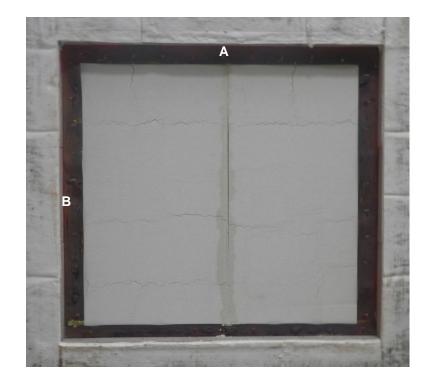
Figure 18 Exposed face of the specimen at the end of the test

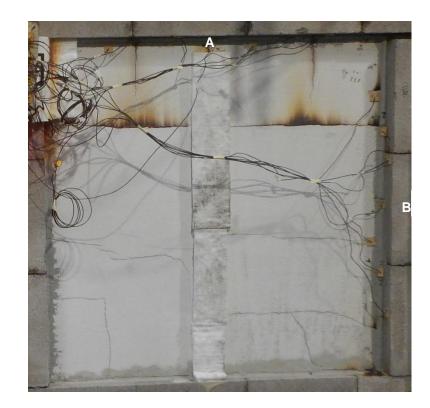
Figure 19 Unexposed face of the specimen at the end of the test
