# Fire resistance test report

Control joints tested in accordance with AS 1530.4:2014

Products: HB Fuller Firesound 1930 and HB Fuller Firesound 2090

Job number: FRT190135

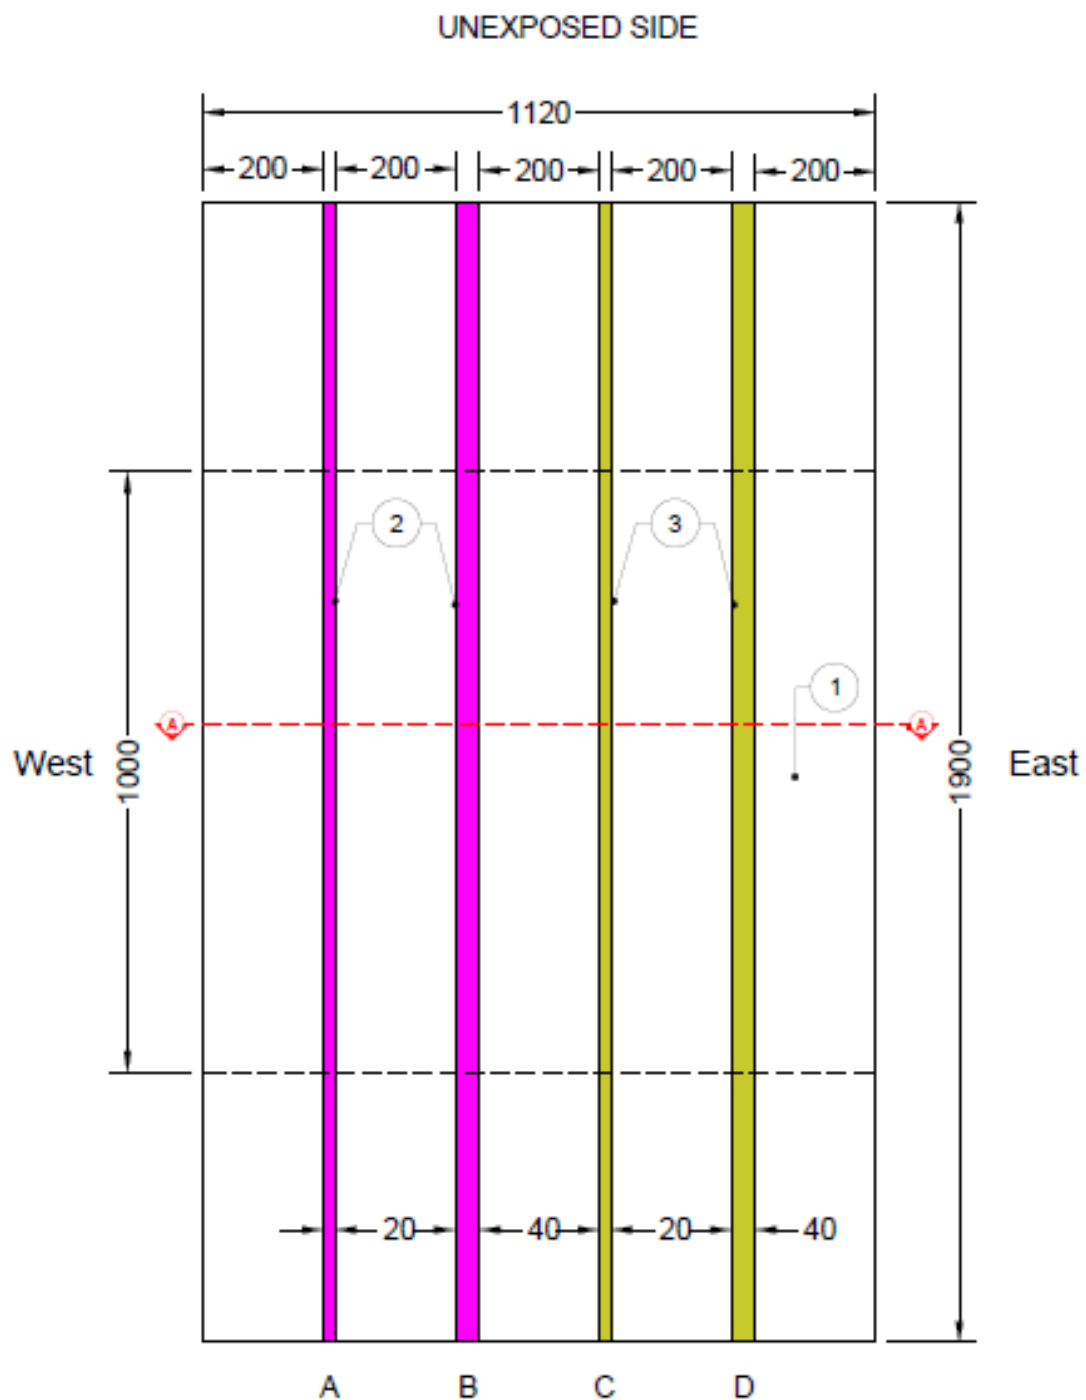
Figure 1 Elevation of test specimen (unexposed side)

Item	Description	
	Protection	Two backing rods (item 4) kept together to form an overall size 60mm x 20mm, was installed into the control joint at a depth of 20mm from both exposed and unexposed faces of wall. The sealant (item 2) was applied into the control joint to the depth of backing rod and finishing flush with the face of the wall. See Figure 1 and Figure 2 in Appendix A for more details.
<b>Control joint C</b>		
C	Control joint detail	Control Joint - nominally 1000mm long x 20mm wide, 10mm deep
	Aperture size	20mm x 1000mm
	Local fire-stopping protection	
	Protection	Backing rod (item 4) of size 30mm x 20mm, was installed into the control joint at a depth of 10mm from both exposed and unexposed faces of wall. The sealant (item 3) was applied into the control joint to the depth of backing rod and finishing flush with the face of the wall. See Figure 1 and Figure 2 in Appendix A for more details.

<b>Control joint D</b>		
D	Control joint detail	Control Joint - nominally 1000mm long x 40mm wide, 20mm deep
	Aperture size	40mm x 1000mm
	Local fire-stopping protection	
	Protection	Two backing rods (item 4) kept together to form an overall size 60mm x 20mm, was installed into the control joint at a depth of 20mm from both exposed and unexposed faces of wall. The sealant (item 3) was applied into the control joint to the depth of backing rod and finishing flush with the face of the wall. See Figure 1 and Figure 2 in Appendix A for more details.

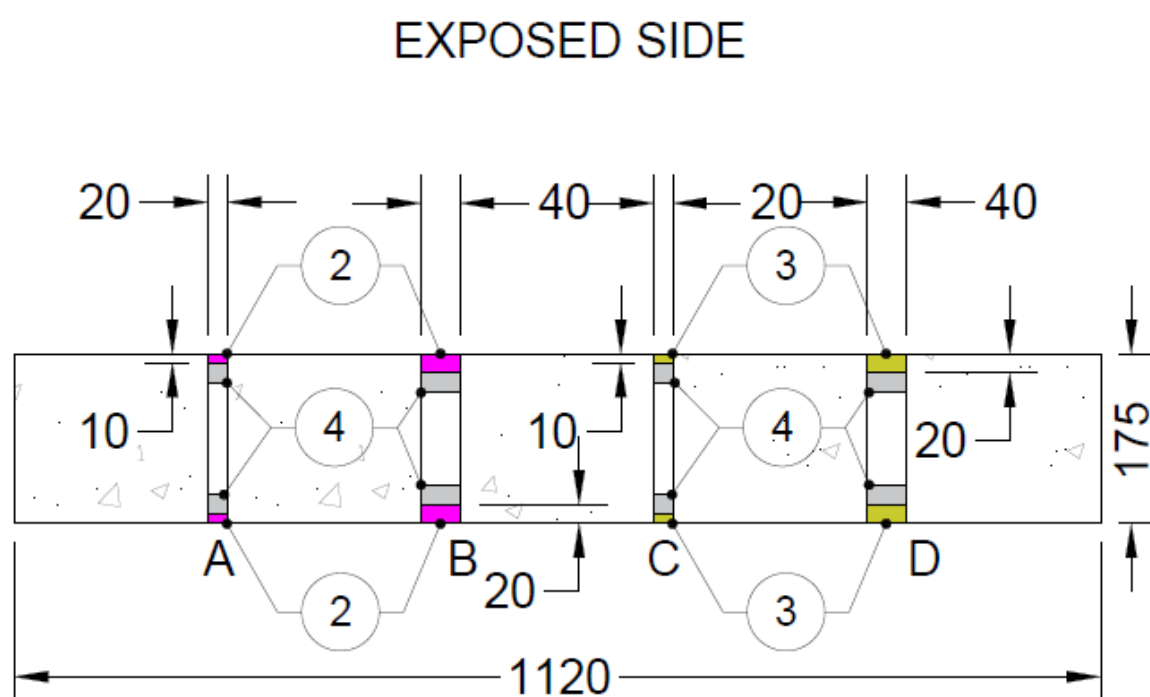
Figure 2 Cross-section A-A

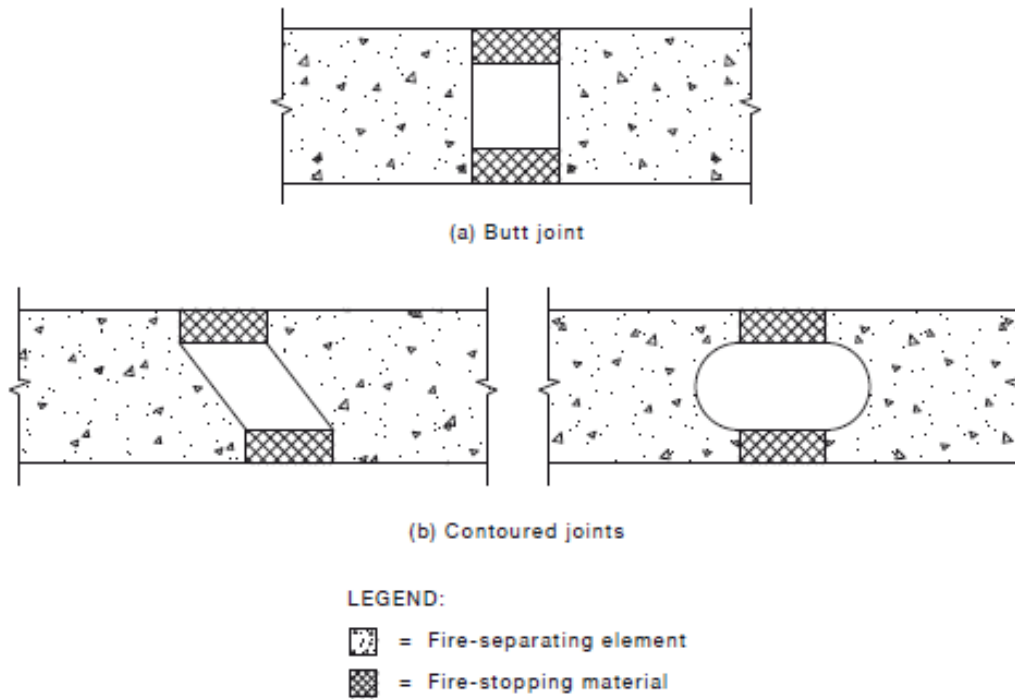
FIGURE 10.12.6 CONTOURED CONTROL JOINTS

Note: Examples of butt and contoured control joints are shown in Figure 10.12.6 of AS 1530.4:2014.
- Facings may be applied to the surface of the fire-stopping system.

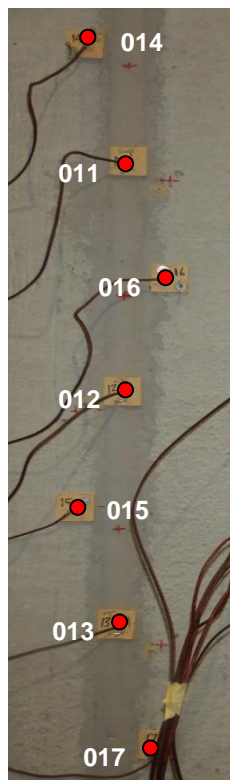
Figure 3

Control Joint A

Control joint	T/C no.	Description
A	011	On control joint, 250mm up from the centre.
	012	On control joint, at the centre.
	013	On control joint, 250mm down from the centre.
	014	25mm from control joint, 375mm up from the centre
	015	25mm from control joint, 125mm down from the centre
	016	25mm from control joint, 125mm up from the centre
	017	25mm from control joint, 375mm down from the centre
B	021	On control joint, 250mm up from the centre.
	022	On control joint, at the centre.
	023	On control joint, 250mm down from the centre.
	024	25mm from control joint, 375mm up from the centre
	025	25mm from control joint, 125mm down from the centre
	026	25mm from control joint, 125mm up from the centre
	027	25mm from control joint, 375mm down from the centre
C	031	On control joint, 250mm up from the centre.
	032	On control joint, at the centre.
	033	On control joint, 250mm down from the centre.
	034	25mm from control joint, 375mm up from the centre

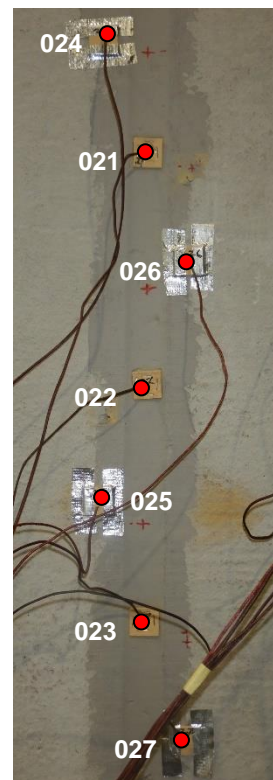
Figure 4

Control Joint B

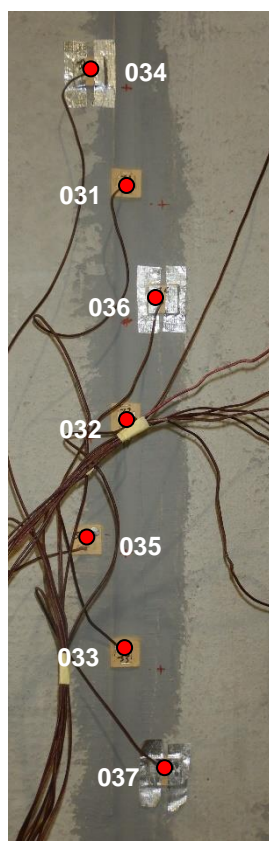
Figure 5

Control Joint C

035	25mm from control joint, 125mm down from the centre
	036	25mm from control joint, 125mm up from the centre
	037	25mm from control joint, 375mm down from the centre
D	041	On control joint, 250mm up from the centre.
	042	On control joint, at the centre.
	043	On control joint, 250mm down from the centre.
	044	25mm from control joint, 375mm up from the centre
	045	25mm from control joint, 125mm down from the centre
	046	25mm from control joint, 125mm up from the centre
	047	25mm from control joint, 375mm down from the centre

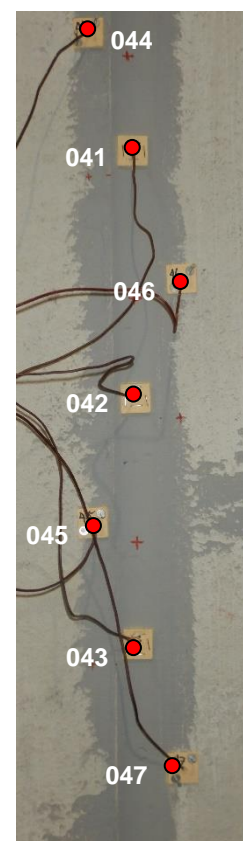
Figure 6

Control Joint D

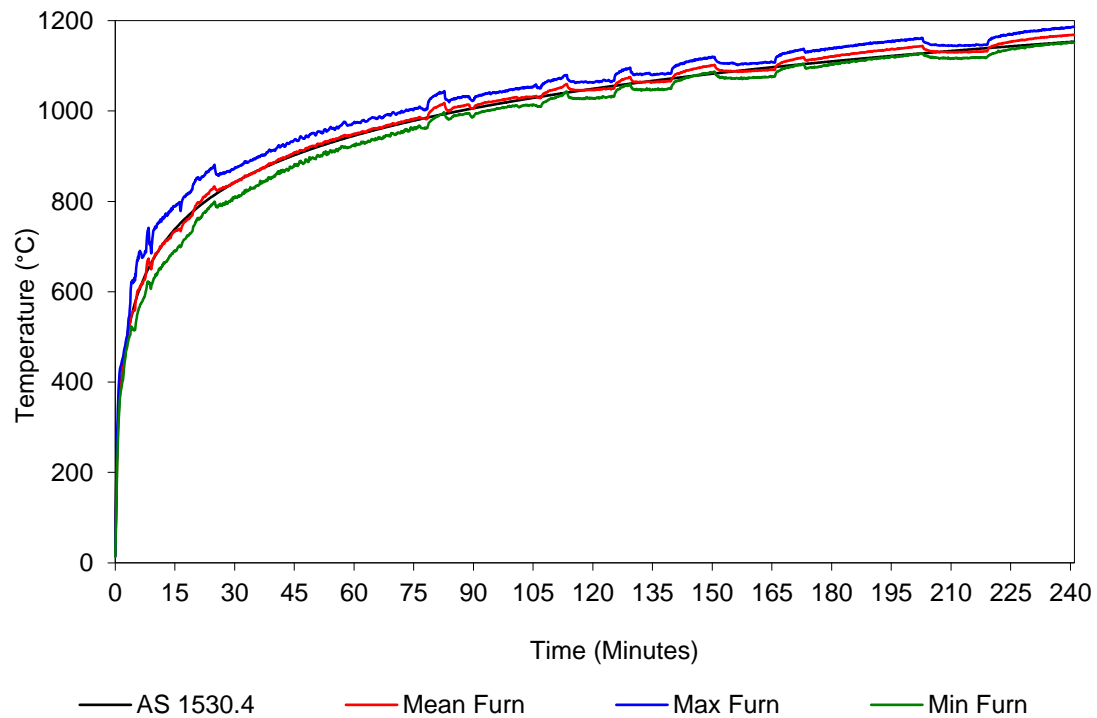
Figure 7 Furnace thermocouple temperature vs time

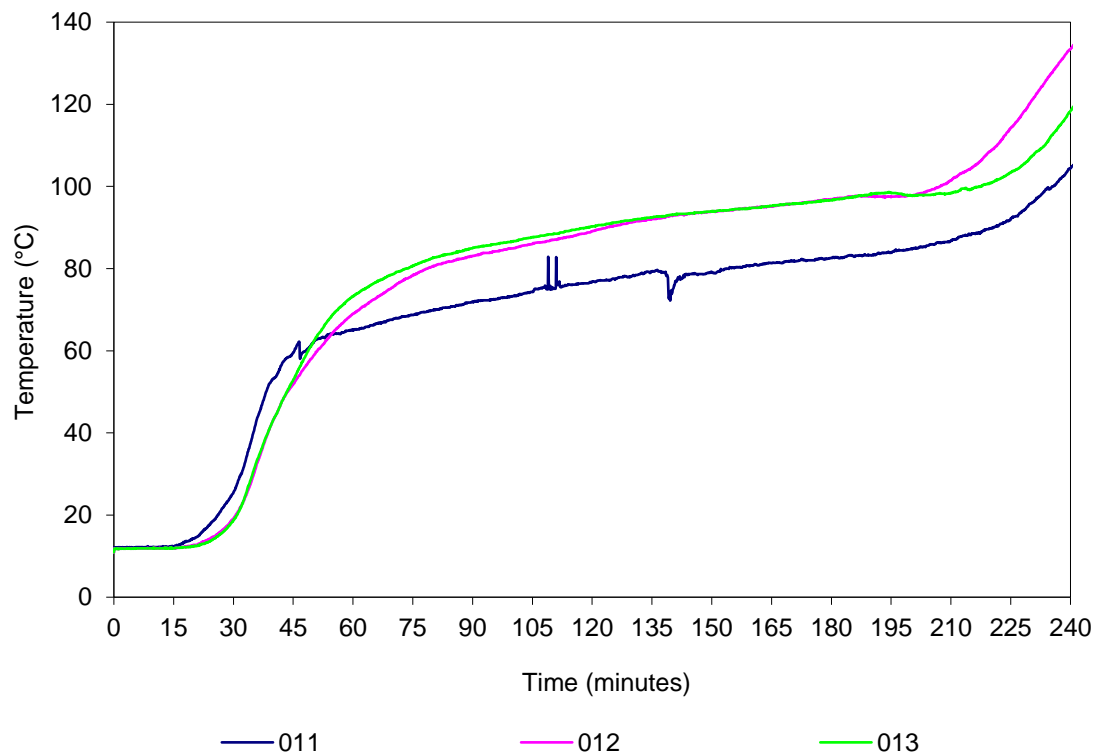
Figure 8 Control Joint A – temperature vs time

Control joint	T/C no.	Description <sup>2</sup>	Temp (°C) at t (minutes)					Limit <sup>1</sup> (minutes)
			t=0	t=60	t=120	t=180	t=240	
A	011	On control joint.	11	65	77	83	105	-
	012	On control joint.	11	69	89	97	134	-
	013	On control joint.	11	73	90	97	119	-
	014	25mm from control joint.	11	58	80	96	115	-
	015	25mm from control joint.	11	61	84	101	129	-
	016	25mm from control joint.	11	63	87	108	145	-
	017	25mm from control joint.	11	59	83	101	127	-
B	021	On control joint.	11	55	77	84	95	-
	022	On control joint.	11	60	85	90	101	-
	023	On control joint.	11	58	87	100	155	-
	024	25mm from control joint.	11	54	85	107	137	-
	025	25mm from control joint.	11	57	92	121	176	-
	026	25mm from control joint.	11	56	89	112	155	-
	027	25mm from control joint.	11	52	87	113	162	-
C	031	On control joint.	11	57	63	94	123	-
	032	On control joint.	11	63	89	96	153	-
	033	On control joint.	11	80	92	98	156	-
	034	25mm from control joint.	11	63	90	109	136	-

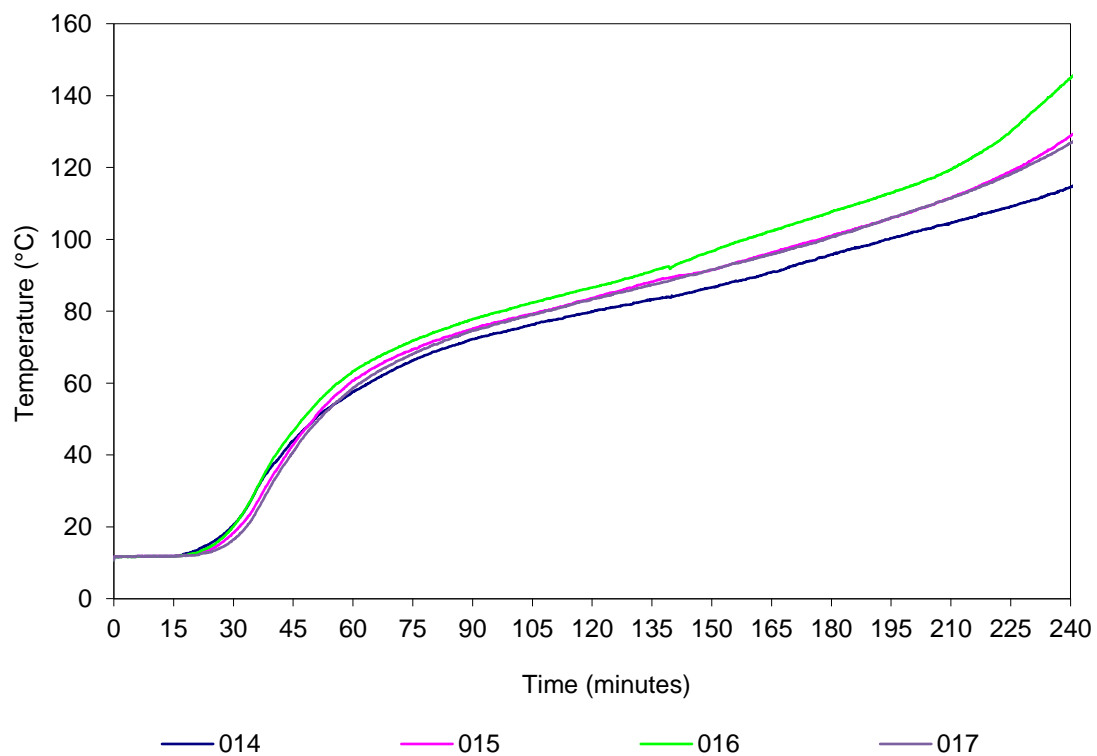
Figure 9 Control Joint A – temperature vs time

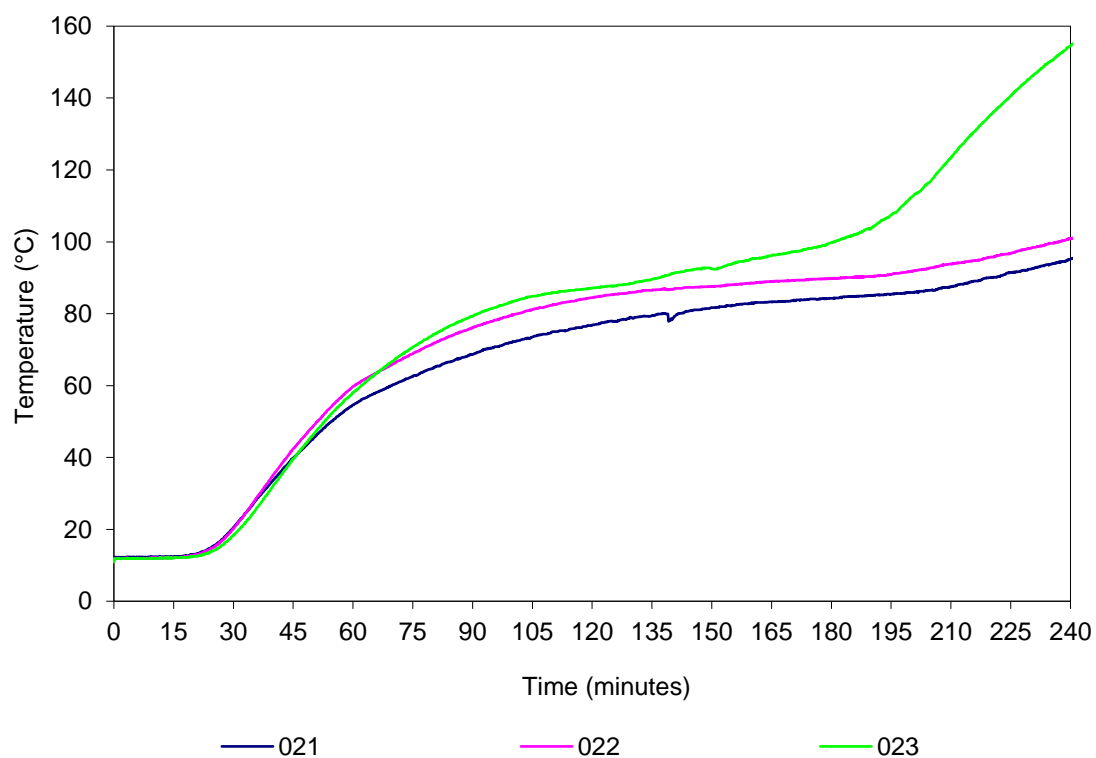
Figure 10 Control Joint B – temperature vs time

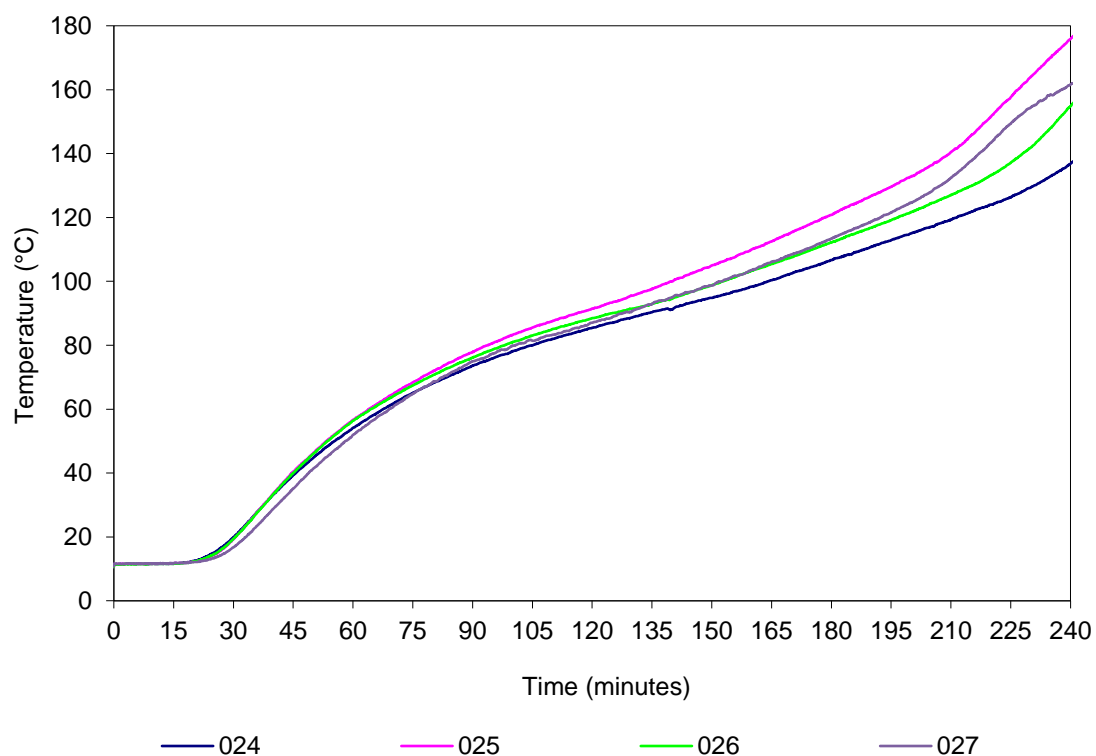
Figure 11 Control Joint B – temperature vs time

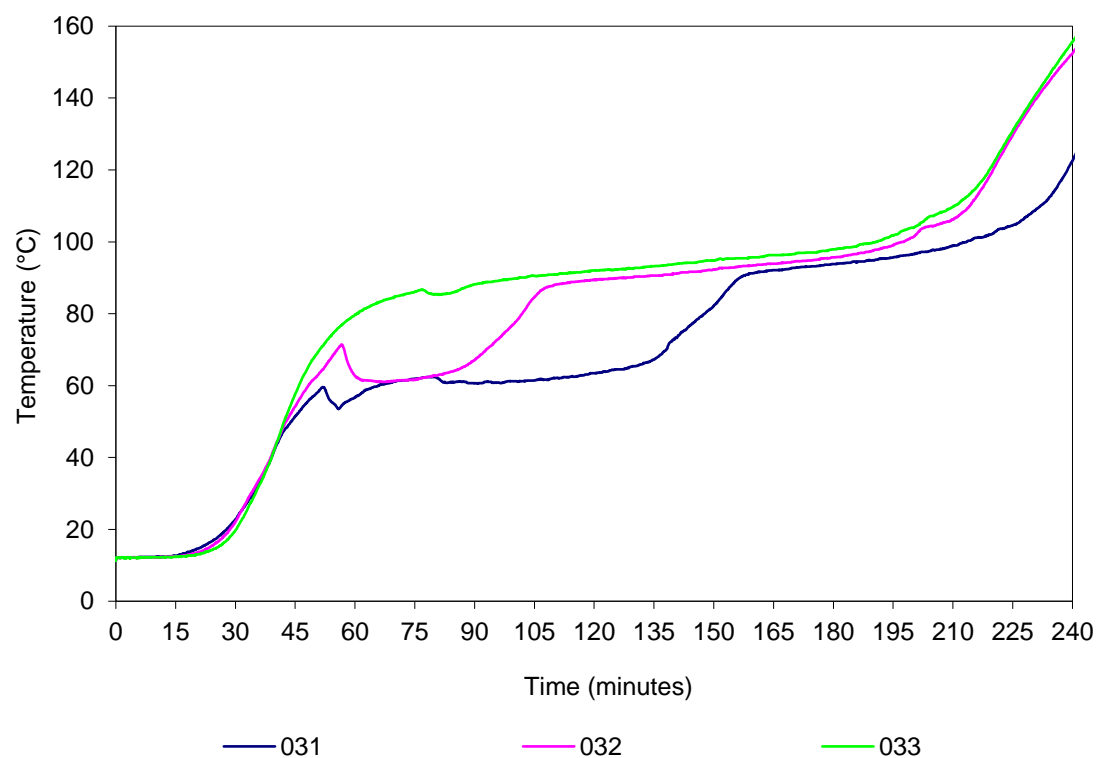
Figure 12 Control Joint C – temperature vs time

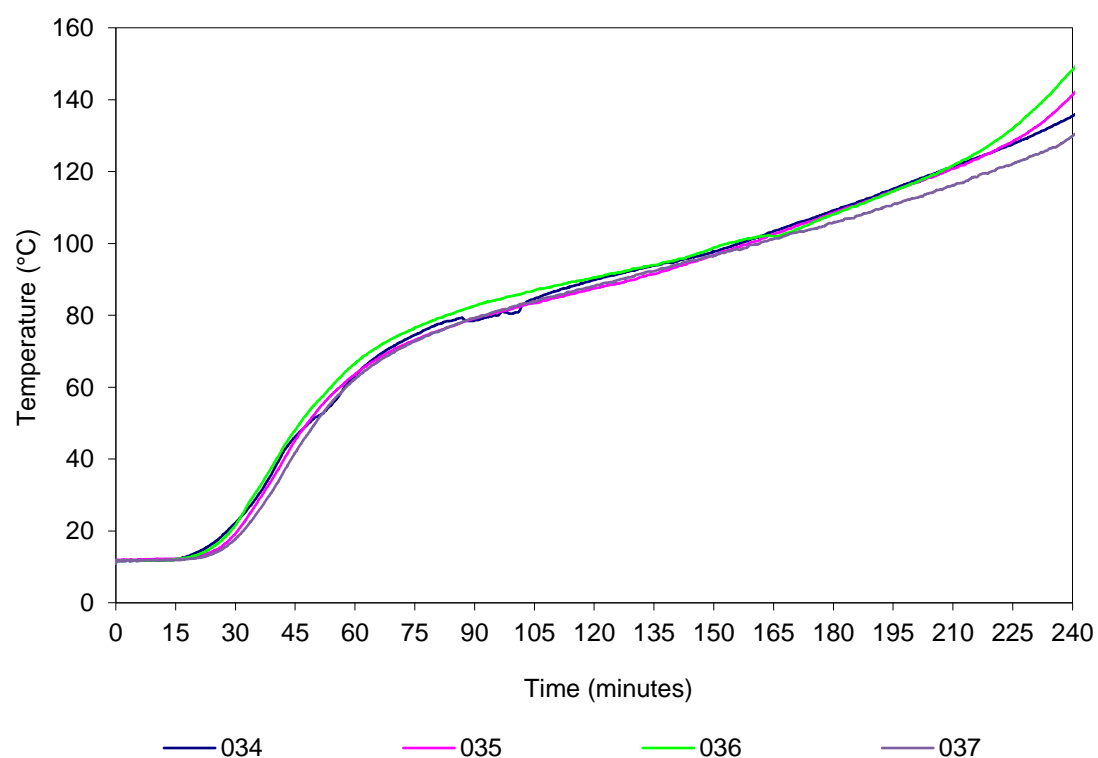
Figure 13 Control Joint C – temperature vs time

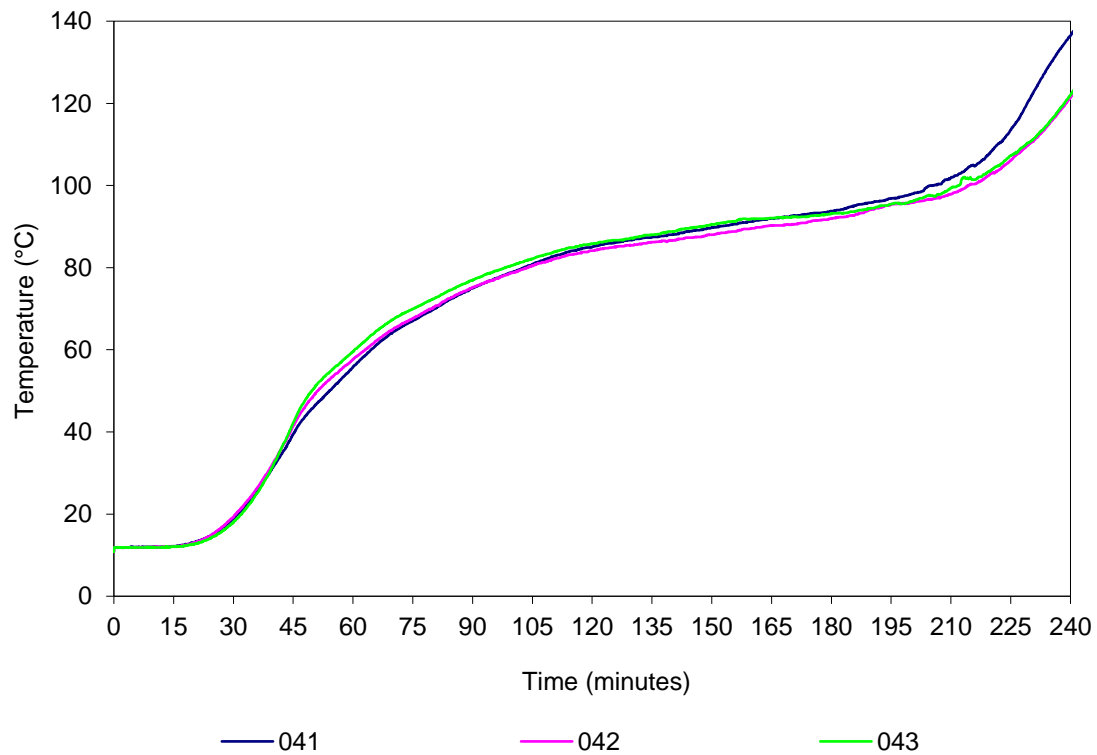
Figure 14 Control Joint D – temperature vs time

035	25mm from control joint.	11	64	88	109	141	-
	036	25mm from control joint.	11	67	91	108	148	-
	037	25mm from control joint.	11	62	88	106	130	-
D	041	On control joint.	11	56	85	94	137	-
	042	On control joint.	11	58	84	92	122	-
	043	On control joint.	11	60	86	93	122	-
	044	25mm from control joint.	11	53	86	109	146	-
	045	25mm from control joint.	11	58	87	111	152	-
	046	25mm from control joint.	11	53	85	107	137	-
	047	25mm from control joint.	11	51	82	101	122	-

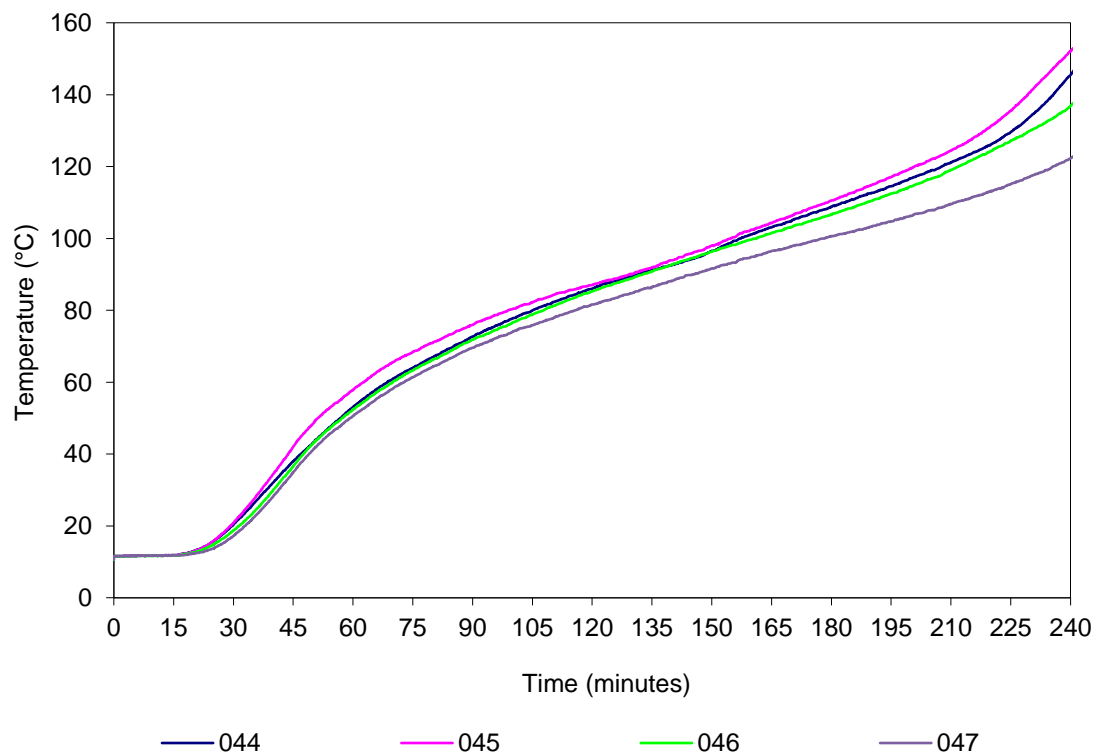
Figure 15 Control Joint D – temperature vs time

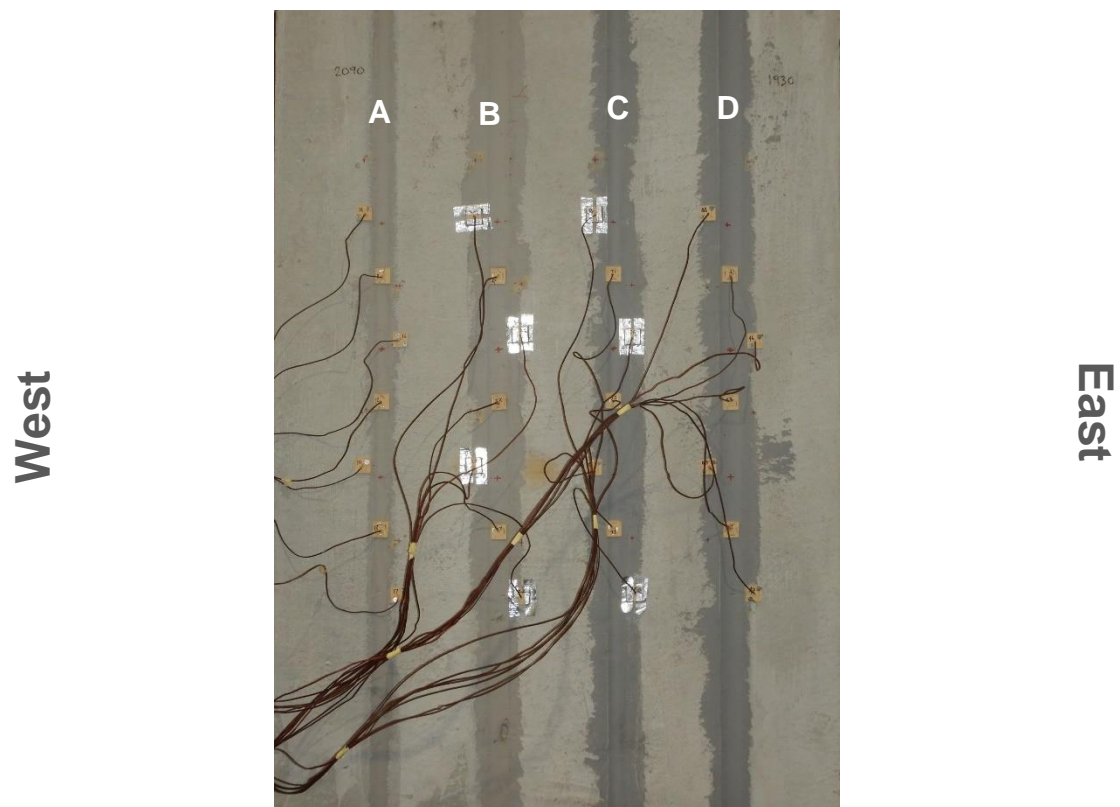
Figure 16 Unexposed face of the specimen before the start of the test

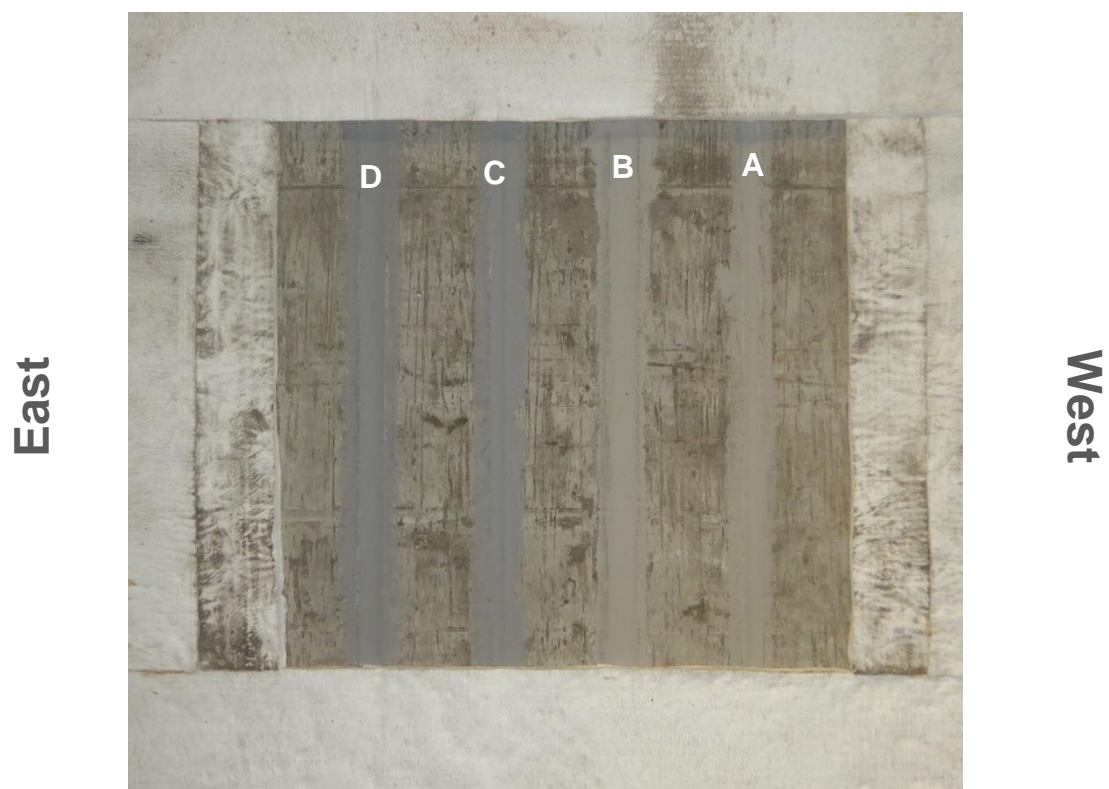
Figure 17 Exposed face of the specimen before the start of the test

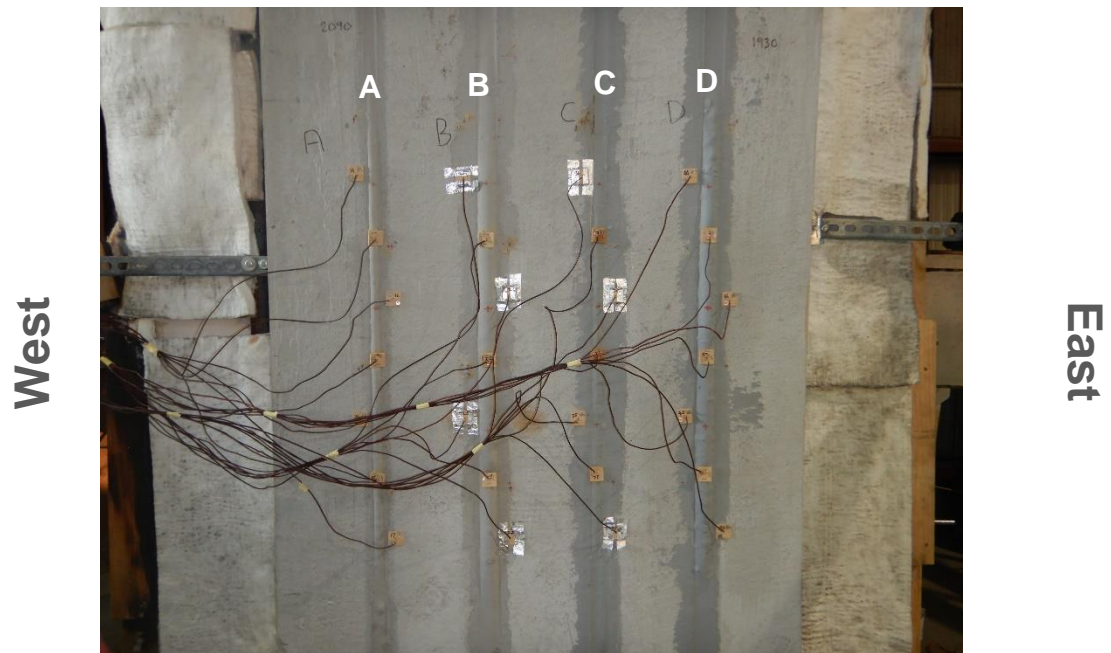
Figure 18 Unexposed face of the specimen at the end of the test

140	45	Sealant had bulged on the control joint.
150	00	Specimen continued to maintain integrity and insulation in accordance with AS 1530.4:2014.
176	35	Bulging on the sealant increased on the control joint.
180	00	Specimen continued to maintain integrity and insulation in accordance with AS 1530.4:2014.
240	00	Specimen continued to maintain integrity and insulation in accordance with AS 1530.4:2014.
241	00	Fire resistance test stopped.
Control Joint C		
00	00	Fire resistance test started, and the initial temperature of the specimen was approximately 11°C.
15	00	Specimen continued to maintain integrity and insulation in accordance with AS 1530.4:2014.

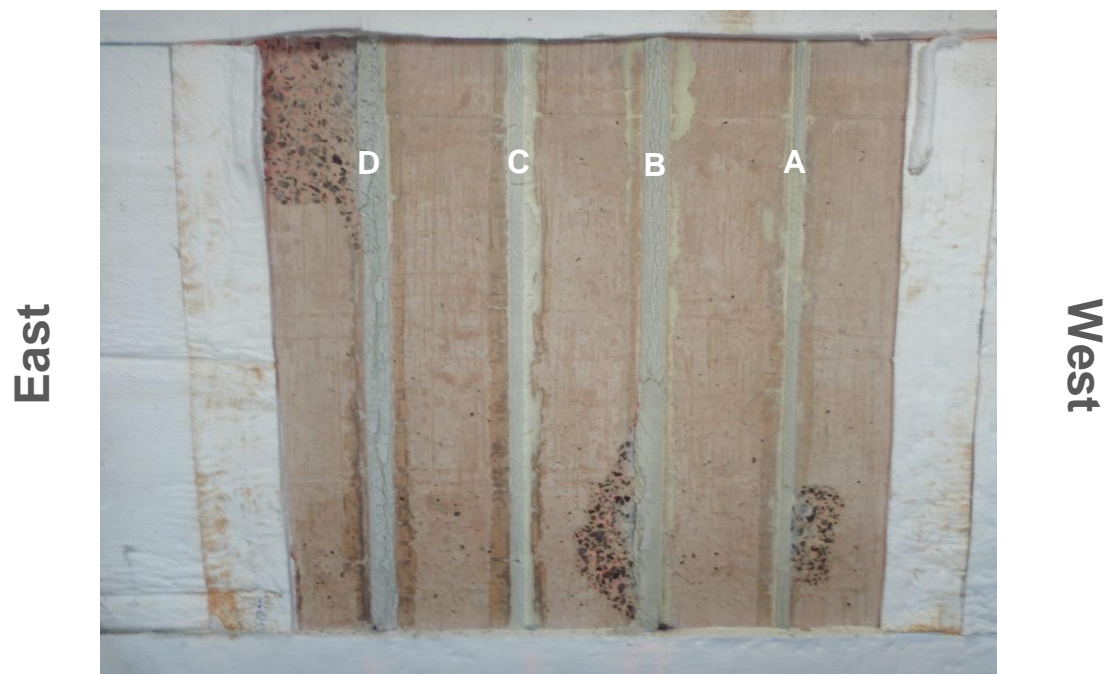
Figure 19 Exposed face of the specimen at the end of the test
