Fire resistance test report

Test standard: Sections 2 and 10 of AS 1530.4:2014

Products: H B Fuller Firesound Original Grey

Job number: FRT200212

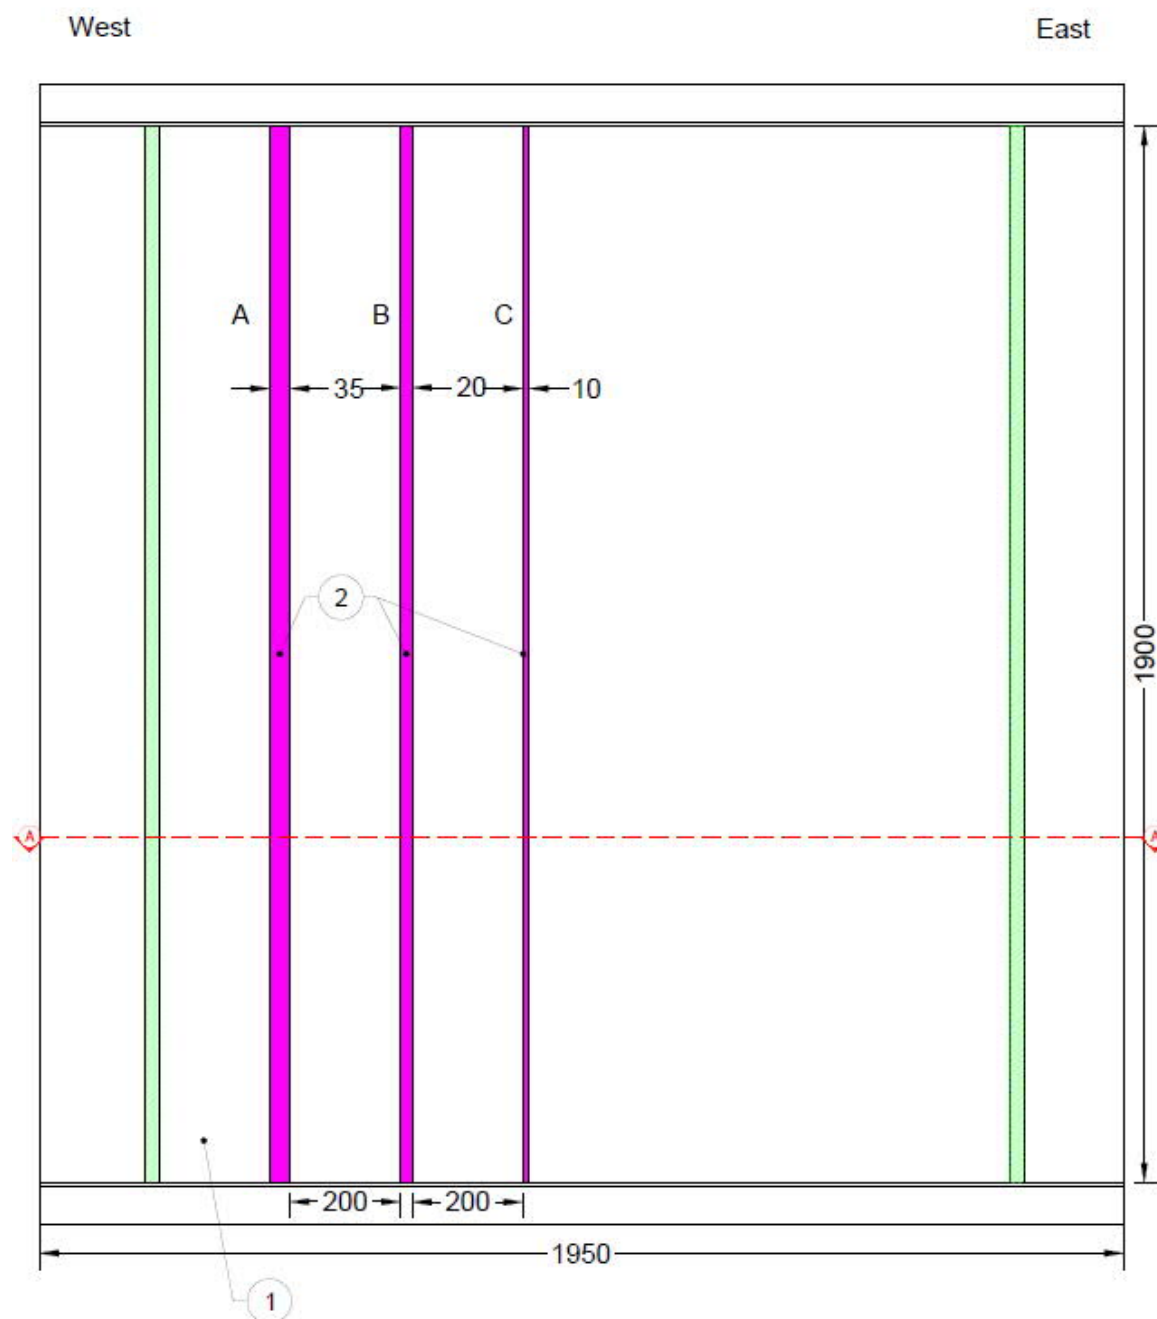
Figure 1 Elevation view of test specimen (unexposed side)

Aperture size	20 mm × 1000 mm	
	Local fire-stopping protection		
	Protection	30 mm wide × 20 mm deep open cell backing rod (item 3), was installed into the control joint at a depth of 15 mm from the unexposed side. The sealant (item 2) was applied into the control joint to the depth of the backing rod and finished flush with the unexposed face of the separating element only. See Figure 1, Figure 2 and Figure 3 in Appendix A for more details.	
Control joint C			
C	Control joint size	Nominally 1000 mm long × 10 mm wide, 10 mm deep. Backing rod and sealant applied on the unexposed side only.	
	Aperture size	10 mm × 1000 mm	
	Local fire-stopping protection		
	Protection	15 mm wide × 15 mm deep open cell backing rod (item 3), was installed into the control joint at a depth of 10 mm from the unexposed side. The sealant (item 2) was applied into the control joint to the depth of the backing rod and finished flush with the unexposed face of the separating element only. See Figure 1, Figure 2 and Figure 3 in Appendix A for more details.

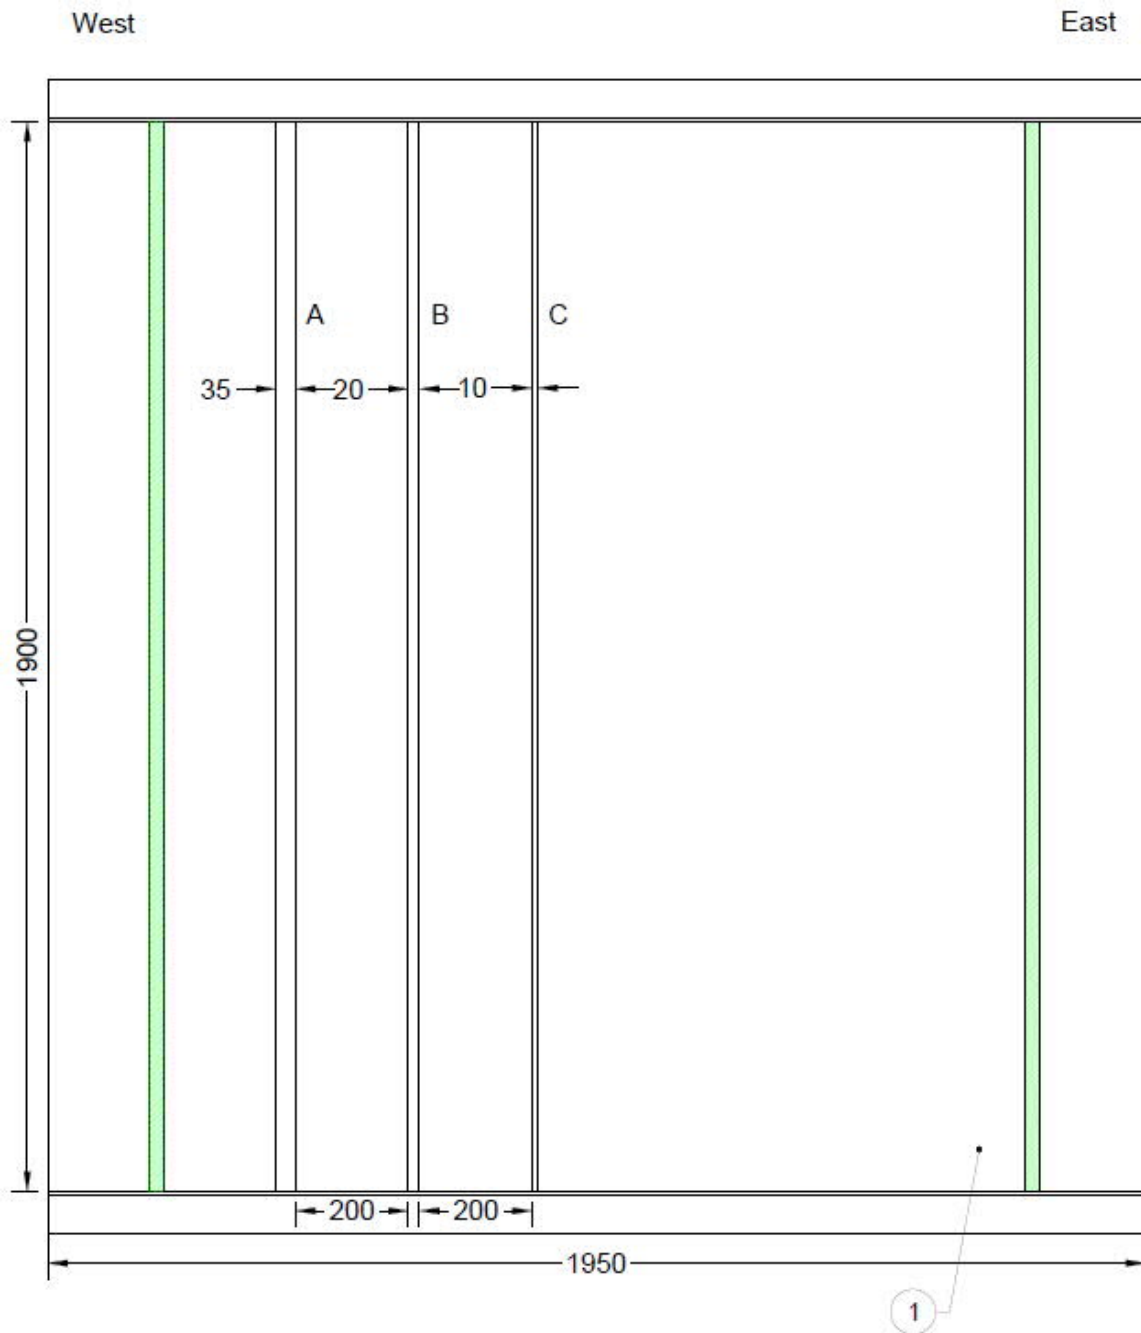
Figure 2 Elevation view of test specimen (exposed side)

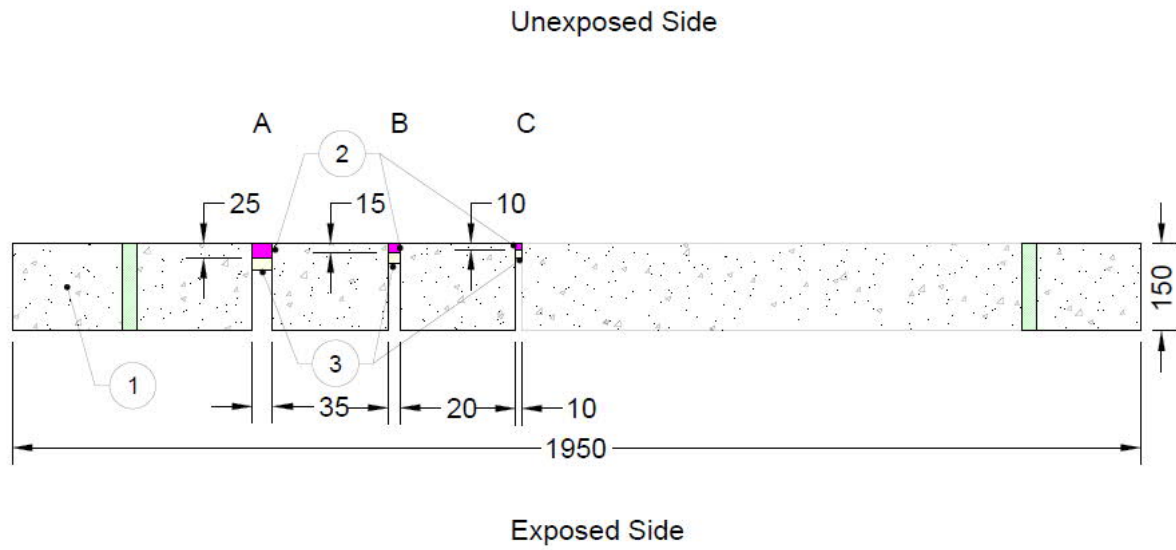
Figure 3 Cross-section A-A

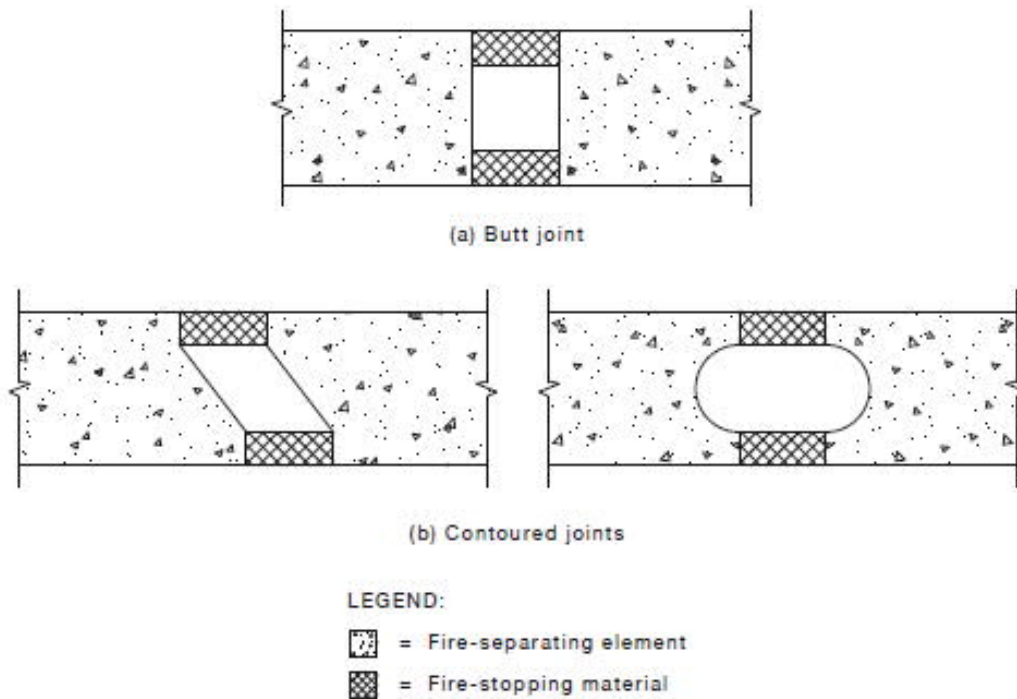
FIGURE 10.12.6 CONTOURED CONTROL JOINTS

- Results obtained from single test on a butt joints may be applied to contoured joints, provided the joints have —
 - equal width and equal or greater depth of sealant; and
 - equal or greater thickness of fire-separating element.
 - Note: Examples of butt and contoured control joints are shown in figure 10.12.6 of AS 1530.4:2014.
- Facings may be applied to the surface of the fire-stopping system.

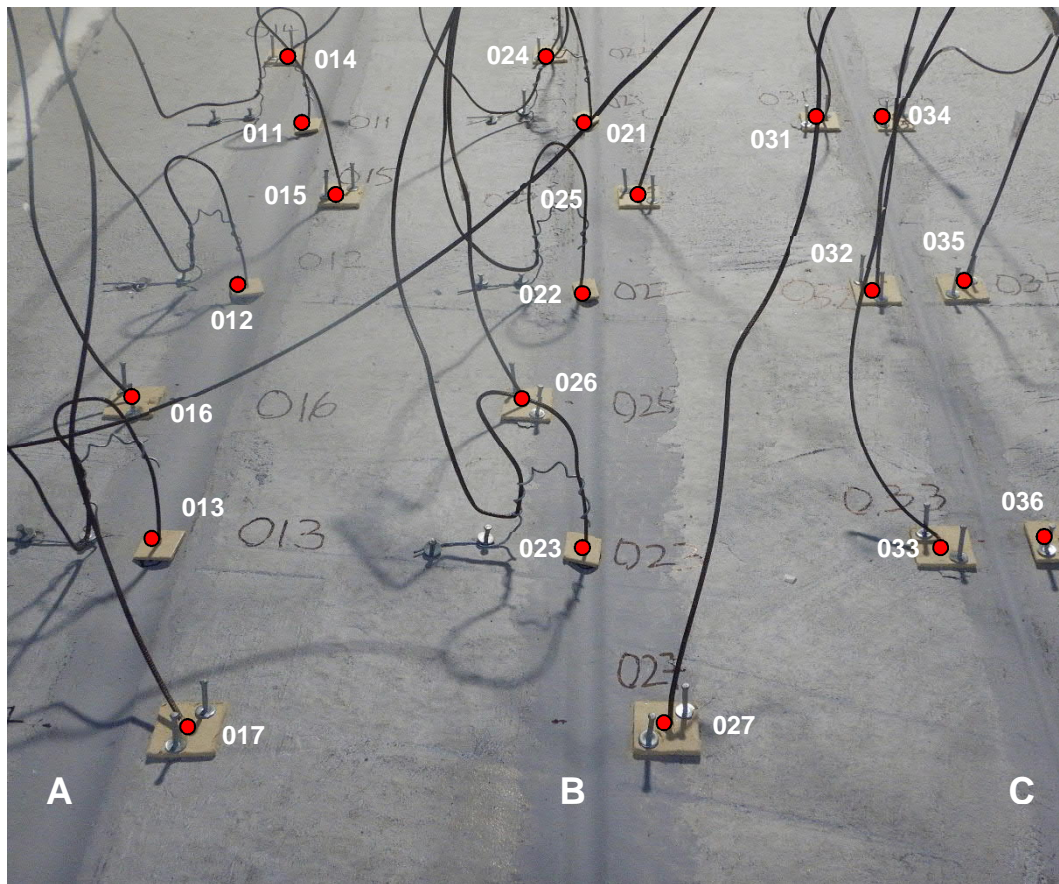
Figure 4 Unexposed side thermocouples – Control joints A, B and C

Control joint	T/C #	Description
A	011	On control joint, 250 mm north from the centre.
	012	On control joint, at the centre
	013	On control joint, 250 mm south from the centre.
	014	On the separating element, 25 mm from the west edge of the control joint and 375 mm north from the centre of the control joint.
	015	On the separating element, 25 mm from the east edge of the control joint and 125 mm north from the centre of the control joint.
	016	On the separating element, 25 mm from the west edge of the control joint and 125 mm south from the centre of the control joint.
	017	On the separating element, 25 mm from the east edge of the control joint and 375 mm south from the centre of the control joint.
B	021	On control joint, 250 mm north from the centre.
	022	On control joint, at the centre
	023	On control joint, 250 mm south from the centre.
	024	On the separating element, 25 mm from the west edge of the control joint and 375 mm north from the centre of the control joint.

025	On the separating element, 25 mm from the east edge of the control joint and 125 mm north from the centre of the control joint.
	026	On the separating element, 25 mm from the west edge of the control joint and 125 mm south from the centre of the control joint.
	027	On the separating element, 25 mm from the east edge of the control joint and 375 mm south from the centre of the control joint.
C	031	On the separating element, 25 mm from the west edge of the control joint and 250 mm north from the centre of the control joint.
	032	On the separating element, 25 mm from the west edge of the control joint at the centre of the control joint.
	033	On the separating element, 25 mm from the west edge of the control joint and 250 mm south from the centre of the control joint.
	034	On the separating element, 25 mm from the east edge of the control joint and 250 mm north from the centre of the control joint.

035	On the separating element, 25 mm from the east edge of the control joint at the centre of the control joint.
	036	On the separating element, 25 mm from the east edge of the control joint and 250 mm south from the centre of the control joint.

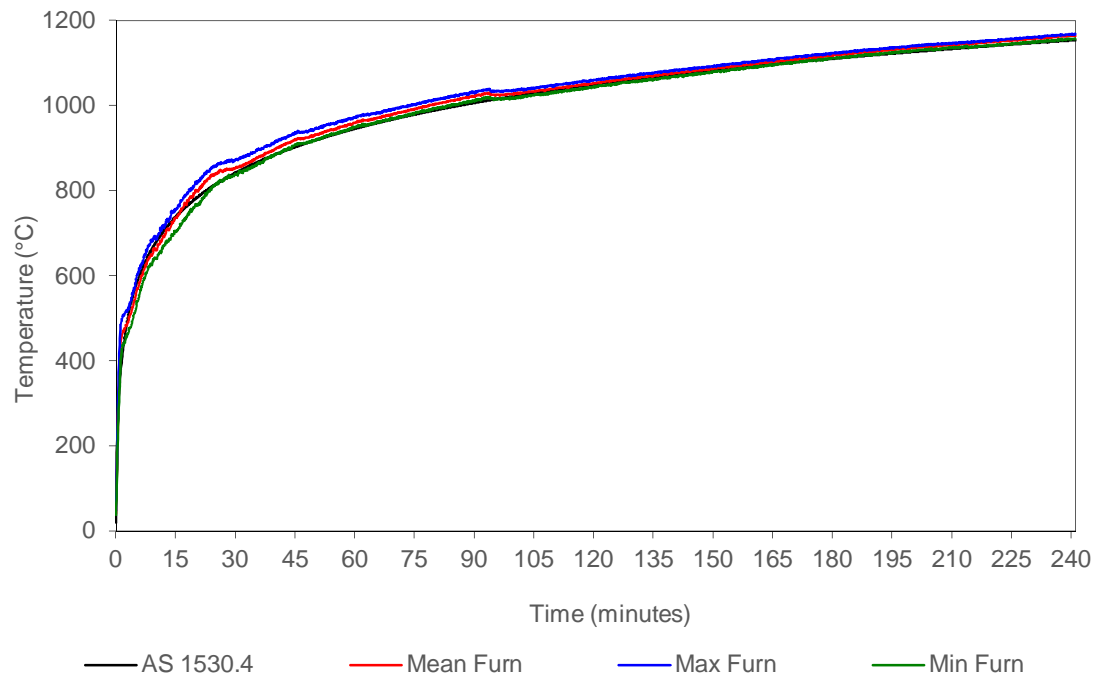
Figure 5 Furnace thermocouple temperature vs time

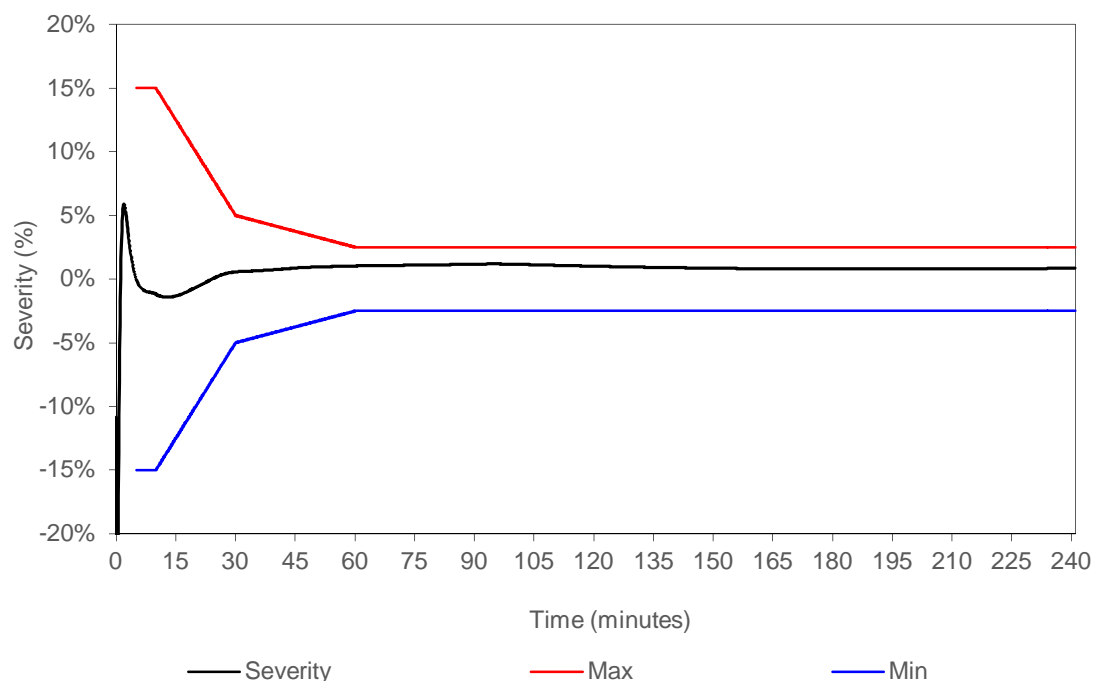
Figure 6 The percentage deviation of exposure severity vs time

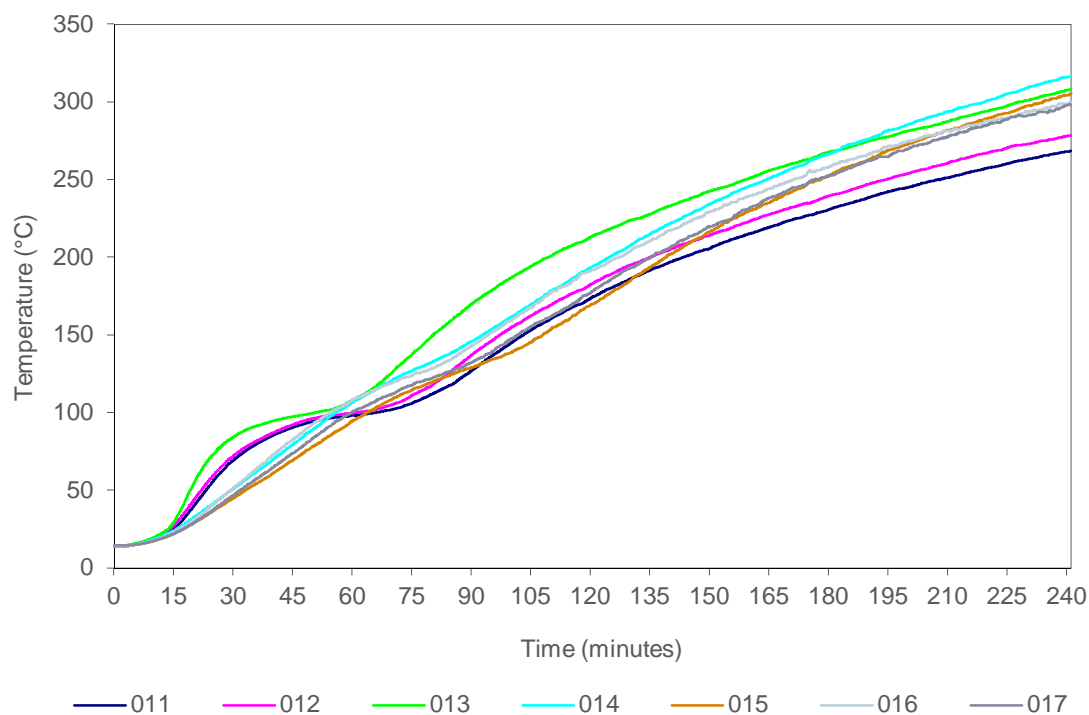
Figure 7 Control joint A– temperature vs time

Control joint	T/C #	Description ¹	Temp (°C) at t (minutes)					Limit ² (minutes)
			t=0	t=60	t=120	t=180	t=240	
A	011	On control joint.	14	98	174	231	268	137
	012	On control joint.	14	100	182	239	278	129
	013	On control joint.	14	108	213	268	308	105
	014	25 mm from the west edge of the control joint.	14	107	193	266	316	120
	015	25 mm from the east edge of the control joint.	14	94	169	252	304	135
	016	25 mm from the west edge of the control joint.	14	108	191	258	299	122
	017	25 mm from the east edge of the control joint.	14	100	177	252	298	131
B	021	On control joint.	14	100	189	246	276	124
	022	On control joint.	14	75	147	207	236	162
	023	On control joint.	14	88	157	220	257	152
	024	25 mm from the west edge of the control joint.	14	86	160	246	291	139
	025	25 mm from the east edge of the control joint.	14	82	141	227	272	152
	026	25 mm from the west edge of the control joint.	14	76	131	208	254	167

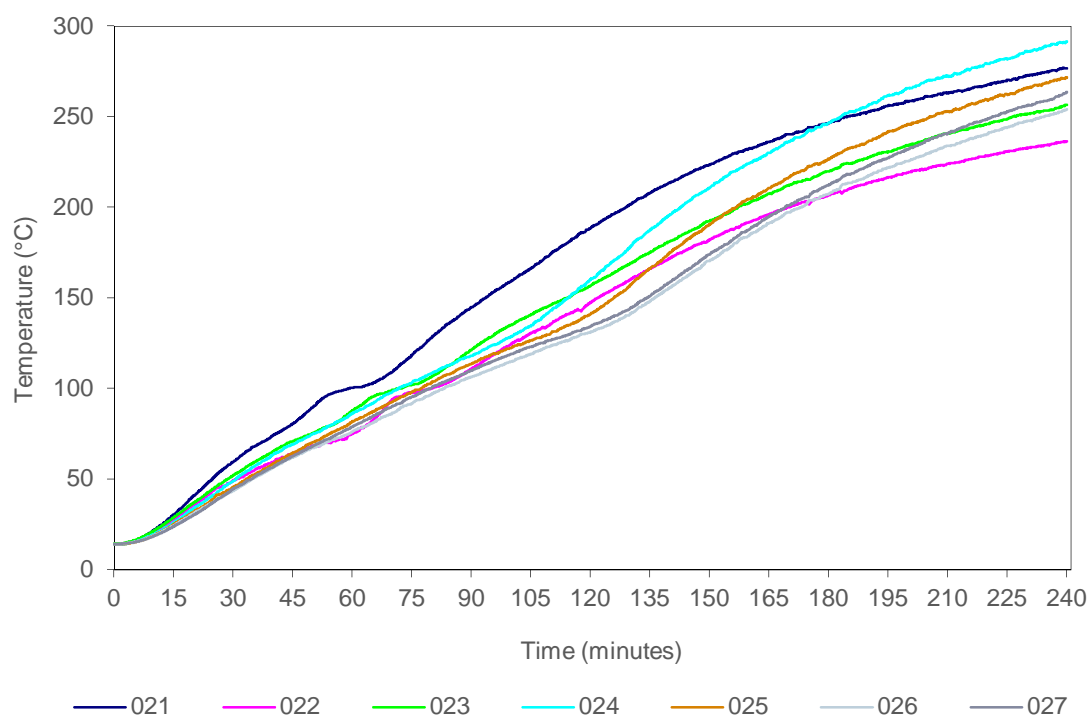
Figure 8 Control joint B– temperature vs time

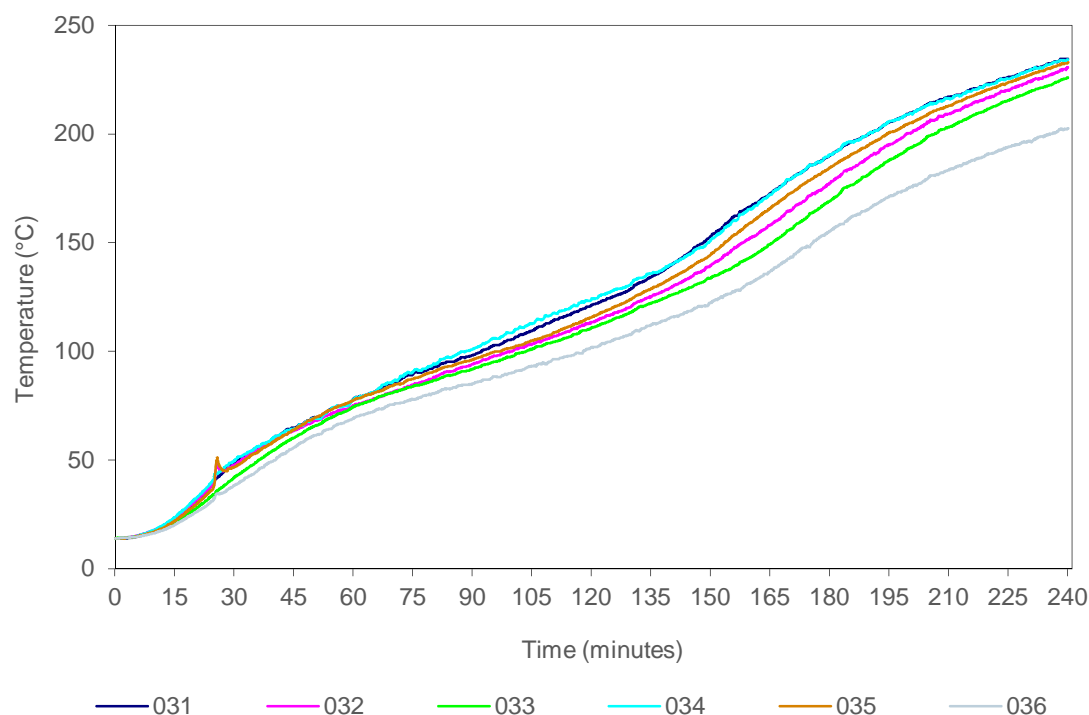
Figure 9 Control joint C– temperature vs time

Control joint	T/C #	Description ¹	Temp (°C) at t (minutes)					Limit ² (minutes)
			t=0	t=60	t=120	t=180	t=240	
	027	25 mm from the east edge of the control joint.	14	79	134	213	264	164
C	031	25 mm from the west edge of the control joint.	14	78	121	190	235	183
	032	25 mm from the west edge of the control joint.	14	75	114	177	231	193
	033	25 mm from the west edge of the control joint.	14	74	111	169	226	201
	034	25 mm from the east edge of the control joint.	14	78	124	190	234	183
	035	25 mm from the east edge of the control joint.	14	78	116	185	233	189
	036	25 mm from the east edge of the control joint.	14	69	102	155	203	225

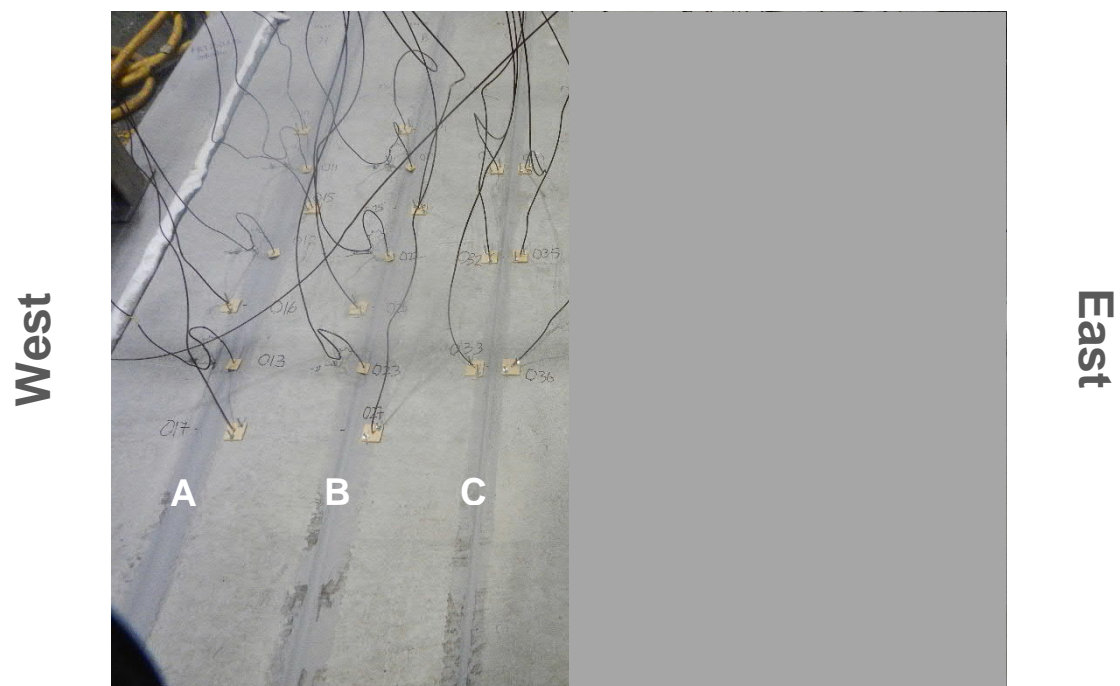
Figure 10 Unexposed face of the specimen before the start of the test

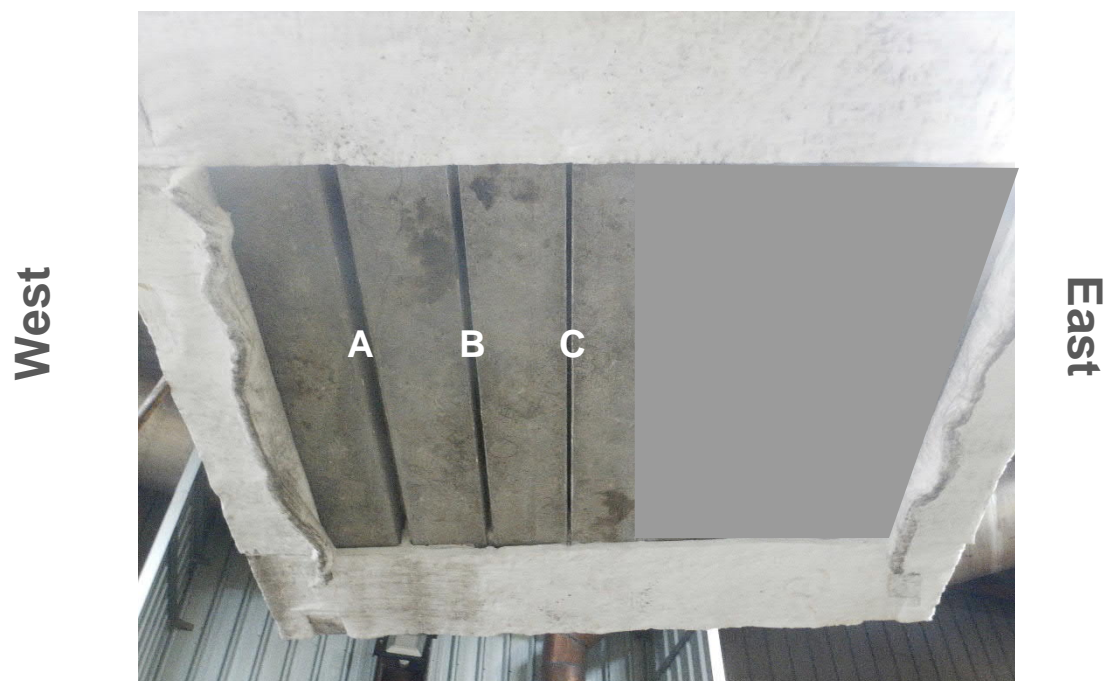
Figure 11 Exposed face of the specimen before the start of the test

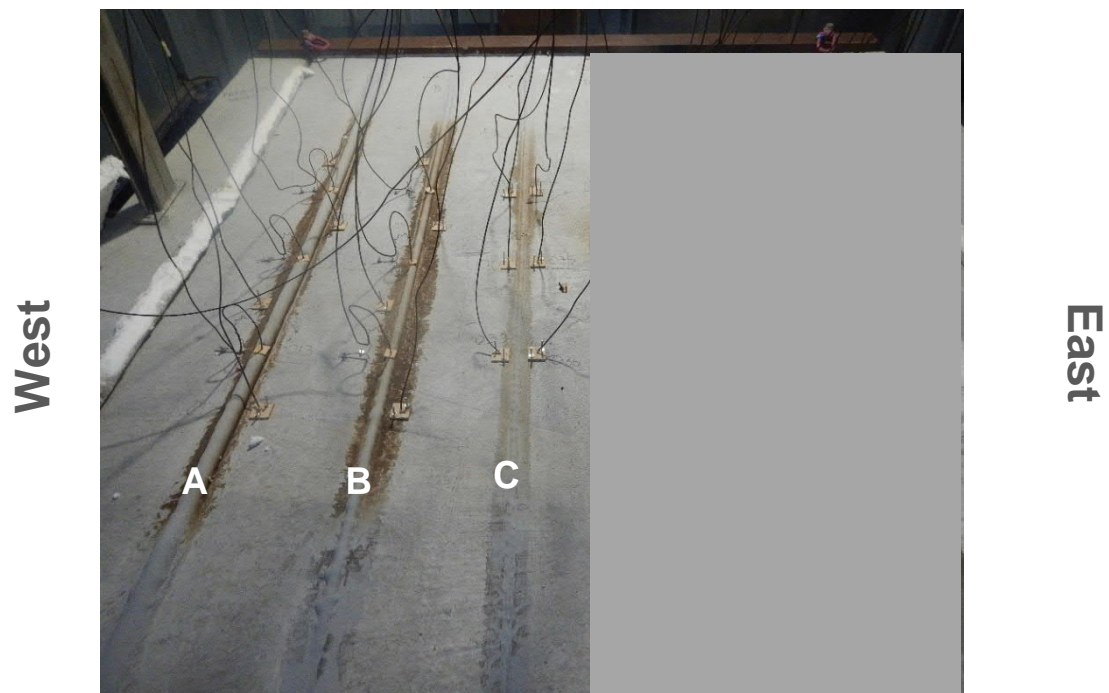
Figure 12 Unexposed face of the specimen at the end of the test

181	00	Discoloration on the separating element near the control joints.
240	00	The test specimen continued to maintain integrity in accordance with AS 1530.4:2014.
241	00	Test stopped.

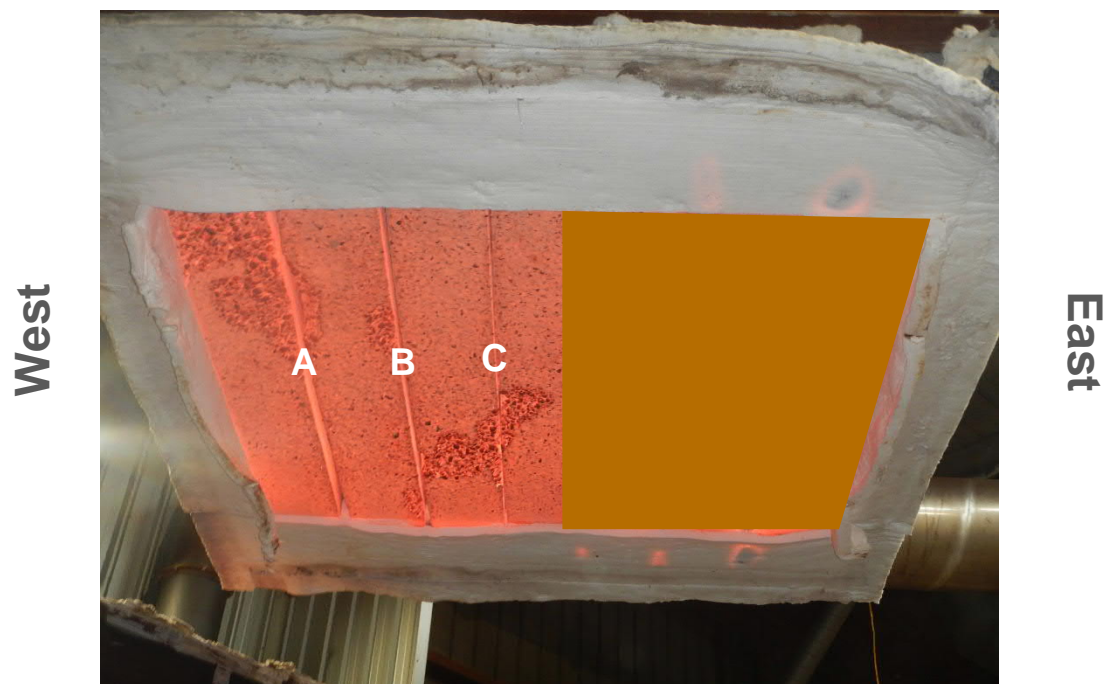
Figure 13 Exposed face of the specimen at the end of the test
