Fire resistance test report

Test standard: Sections 2 and 10 of AS 1530.4:2014

Test sponsor: H B Fuller Australia Pty Ltd

Job number: FRT200220

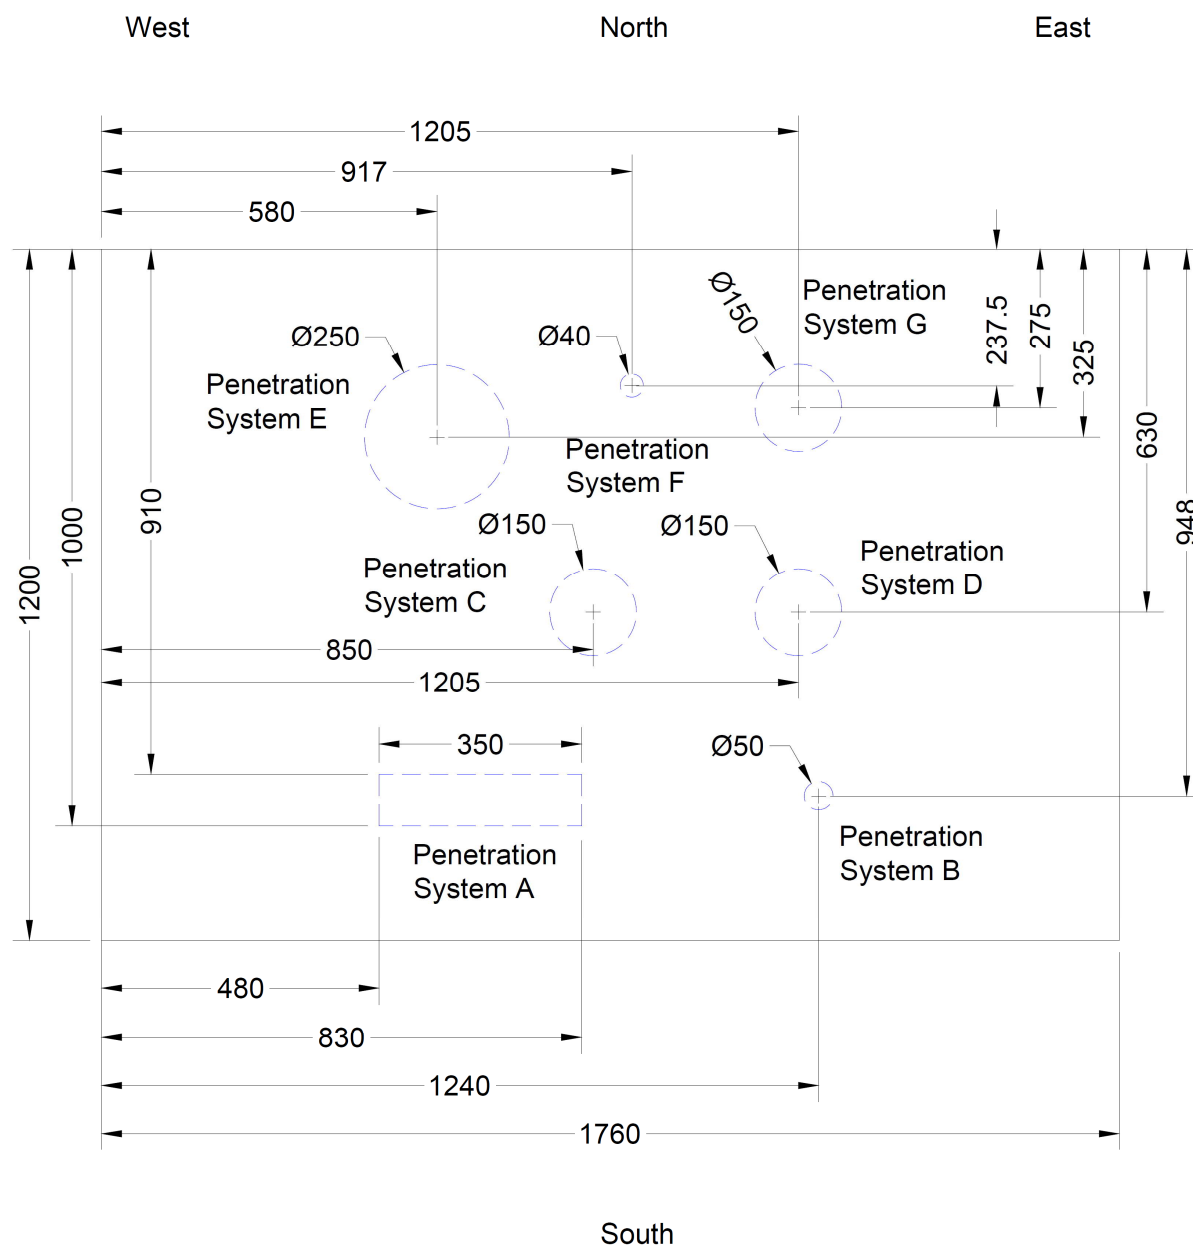
Figure 1 Core hole locations of test specimen (unexposed side)

The leaders in the drawings represent the items listed in section 2.1. All measurements – unless indicated – are in millimetres.

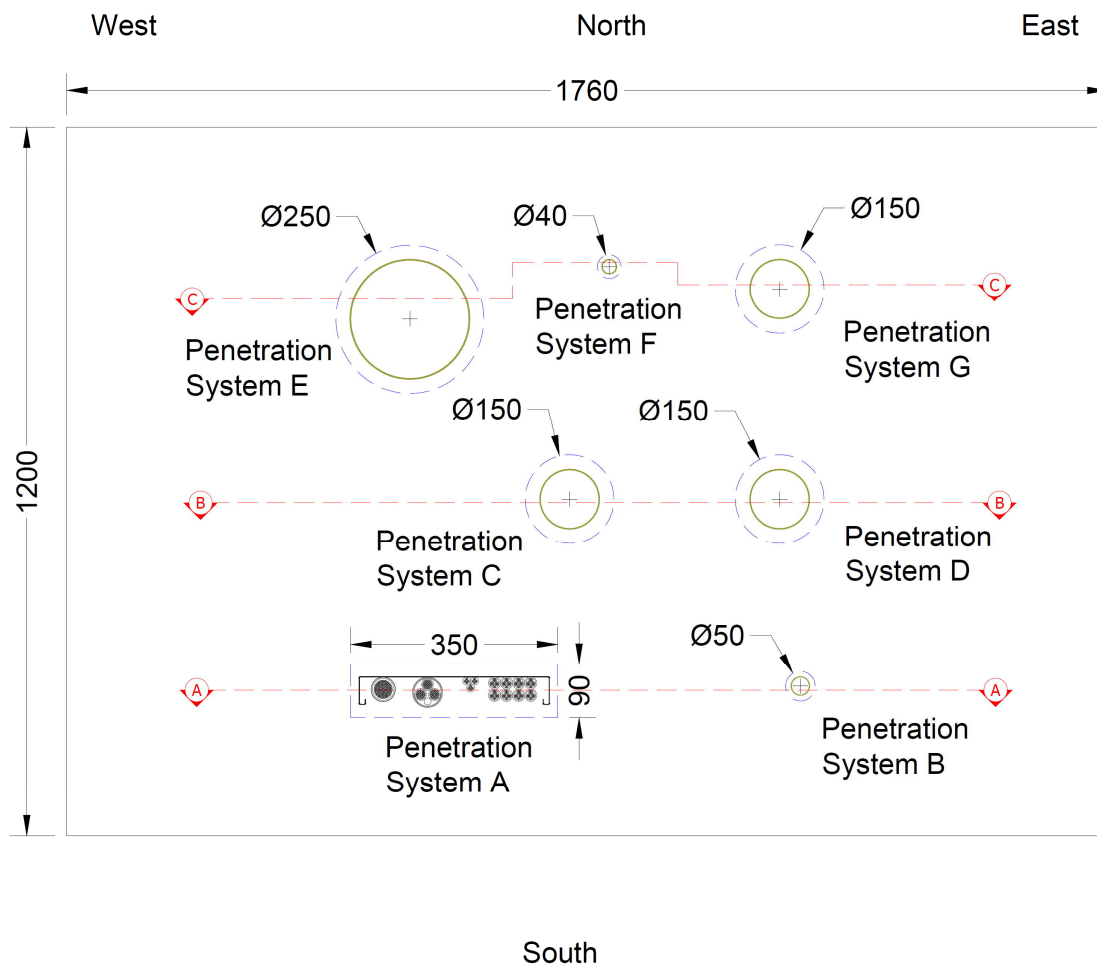
Figure 2 Plan view of test specimen (unexposed side)

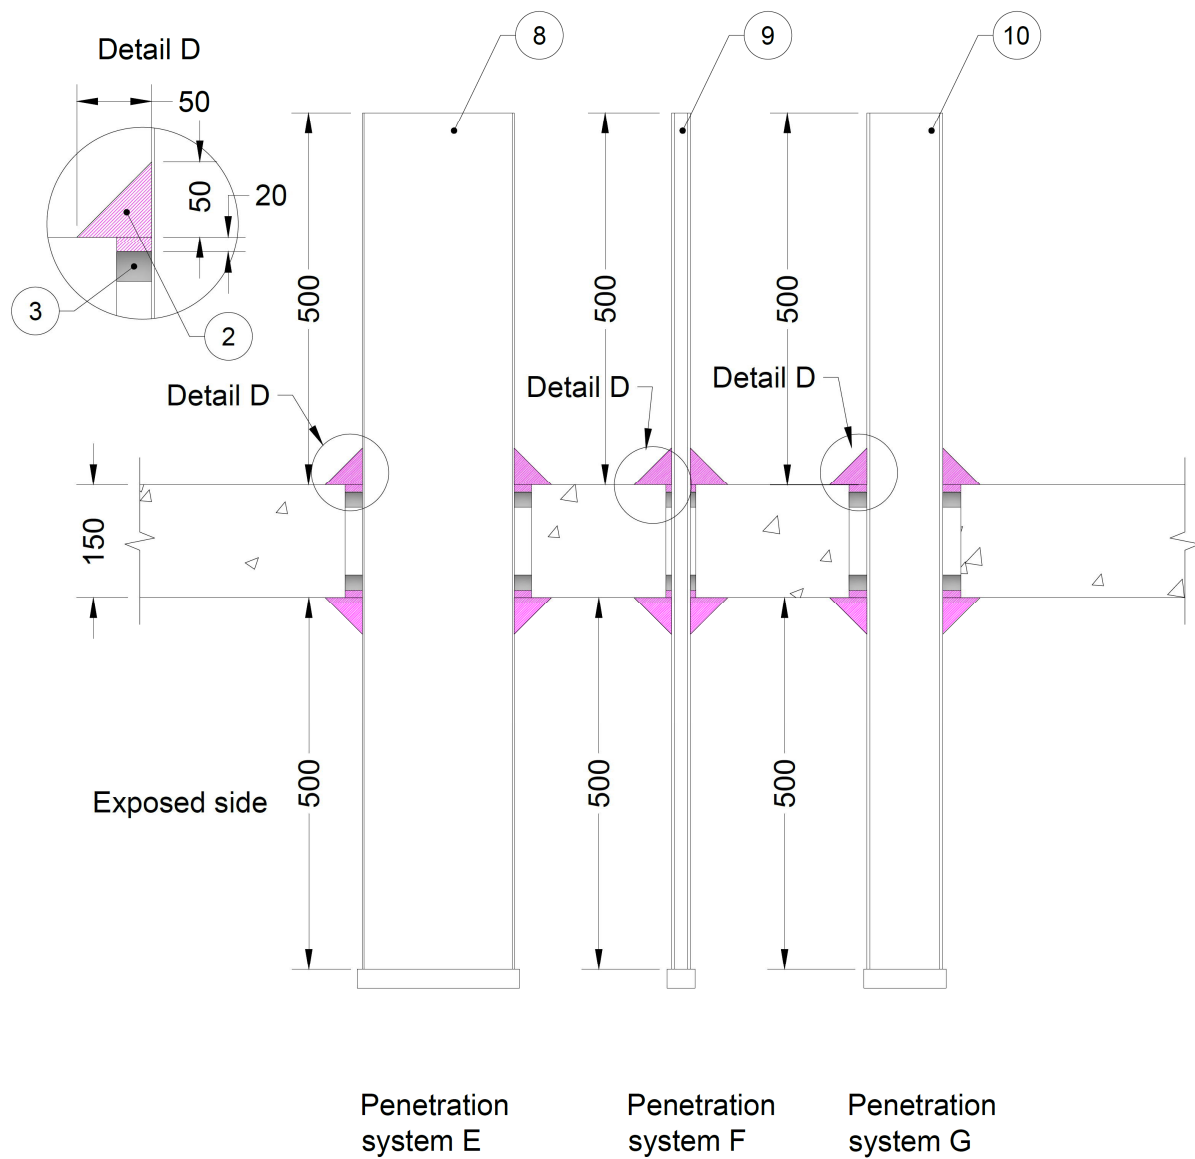
Figure 5 Cross-section C-C
