**FIRE RESISTANCE TEST IN GENERAL ACCORDANCE WITH
 AS 1530.4-1997 SECTIONS 2, 3 & 10 AS APPROPRIATE ON A STEEL FRAMED
 PARTITION FACED WITH 2 LAYERS OF 13mm FIRE RATED PLASTERBOARD
 BOTH SIDES INCORPORATING THE STANDARD CONFIGURATION FOR MULTIPLE
 PENETRATIONS, SEALED WITH FIRESOUND ACRYLIC SEALANT.**

H.B. Fuller
 16-22 Redgum Drive,
 Dandenong South,
 Vic 3175.

Report Sponsor	H.B. Fuller, 16-22 Redgum Drive, Dandenong South, Vic 3175.
Test Laboratory	Warrington Fire Research (Aust) Pty Ltd, Unit 2, 409-411 Hammond Road, Dandenong South, VIC 3175.
Test Date	3 rd December 2004.
Test standards prescribed Supplementary Standards	In general accordance with AS 1530.4-1997 Sections 2, 3 and 10, and AS 4072 as appropriate. Nil
Variations from test standard	Average furnace pressure was maintained between 5 Pa and 13 Pa for the duration of the test. This variation is considered not to have adversely affected the results of the test as no gaps or fissures had developed at any of the service penetrations which would allow an increased flow of furnace gases due to a higher pressure level.
General description of tested specimens	The test assembly comprised a 1300mm wide × 1250mm high 64mm ste

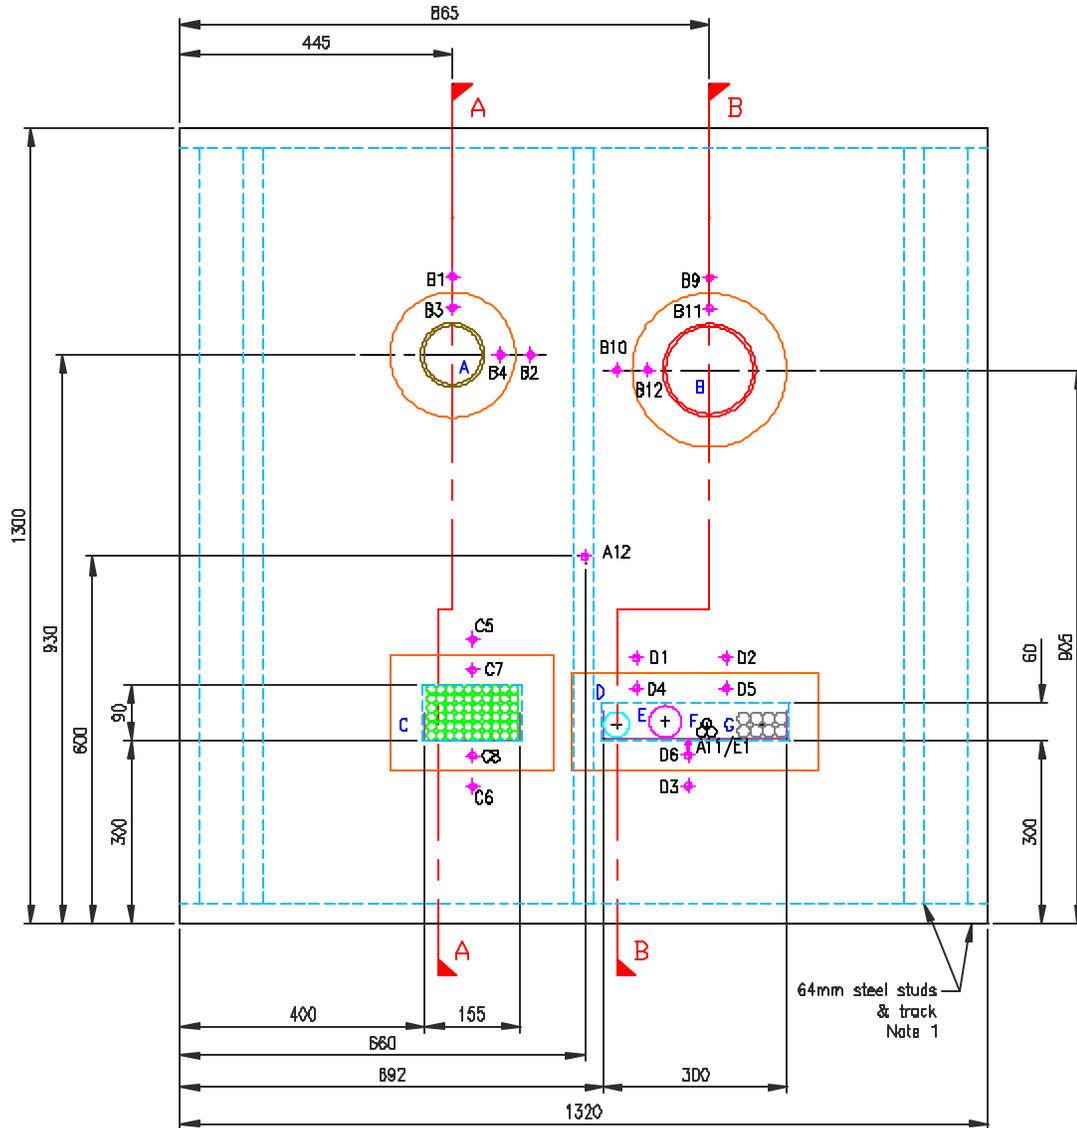
UNEXPOSED FACE ELEVATION

1. Wall consists of 2 layers of 13mm thick fire rated plasterboard screwfixed to either side of 64mm deep steel studs,
2. All dimensions shown are in mm and nominal.

- A1.1.2 Details of the test construction are shown schematically on Drawings No. 41118-TS-01 and 41118-TS-02.
- A1.1.3 The materials for the separating element and services for the test specimen were supplied and installed by WFRA staff into the steel test restraint frame and who subsequently attached thermocouples after the specimen construction had been completed. The FireSound Acrylic Sealant was supplied and installed by the test sponsor.

- A1.2.2.6 All service locations are shown on Drawing 41118-TS-01.

- A1.3.5.1 Upon construction completion, personnel from Warrington Fire Research (Aust.) Pty Ltd attached surface thermocouples to the unexposed face of the test specimen as specified in AS 1530.4-1997 (See drawings 41118-TS-01 and 41118-TS-02).

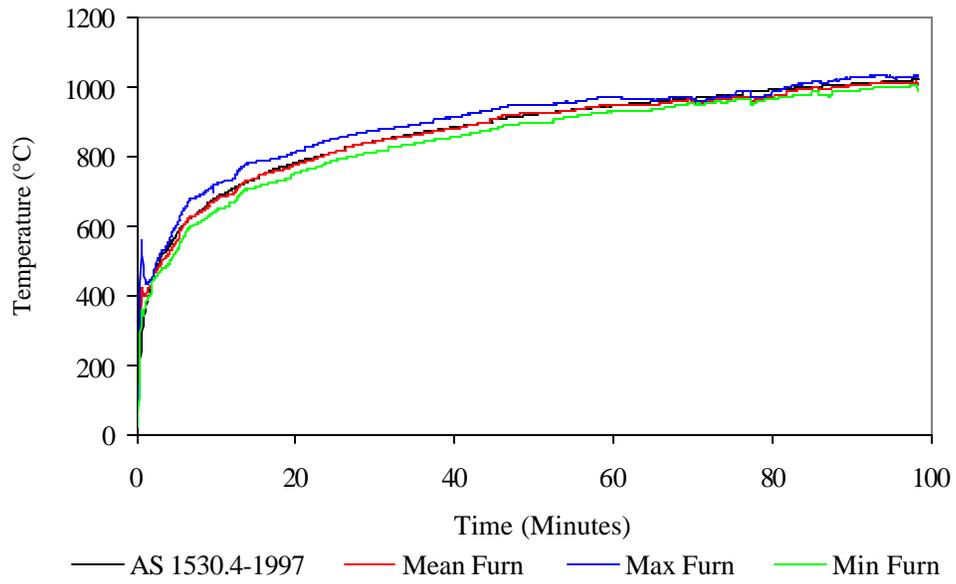
Figure A2.1: Furnace Temperatures vs Time

Test Procedures	Test procedures were in general accordance with AS 1530.4:1997 as appropriate. Control of the furnace temperature was maintained within the prescribed limits of variance from the time/temperature curve that are specified in Clause 2.9.2 of AS 1530.4:1997 for the duration of the fire resistance test. The furnace pressure was measured level with the centre of the lowest penetration (350mm above the notional floor level) and was maintained between 5 Pa and 13 Pa for the duration of the fire-resistance test.
Test Duration	98 minutes

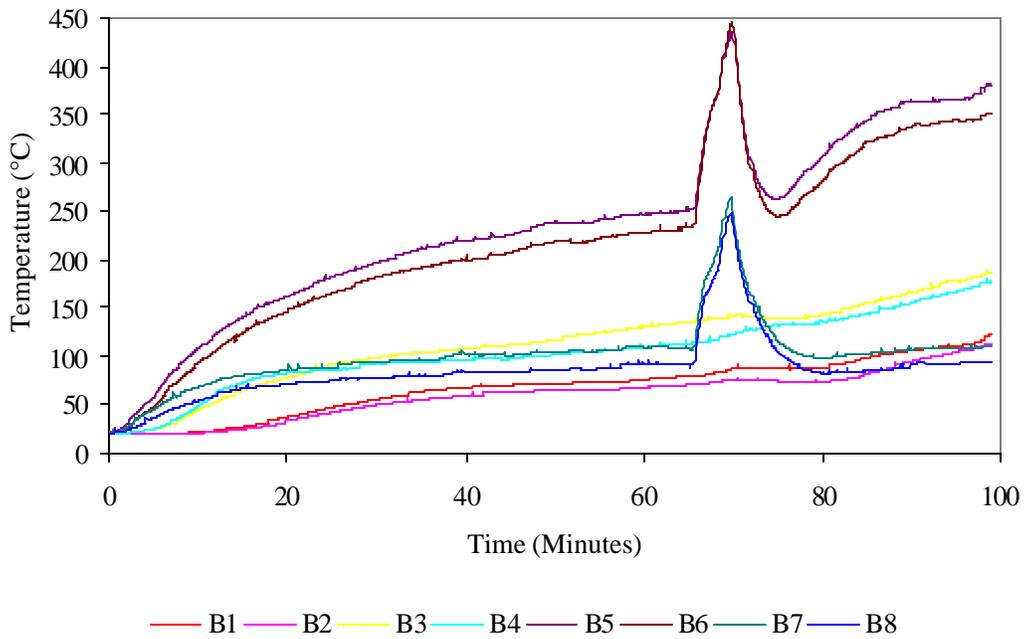
Figure A2.2 : Service A (Brass pipe). Temperatures vs Time

Service	T/C No.	Surface	Description ²	Temp (°C) at t (minutes)					Limit ¹ (Mins)
				t=0	t=15	t=30	t=60	t=98 (end)	
A	B1	P/b ³	25mm from the sealant.	21	30	56	77	120	-
	B2	P/b ³	25mm from the sealant.	21	27	52	69	113	-
	B3	Sealant	25mm from the pipe.	21	65	99	131	182	-
	B4	Sealant	25mm from the pipe.	21	74	93	111	173	-
	B5	Pipe	25mm from the sealant.	21	144	199	248	377	31
	B6	Pipe	25mm from the sealant.	21	126	183	229	349	39
	B7	Pipe	400mm from the sealant.	22	83	95	111	112	67
	B8	Pipe	400mm from the sealant.	22	68	79	92	94	68
B	B9	P/b ³	25mm from the sealant.	21	30	59	79	108	-
	B10	P/b ³	25mm from the sealant.	21	27	54	72	105	-
	B11	Sealant	25mm from the pipe.	21	69	93	135	177	-
	B12	Sealant	25mm from the pipe.	21	83	98	135	176	-
	C1	Pipe	25mm from the sealant.	21	122	231	342	377	25
	C2	Pipe	25mm from the sealant.	21	117	219	323	371	26
	C3	Pipe	400mm from the sealant.	21	55	116	169	124	-
	C4	Pipe	400mm from the sealant.	21	46	97	141	108	-

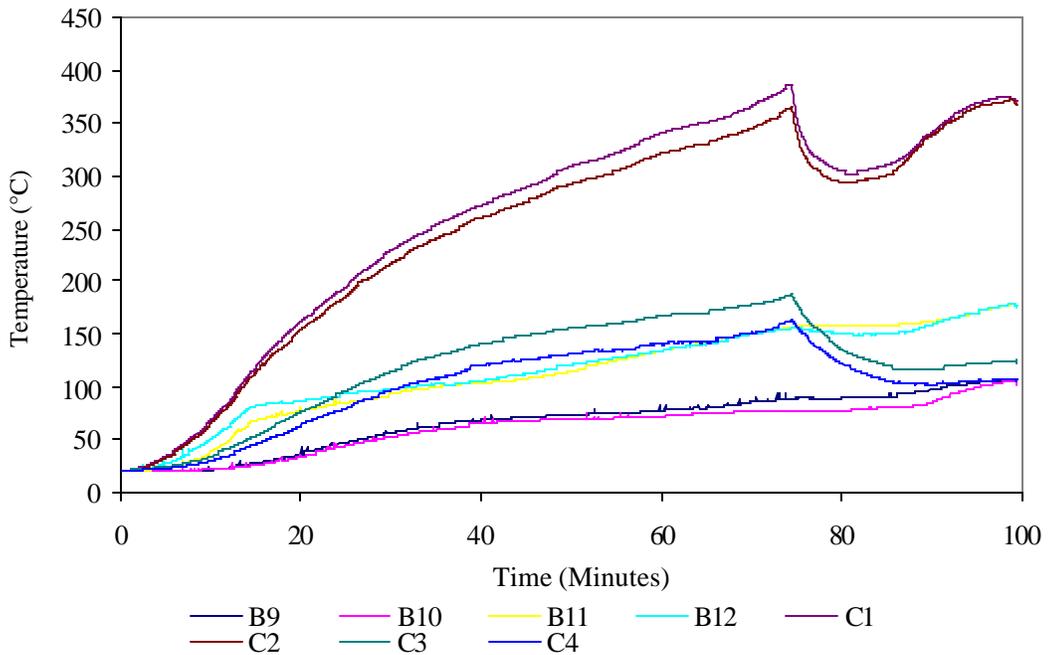
Figure A2.3: Service B (Copper pipe). Temperatures vs Time

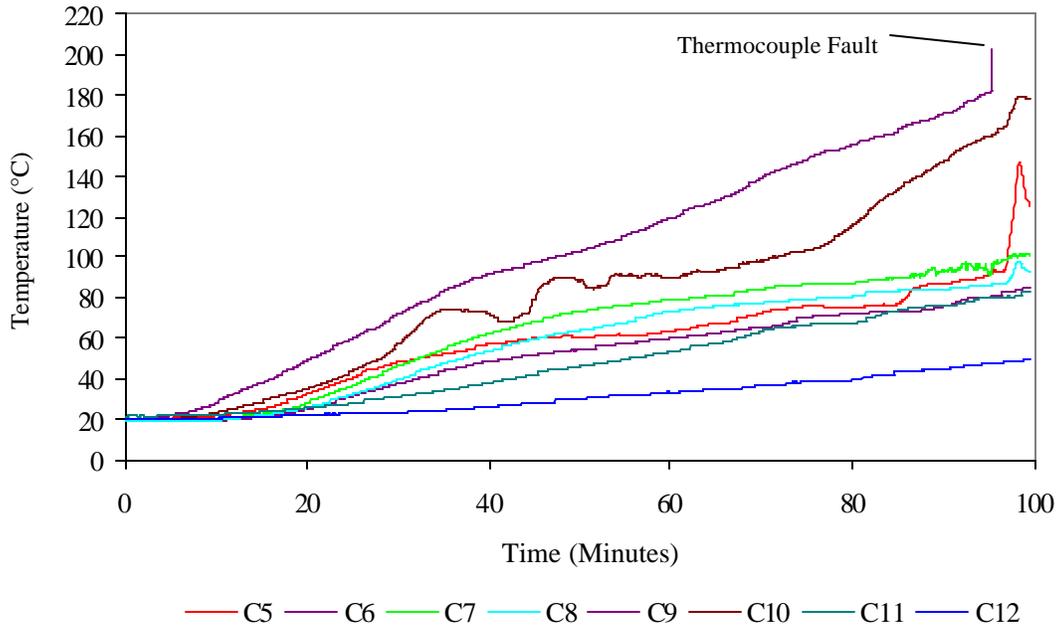
Figure A2.4 : Service C (Communications cable tray). Temperature vs Time

Service	T/C No.	Surface	Description ²	Temp (°C) at t (minutes)					Limit ¹ (Mins)
				t=0	t=15	t=30	t=60	t=98 (end)	
C	C5	P/b ³	25mm from the sealant.	20	25	49	64	142	-
	C6	P/b ³	25mm from the sealant.	19	22	39	60	83	-
	C7	Sealant	25mm from the cables.	20	24	48	80	102	-
	C8	Sealant	25mm from the cables.	19	23	41	73	97	-
	C9	Cable	25mm from the sealant.	20	39	73	120	235	95
	C10	Tray	25mm from the sealant.	19	29	58	90	178	-
	C11	Cable	400mm from the sealant.	21	24	32	53	81	-
	C12	Tray	400mm from the sealant.	20	20	23	32	47	-
D	A5	Cable	25mm from the sealant.	20	37	70	123	204	96
	A6	Cable	400mm from the sealant.	20	23	37	81	131	-
E	D7	Cable	25mm from the sealant.	20	32	63	111	130	-
	D8	Cable	400mm from the sealant.	20	22	32	70	99	-
F	D9	Cable	25mm from the sealant.	20	27	41	73	108	-
	D10	Cable	400mm from the sealant.	21	22	24	34	44	-
G	D11	Cable	25mm from the sealant.	19	30	55	92	119	-
	D12	Cable	400mm from the sealant.	20	22	27	44	67	-

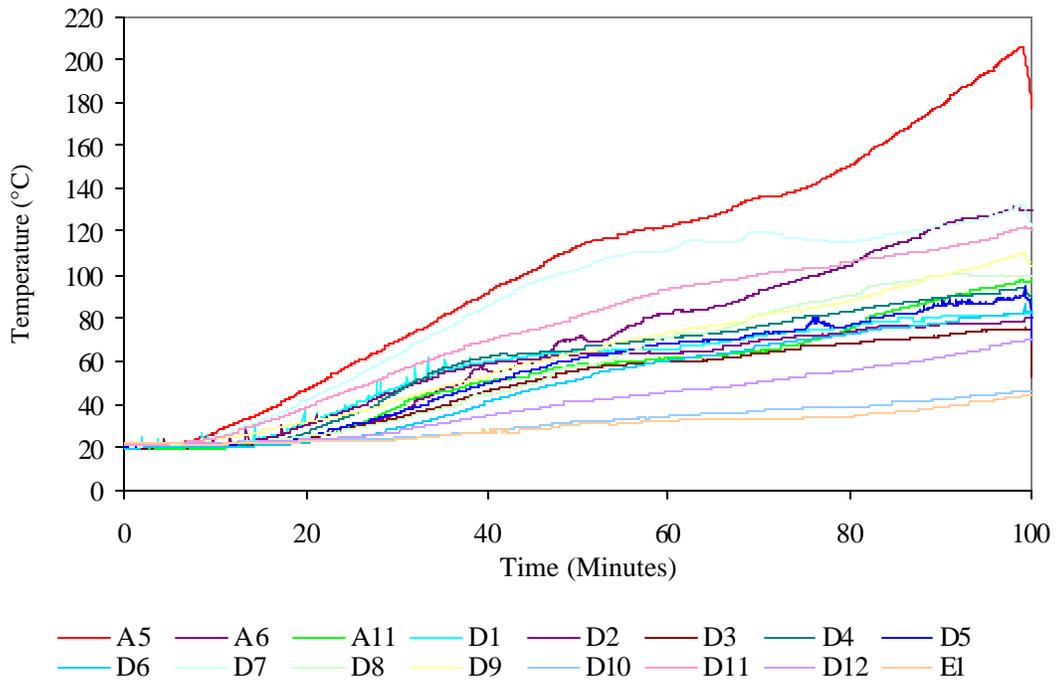
Figure A2.5: Services D-G (Electrical cable tray). Temperature vs Time

Service	T/C No.	Surface	Description ²	Temp (°C) at t (minutes)					Limit ¹ (mins)
				t=0	t=15	t=30	t=60	t=98 (end)	
Around D-G	D1	P/b ³	25mm from the sealant.	21	25	49	66	81	-
	D2	P/b ³	25mm from the sealant.	20	24	47	64	78	-
	D3	P/b ³	25mm from the sealant.	19	21	34	59	74	-
	D4	Sealant	Centre of sealant.	20	22	46	70	92	-
	D5	Sealant	Centre of sealant.	20	22	36	67	88	-
	D6	Sealant	Centre of sealant.	19	20	28	59	80	-
	A11	Tray	25mm from the sealant.	19	22	40	62	97	-
	E1 ⁴	Tray	400mm from the sealant.	22	22	23	32	43	-
Centre of wall.	A12	P/b ³	Centre of the plaster-board wall.	20	24	45	65	101	-

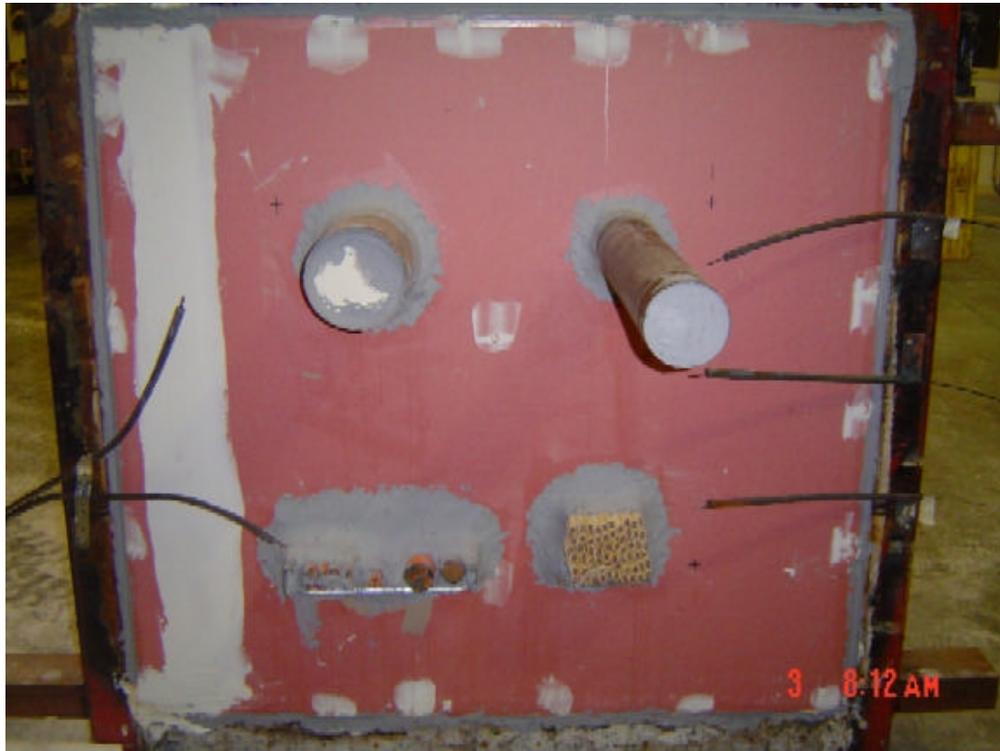
Plate 1: Exposed face of test specimen prior to commencement of the fire-resistance test

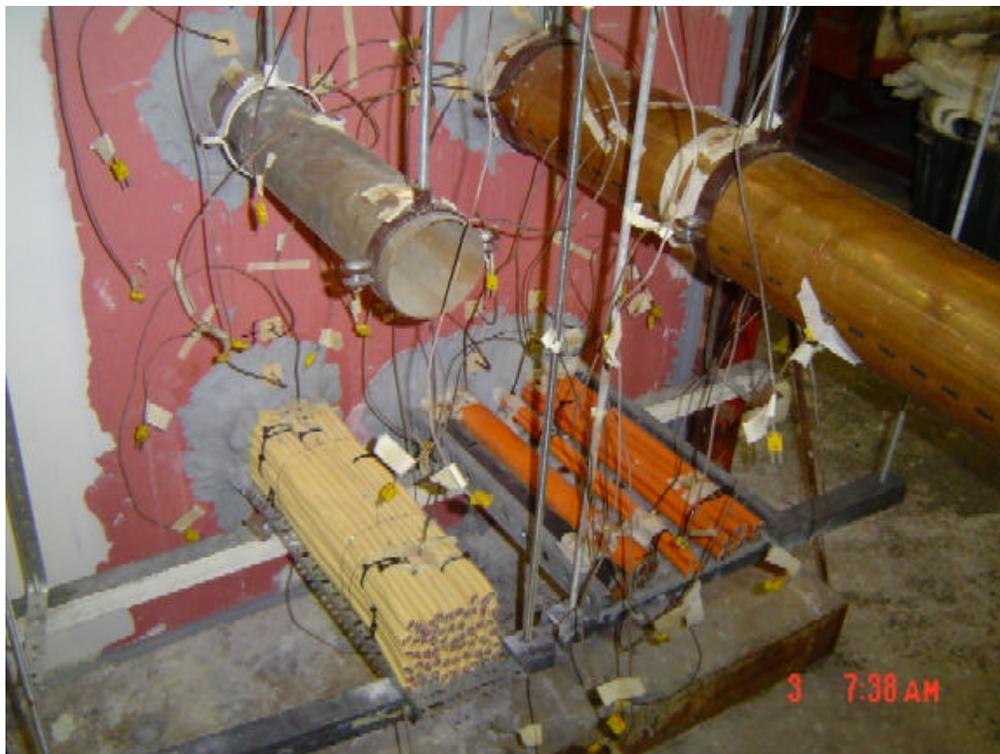
Plate 2: Unexposed face of test specimen prior to commencement of the fire-resistance test

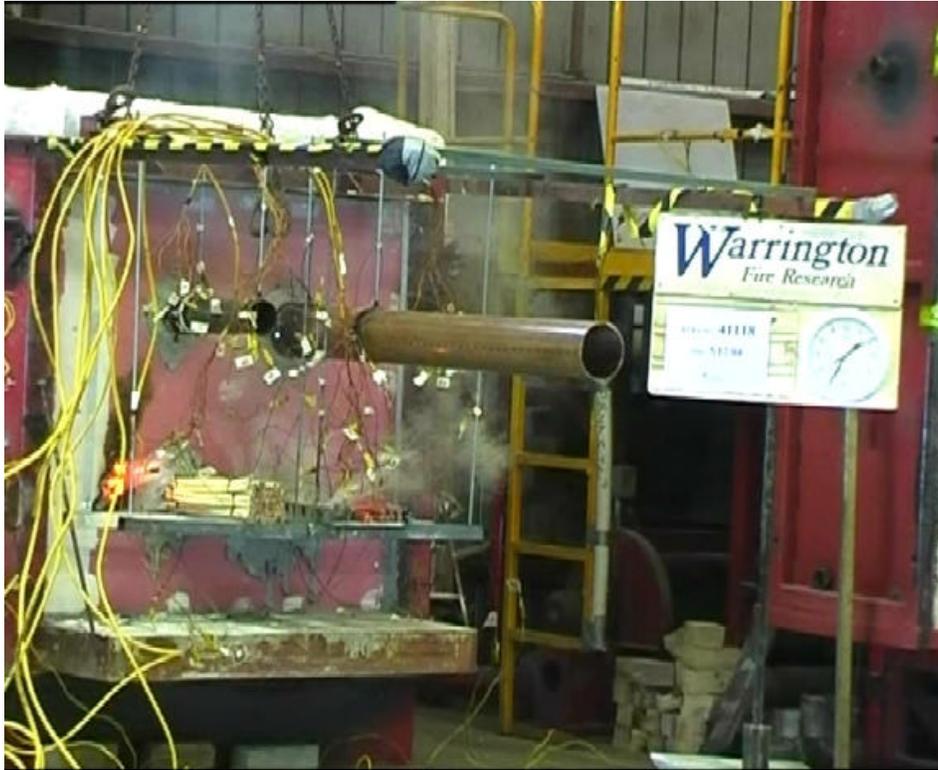
Plate 3: Partition failed integrity in accordance with AS 1530.4 -1997 at 98 mins by evidence of a through gap into the furnace.

¹ Failure due to integrity failure of separating element.

60	00	All penetrations had been checked, no through gaps had become evident.
70	00	All penetrations had been checked, no through gaps had become evident.
90	00	An opening had formed in the plasterboard wall, and was sealed with KAO wool. No through gaps at any Service penetration.
98	00	Test was stopped for safety reasons.

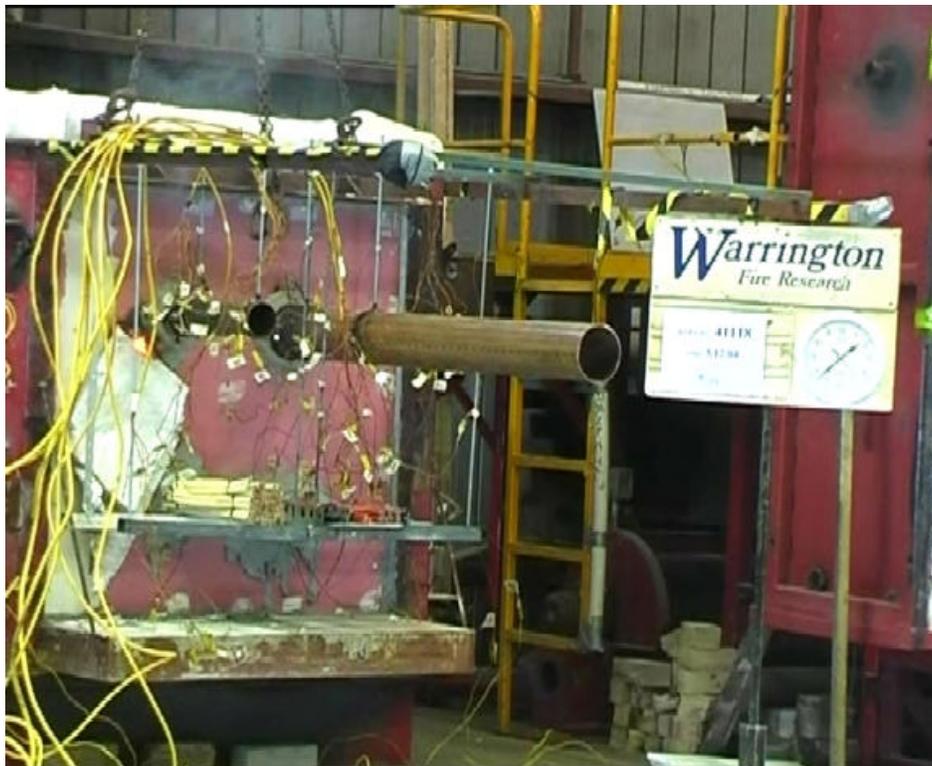
Plate 4: Unexposed face of test specimen after completion of the fire-resistance test

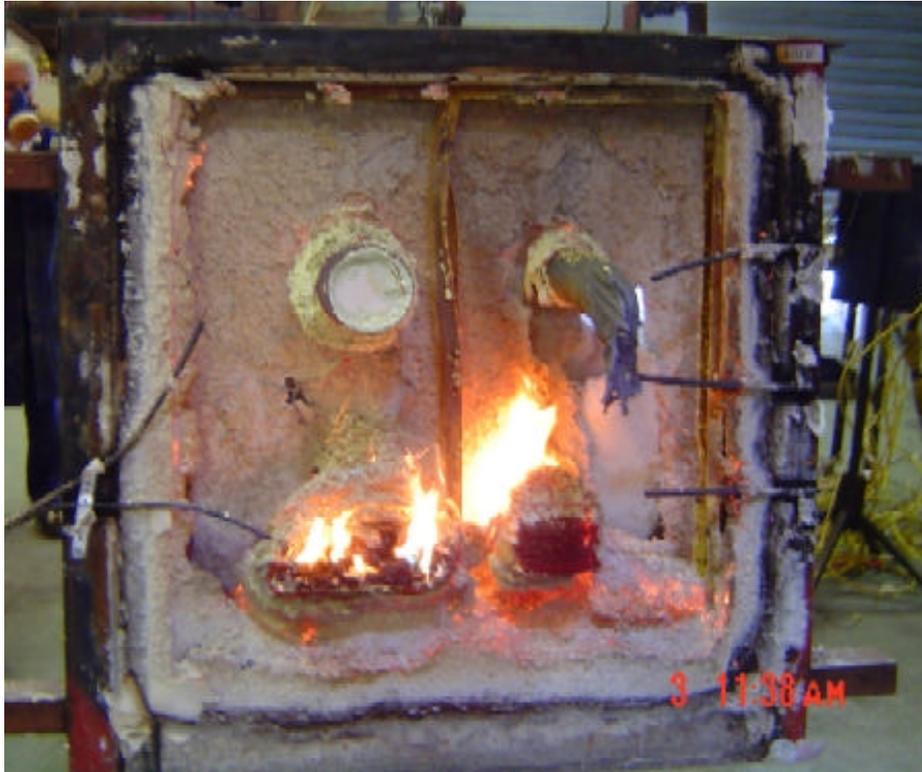
Plate 5: Exposed face of test specimen after completion of the fire-resistance test
