TEST REPORT

A fire resistance test of six control joints in concrete wall in accordance with AS 1530.4:2014

Test sponsor: HB Fuller Aust Co P/L

Job number: FRT180400 Author: Pius Jerome

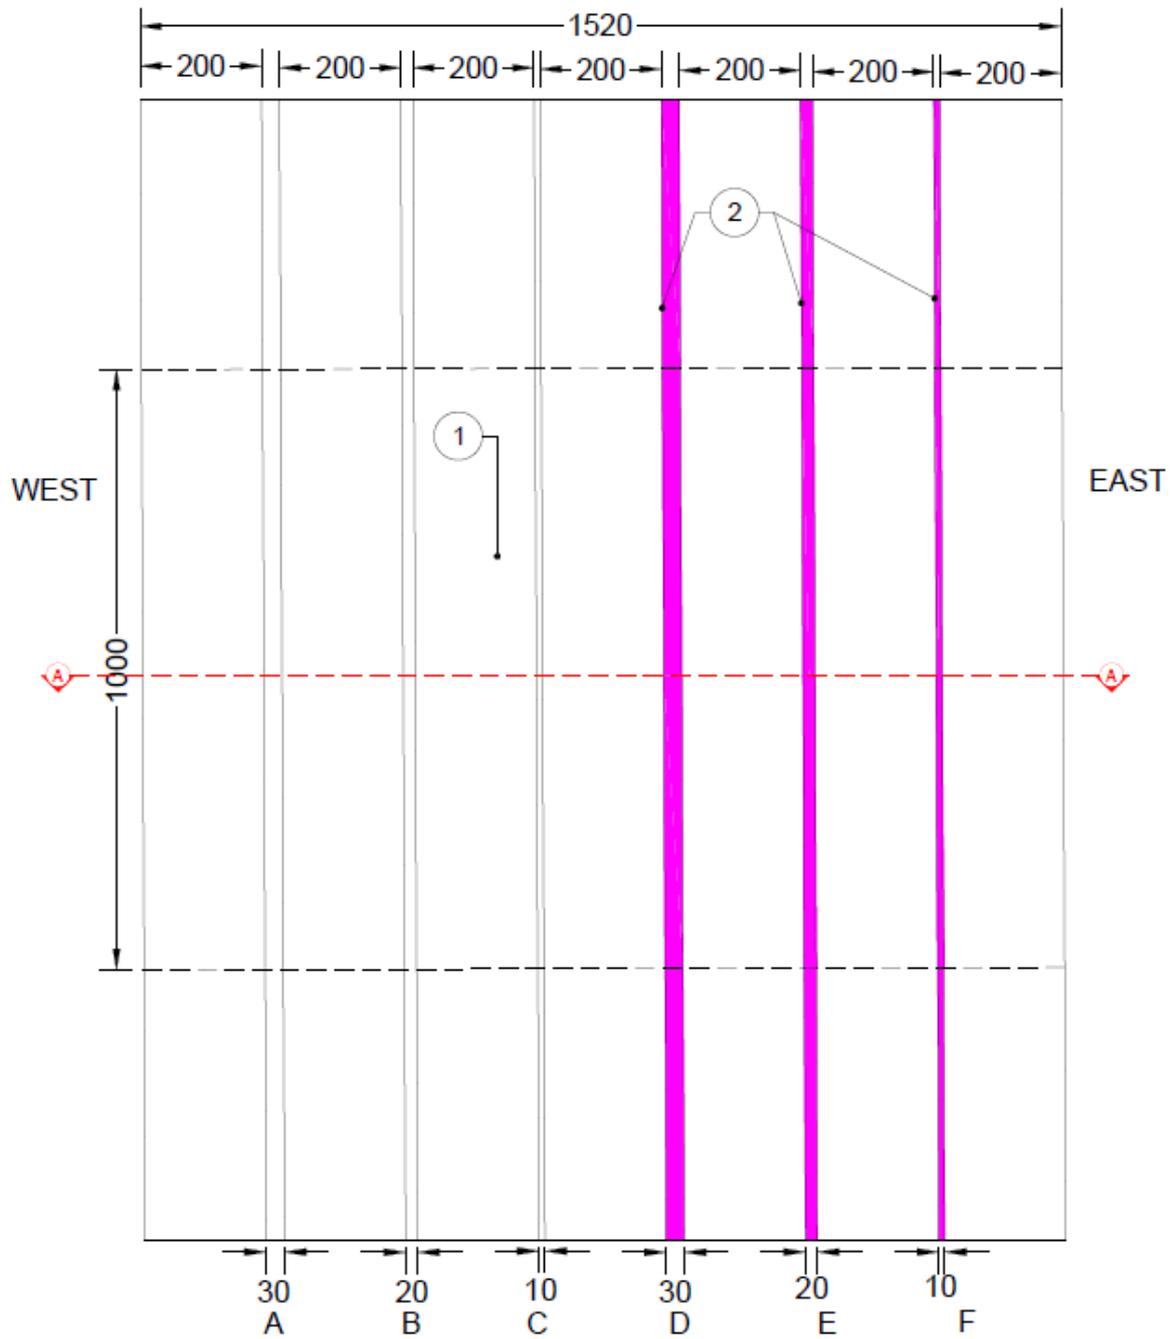
Figure 1 Elevation view of test specimen (unexposed side)

A full description of the specimen is provided in Appendix A and Section 2.

Aperture size	20mm x 1000mm
	Local fire-stopping protection	
	Protection	Backing rod (item 3) of size 29mm x 20mm, was installed into the control joint at a depth of 15mm from the exposed face of the wall. The sealant (item 2) was applied into the control joint to the depth of backing rod and finished flush with the face of wall. The backing rod & sealant is applied only on the exposed side. See Figure 1, Figure 2 and Figure 3 in Appendix A for more details.

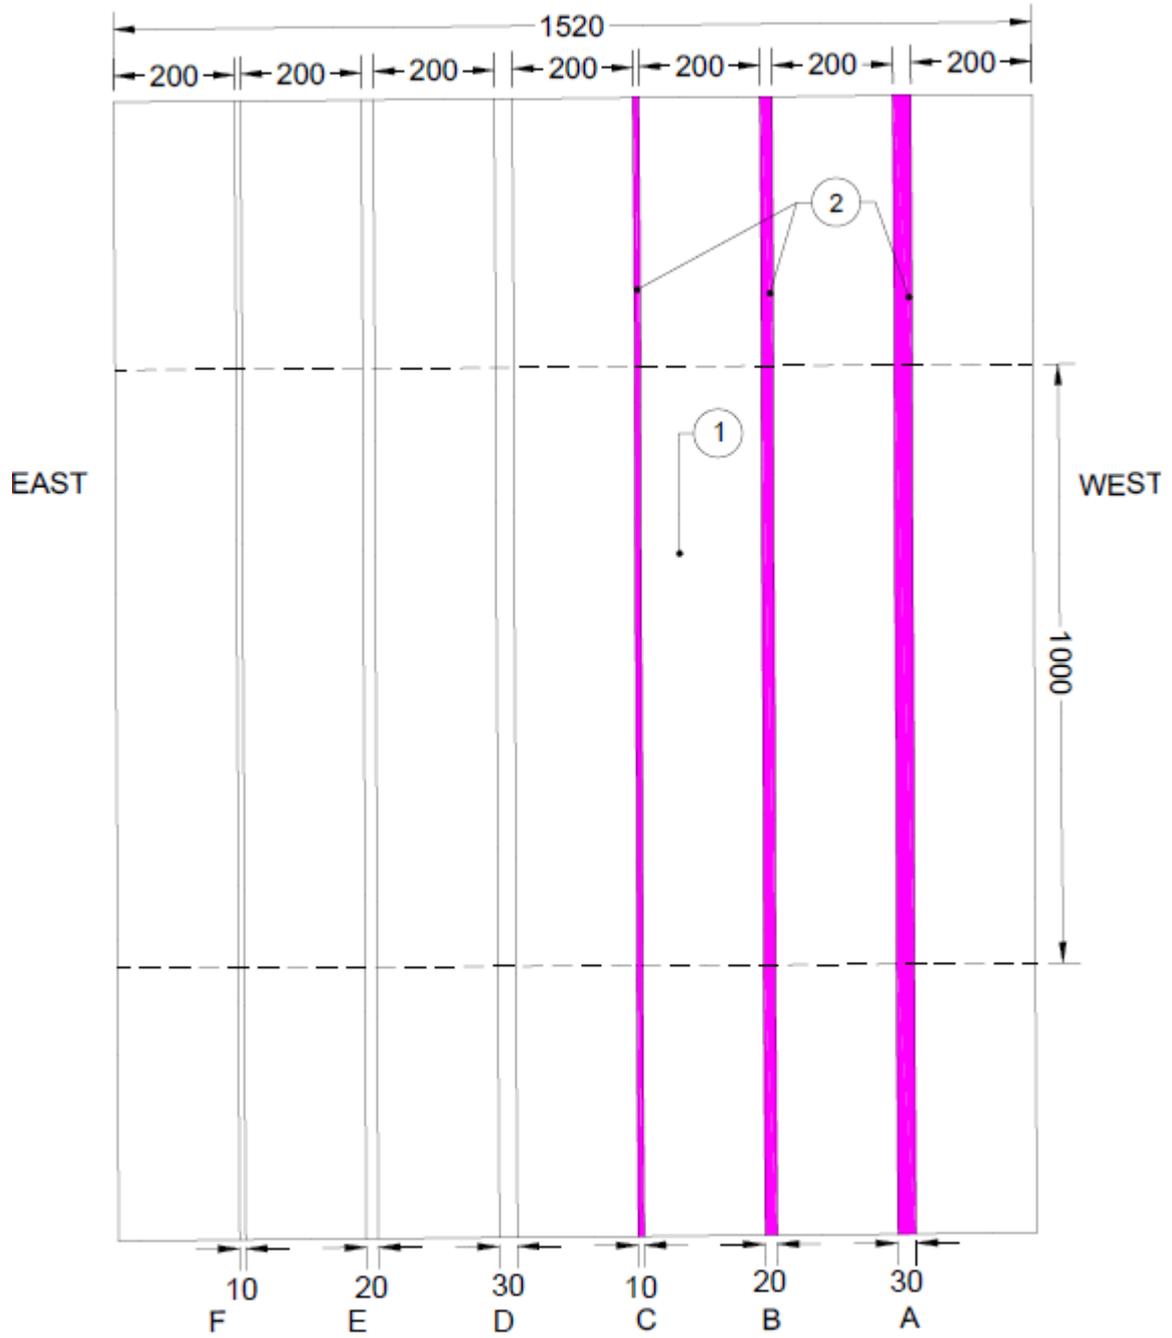
Figure 2 Elevation view of test specimen (exposed side)

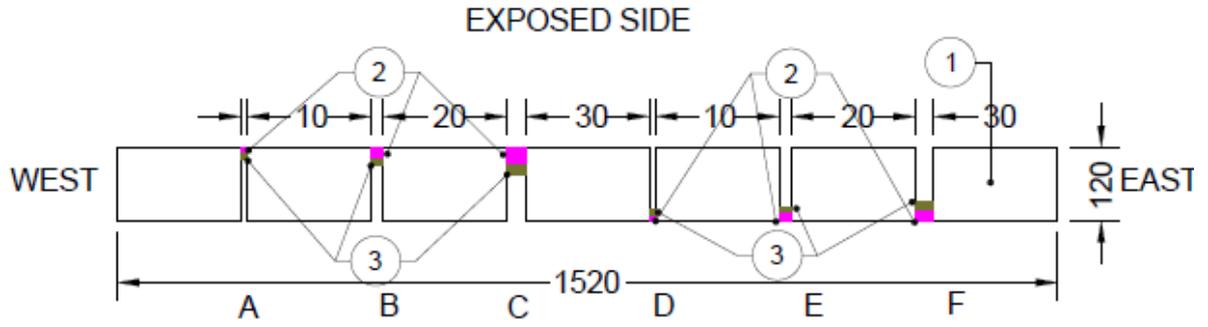
Figure 3 Section A-A

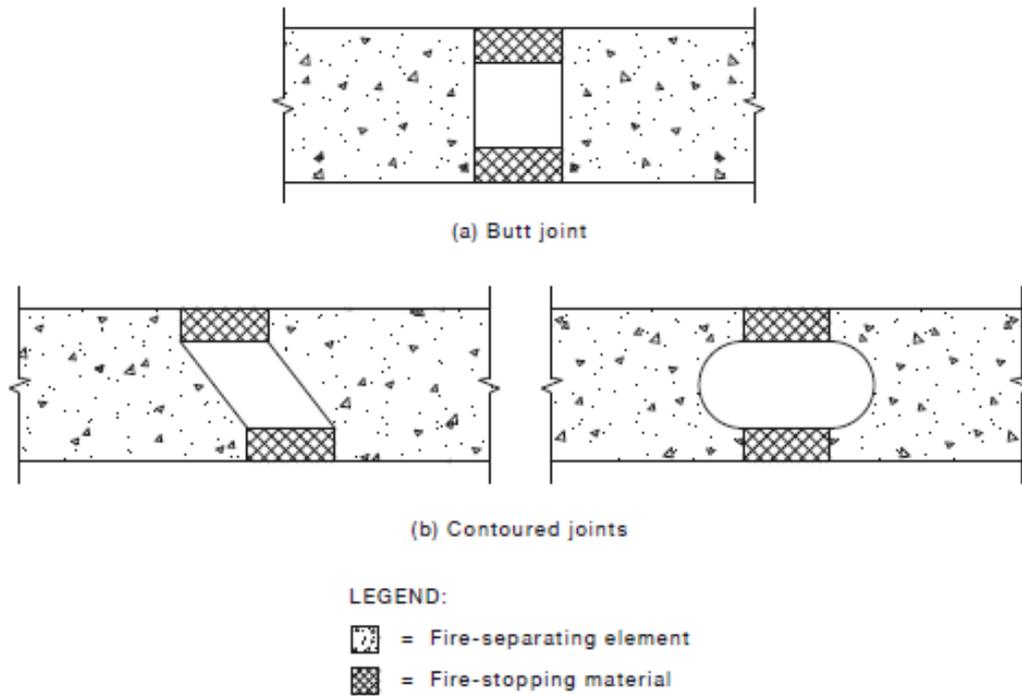
FIGURE 10.12.6 CONTOURED CONTROL JOINTS

- Results obtained from single test on a butt joints may be applied to contoured joints, provided the joints have —
 - equal width and equal or greater depth of sealant; and
 - equal or greater thickness of fire-separating element.
 - NOTE: Examples of butt and contoured control joints are shown in Figure 10.12.6.
- Facings may be applied to the surface of the fire-stopping system.

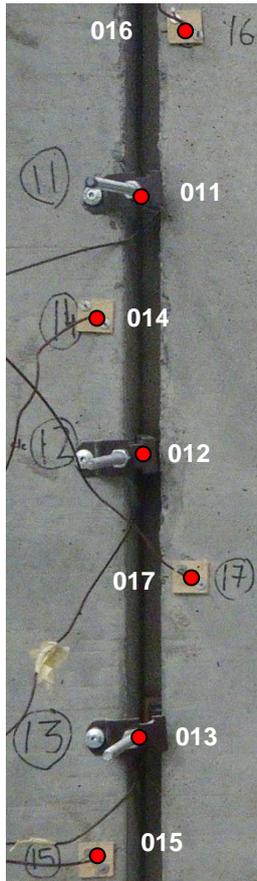
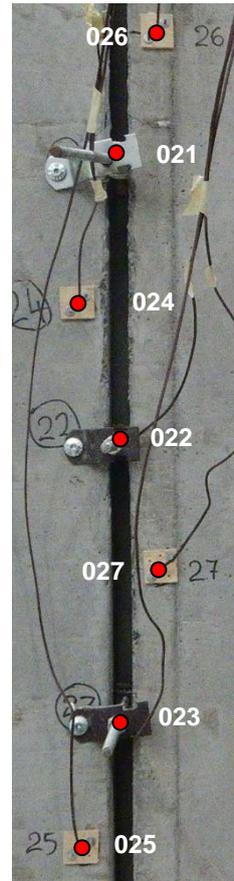
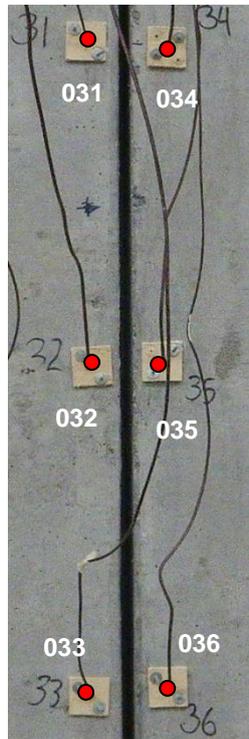
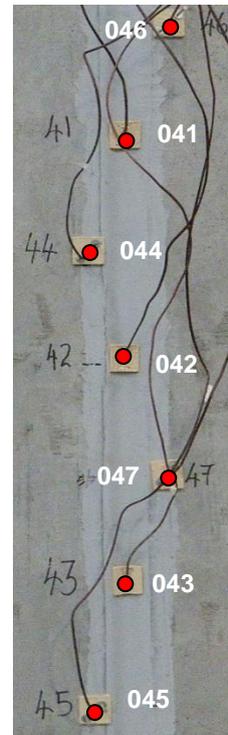
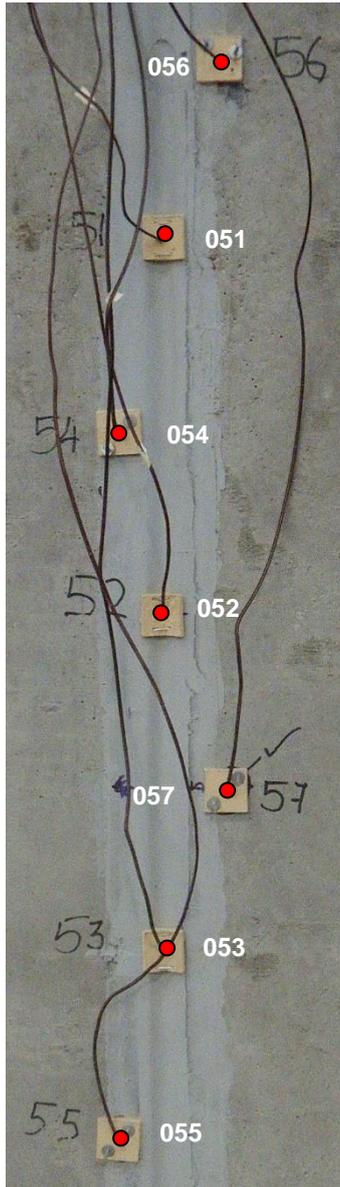
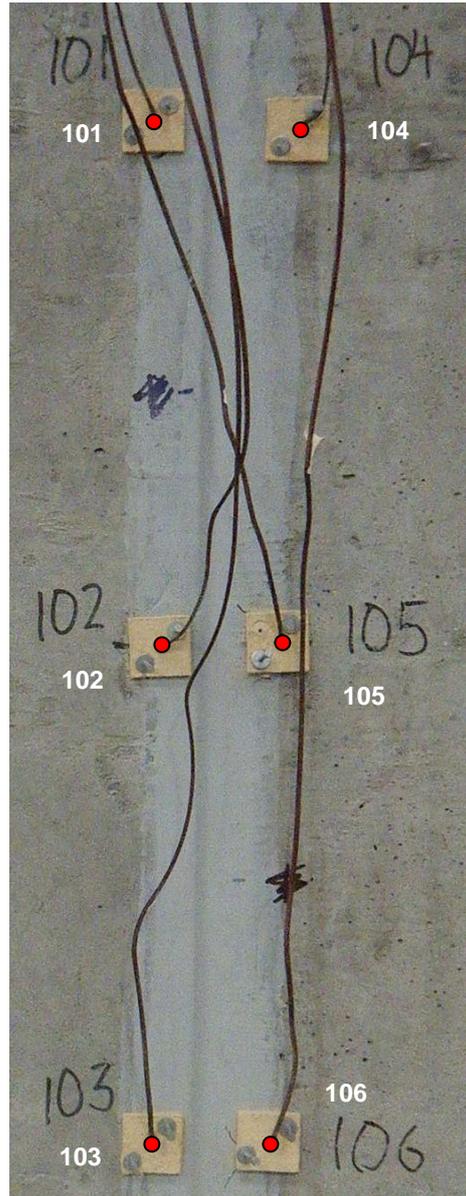
Figure 4 Penetration system A

Figure 5 Penetration system B

Figure 6 Penetration system C

Figure 7 Penetration system D

Figure 8 Penetration system E

Figure 9 Penetration system F

- The non-fire side specimen temperatures were measured by Type K thermocouples with wire diameters less than 0.5mm soldered to 12mm diameter x 0.2mm thick copper discs covered by 30mm x 30mm x 2.0 mm inorganic insulating pads. The thermocouple positions are shown in Table 6 and Figure 4 to Figure 9 in Appendix D.

System	T/C No.	Description
A	011	On control joint, 250mm up from the centre.
	012	On control joint, at the centre.
	013	On control joint, 250mm down from the centre.
	014	25mm from control joint, 125mm up from the centre.
	015	25mm from control joint, 375mm down from the centre.
	016	25mm from control joint, 375mm up from the centre.
	017	25mm from control joint, 125mm down from the centre.
B	021	On control joint, 250mm up from the centre.
	022	On control joint, at the centre.
	023	On control joint, 250mm down from the centre.
	024	25mm from control joint, 125mm up from the centre.
	025	25mm from control joint, 375mm down from the centre.
	026	25mm from control joint, 375mm up from the centre.
	027	25mm from control joint, 125mm down from the centre.
C	031	25mm from control joint, 250mm up from the centre.
	032	25mm from control joint, at the centre.
	033	25mm from control joint, 250mm down from the centre.

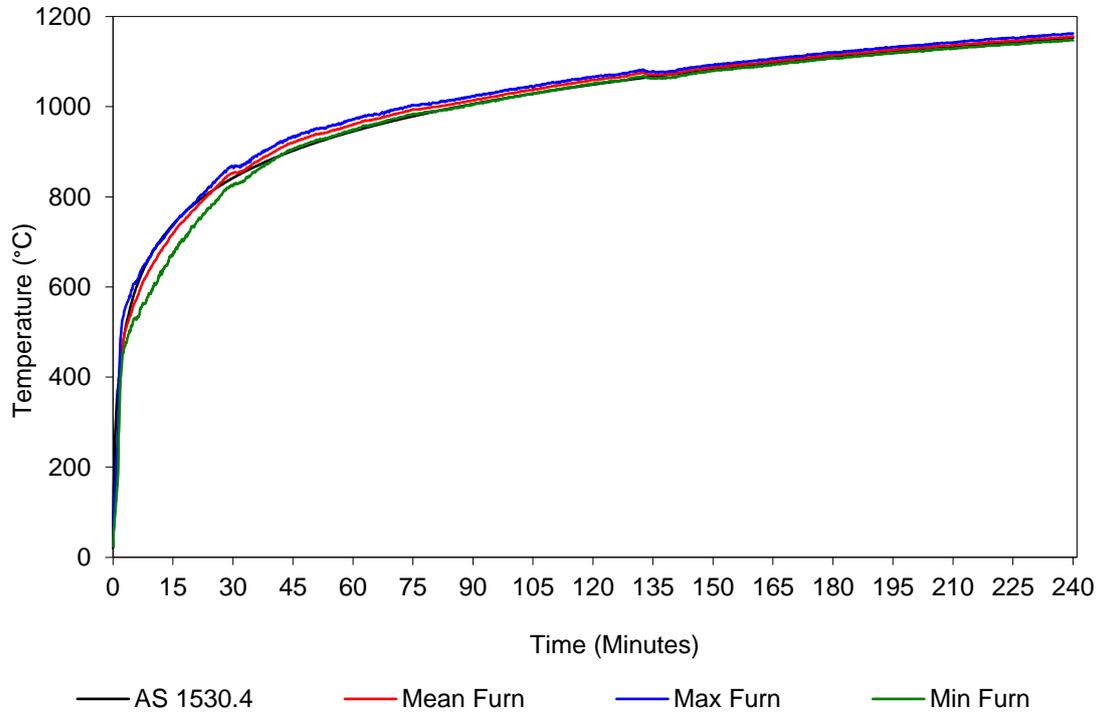
Figure 10 Furnace thermocouple temperature vs time

The furnace temperature and pressure data are provided in Figure 10 and Table 7 in Appendix E.

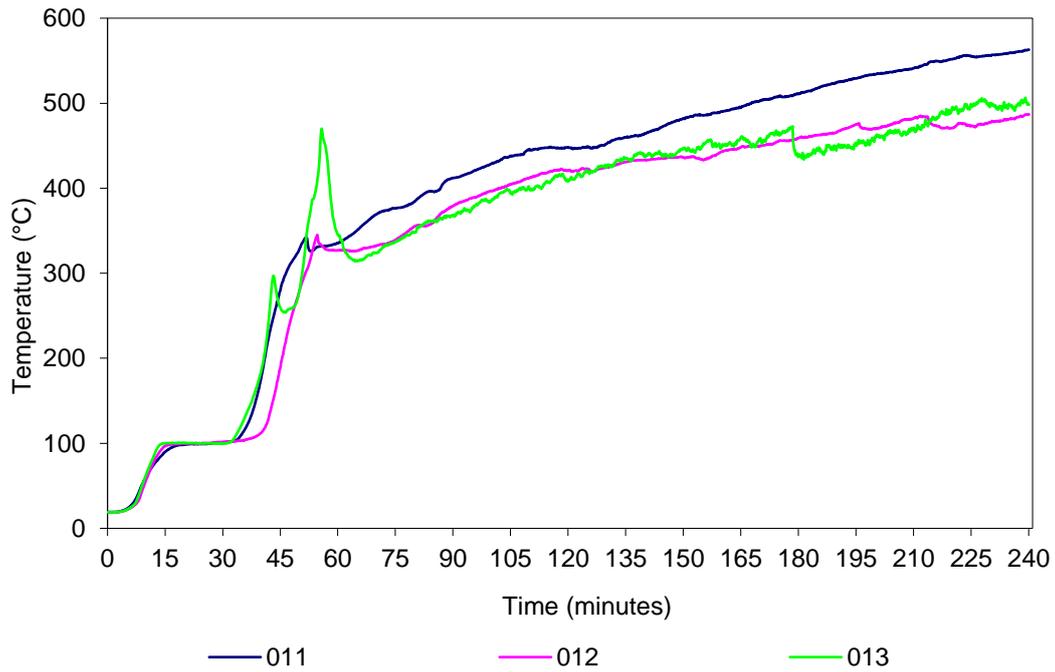
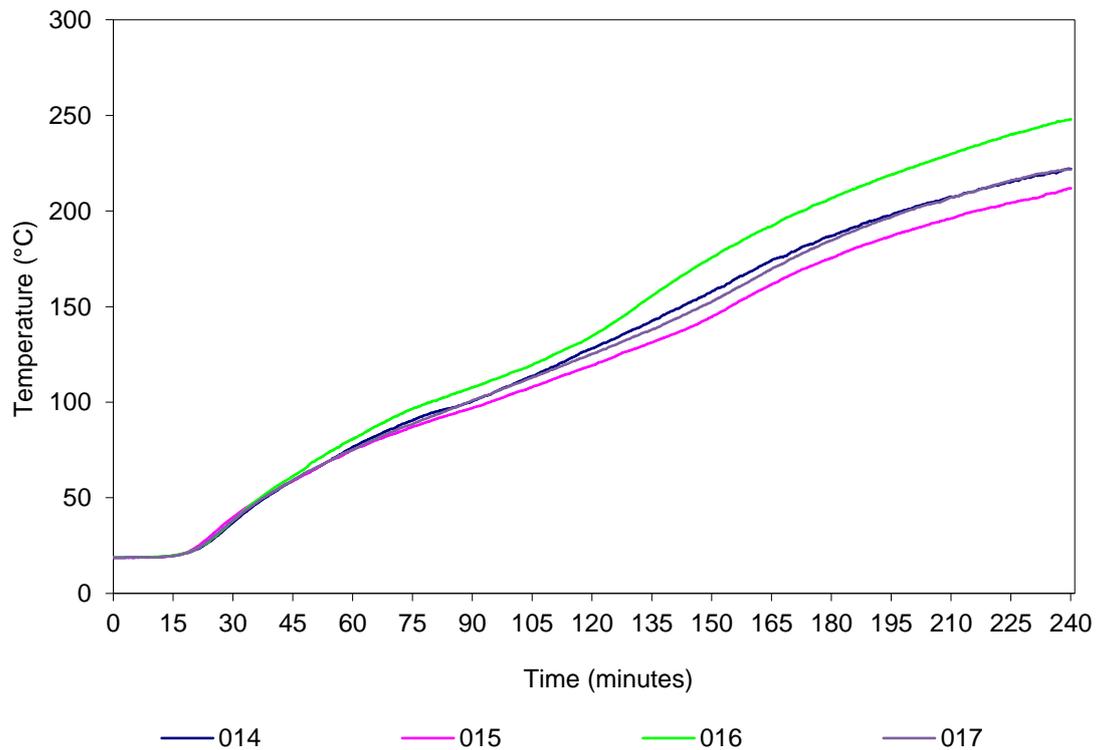
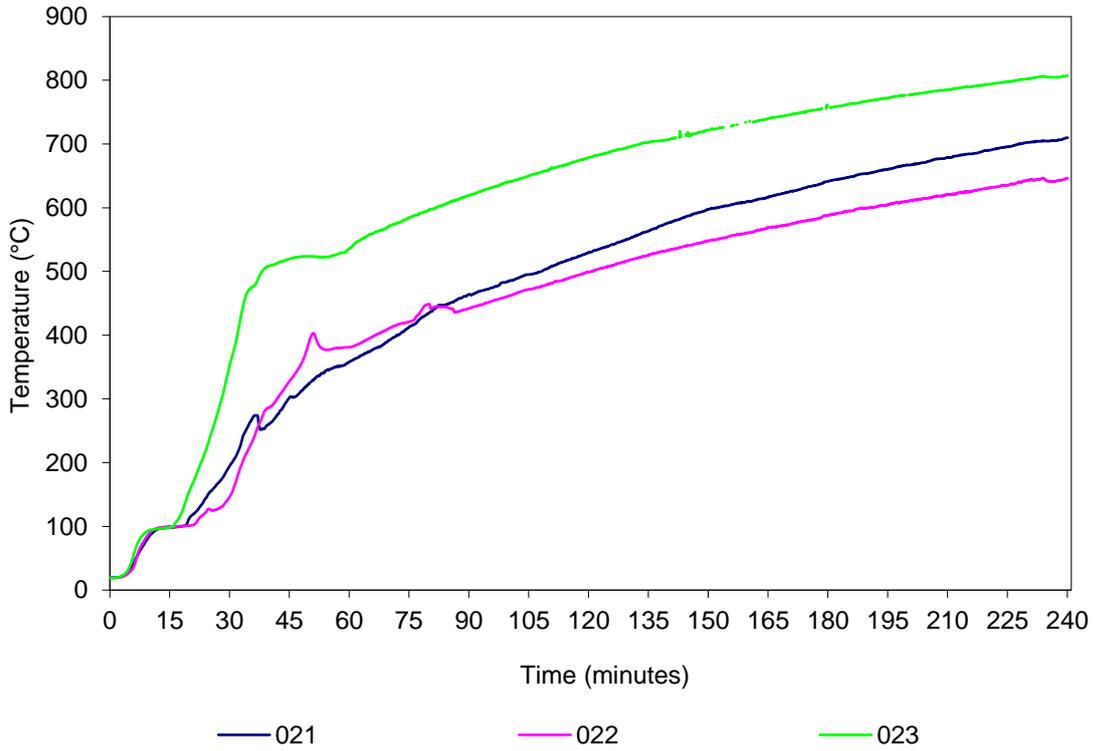
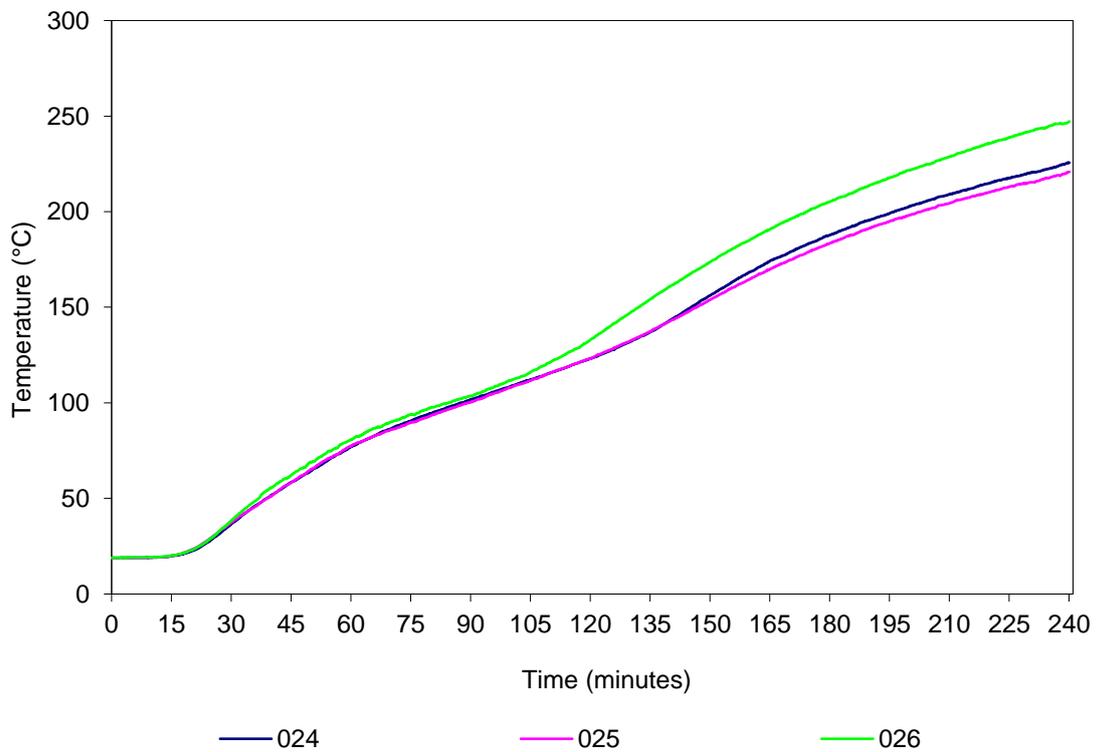
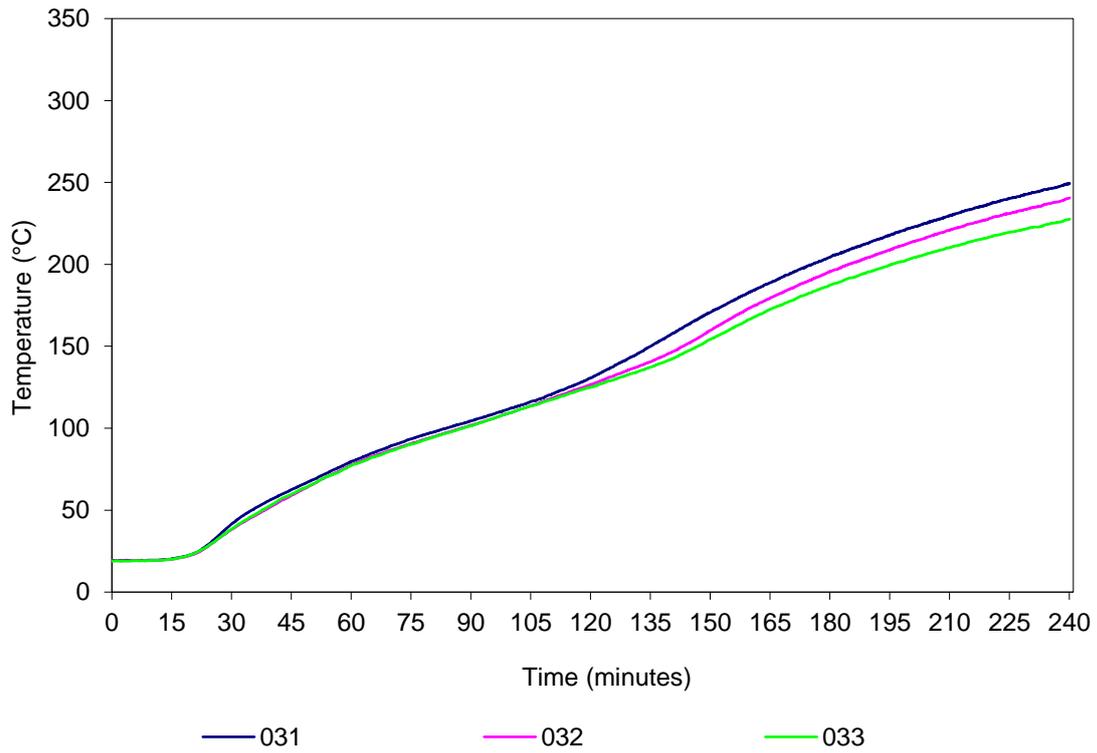
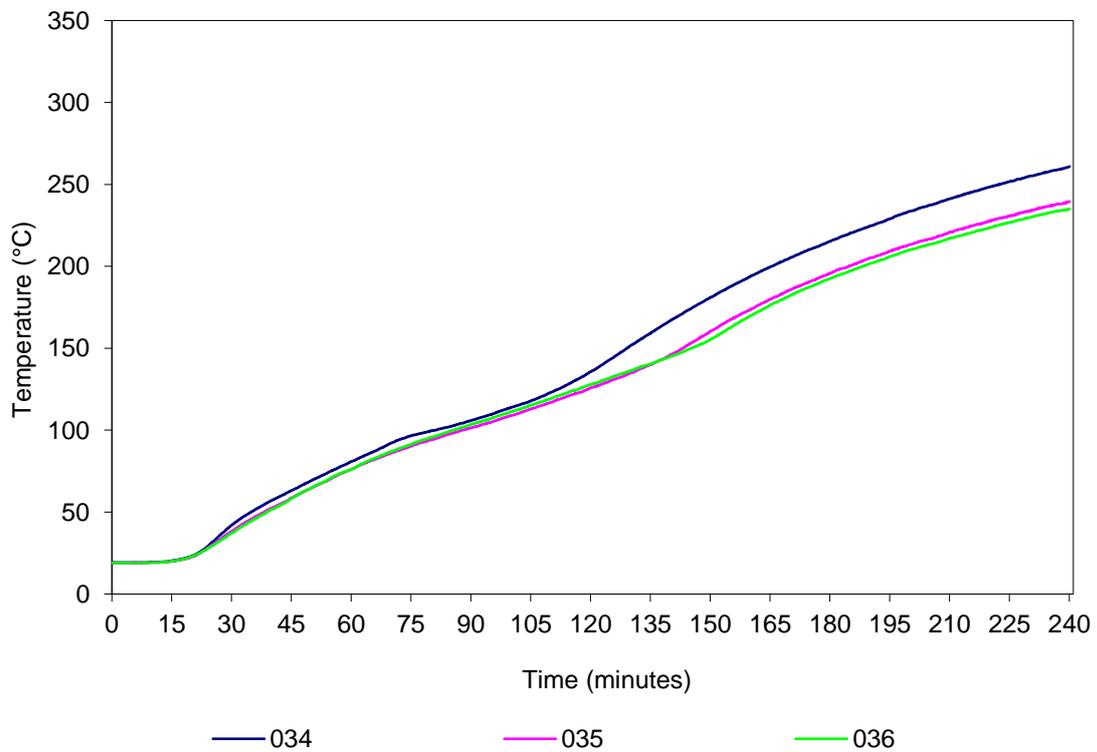
Figure 11 Penetration system A – temperature vs time

Figure 12 Penetration system A – temperature vs time

Figure 13 Penetration system B – temperature vs time

Figure 14 Penetration system B – temperature vs time

Figure 15 Penetration system C – temperature vs time

Figure 16 Penetration system C – temperature vs time

The specimen temperature data is provided in Figure 11 to Figure 22 and Table 8 in Appendix E.

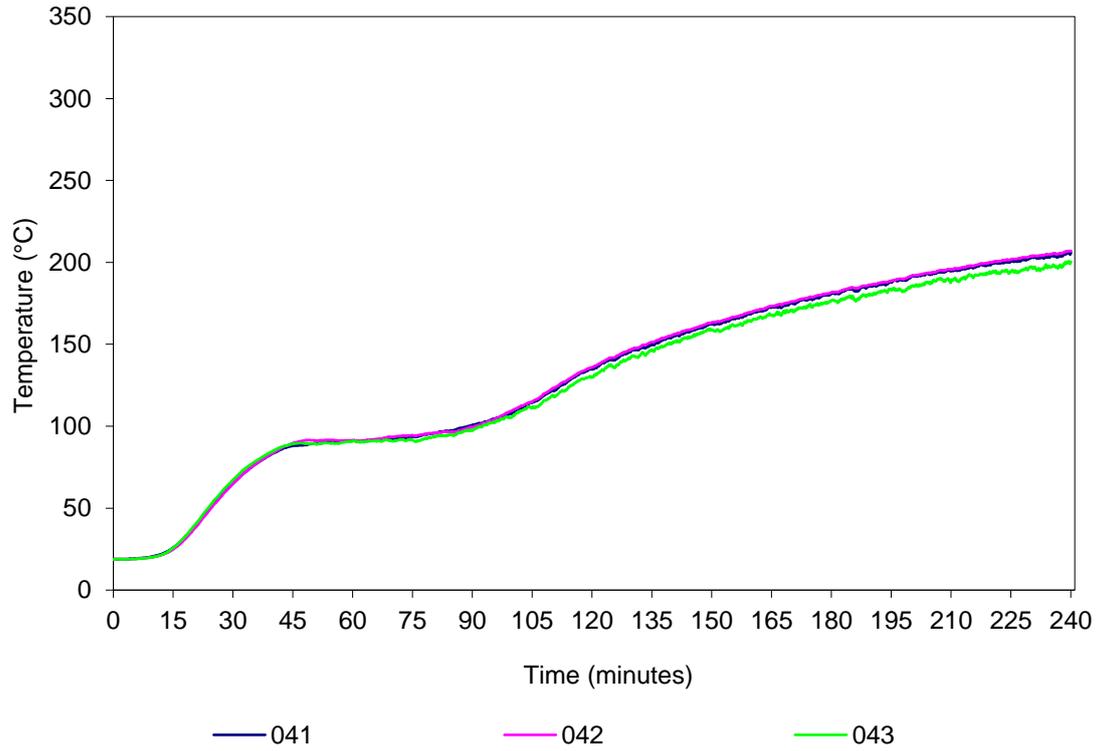
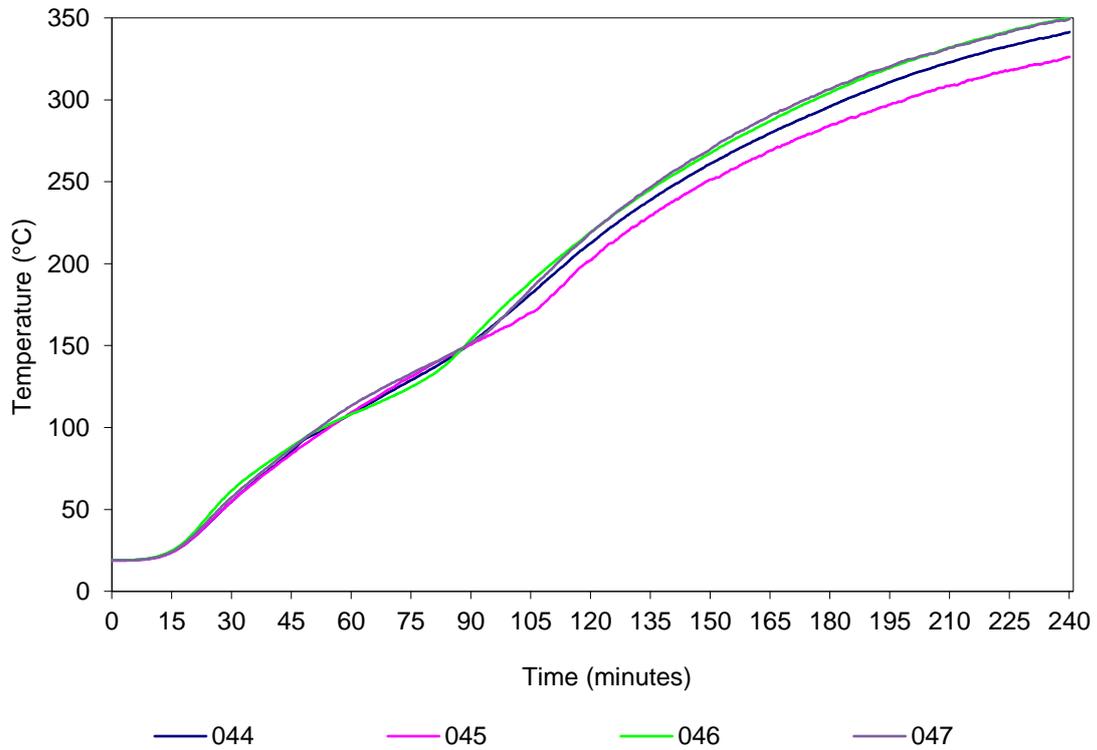
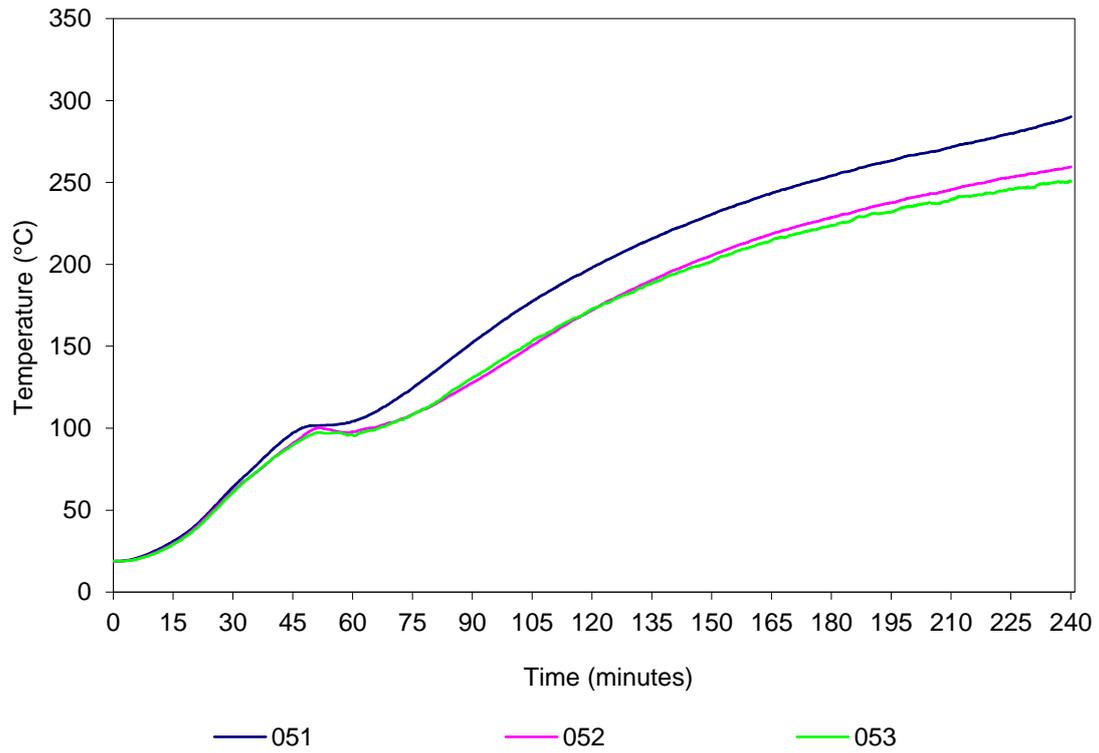
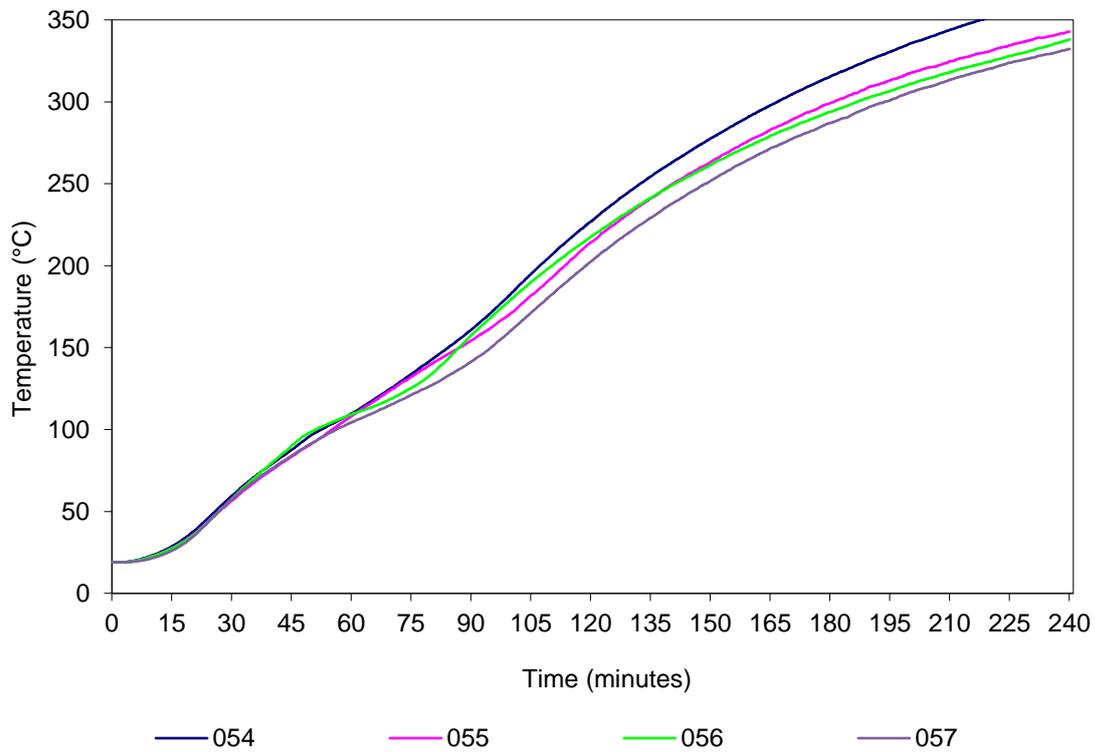
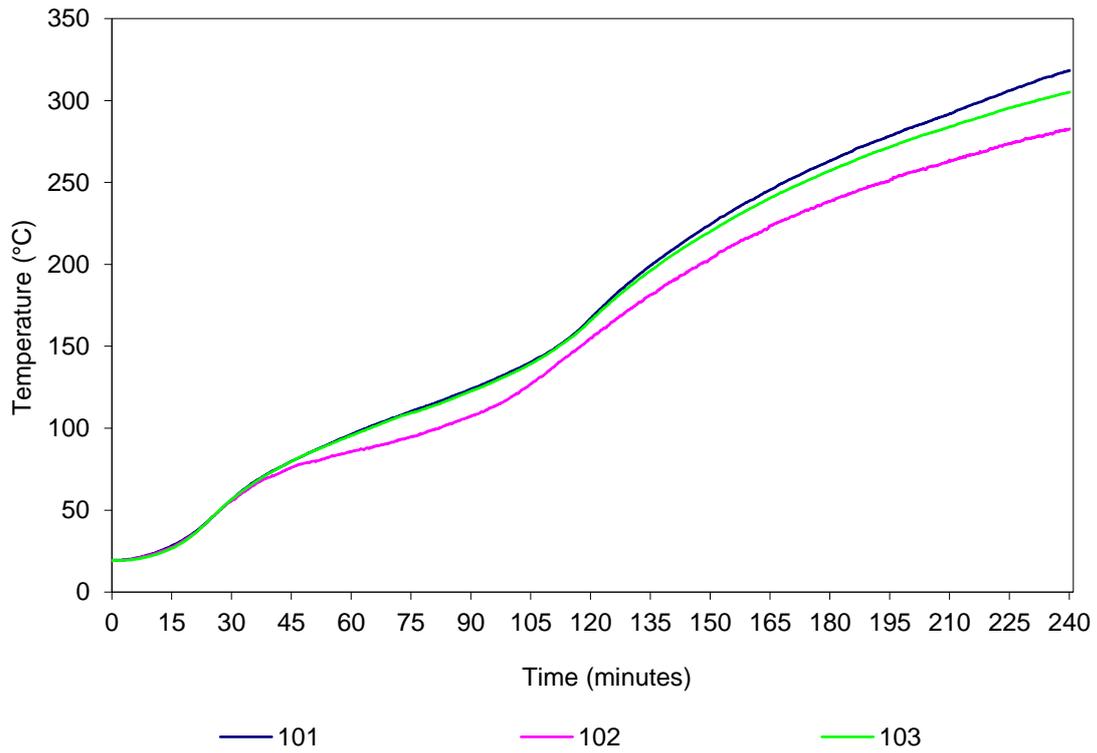
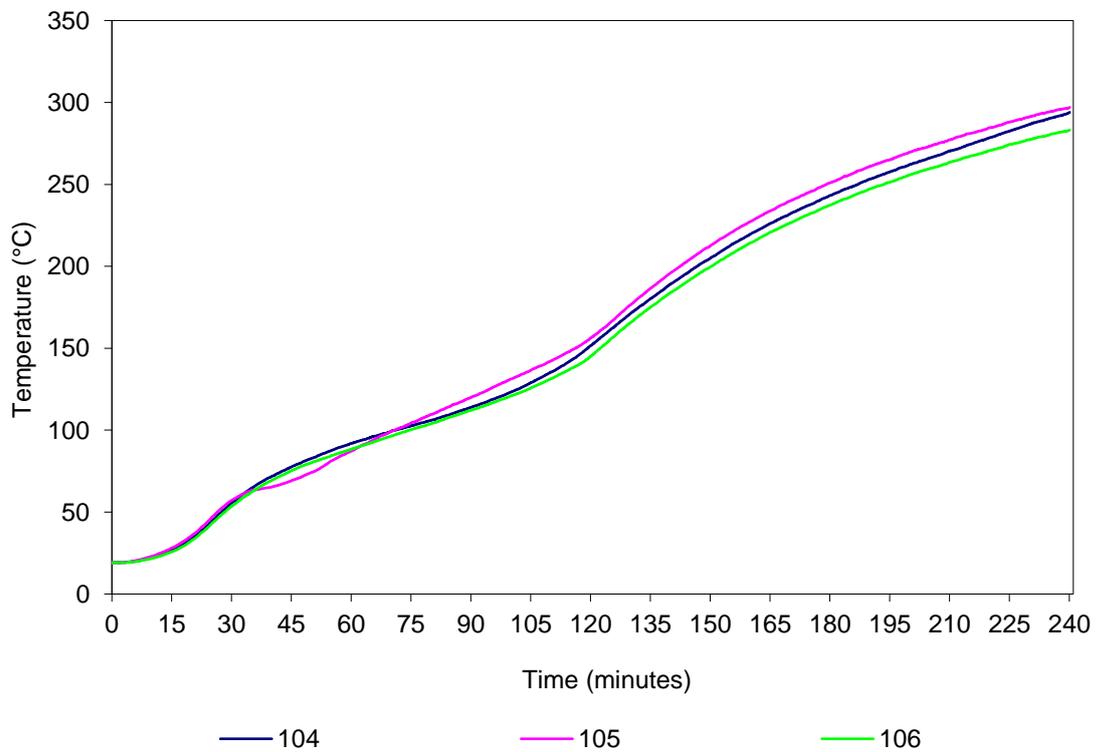
Figure 17 Penetration system D – temperature vs time

Figure 18 Penetration system D – temperature vs time

Figure 19 Penetration system E – temperature vs time

Figure 20 Penetration system E – temperature vs time

Figure 21 Penetration system F – temperature vs time

Figure 22 Penetration system F – temperature vs time

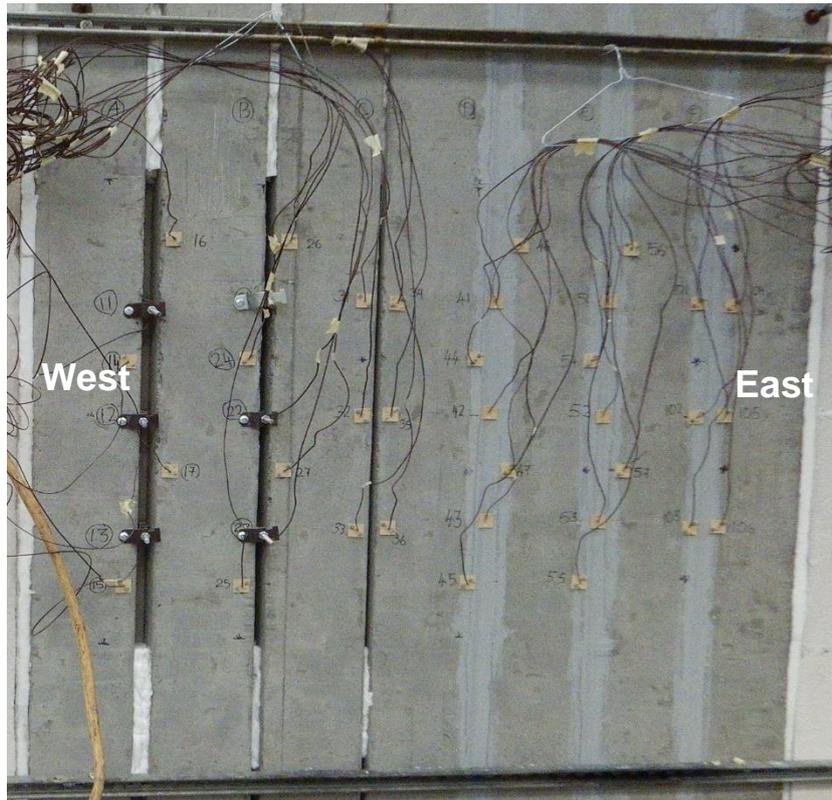
Figure 23 Unexposed face of specimen before the start of the fire-resistance test

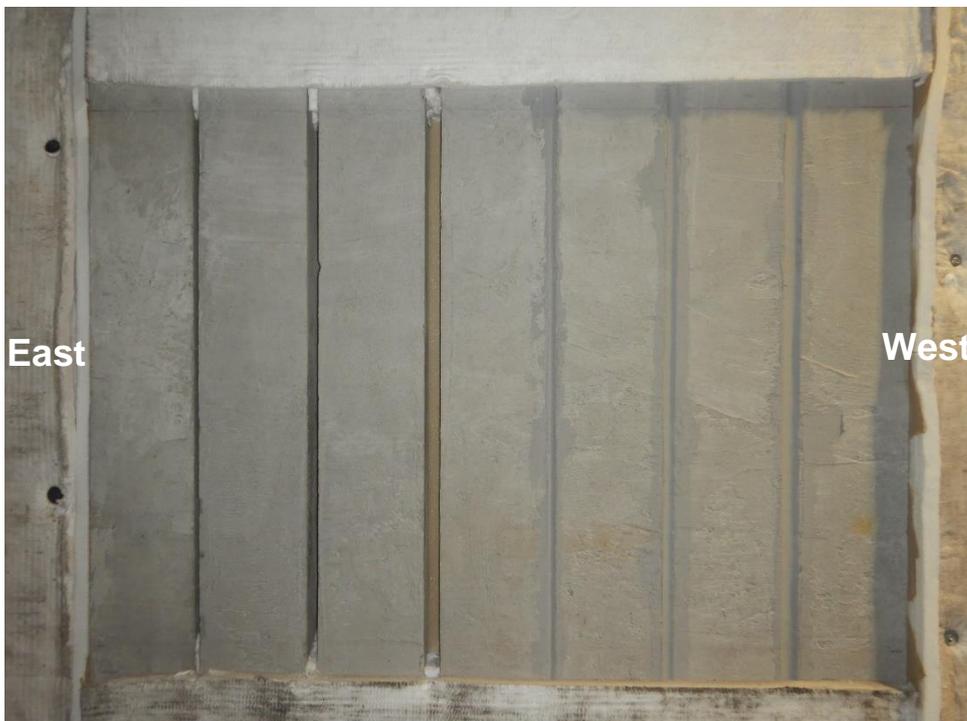
Figure 24 Exposed face of the specimen before the start of the fire-resistance test

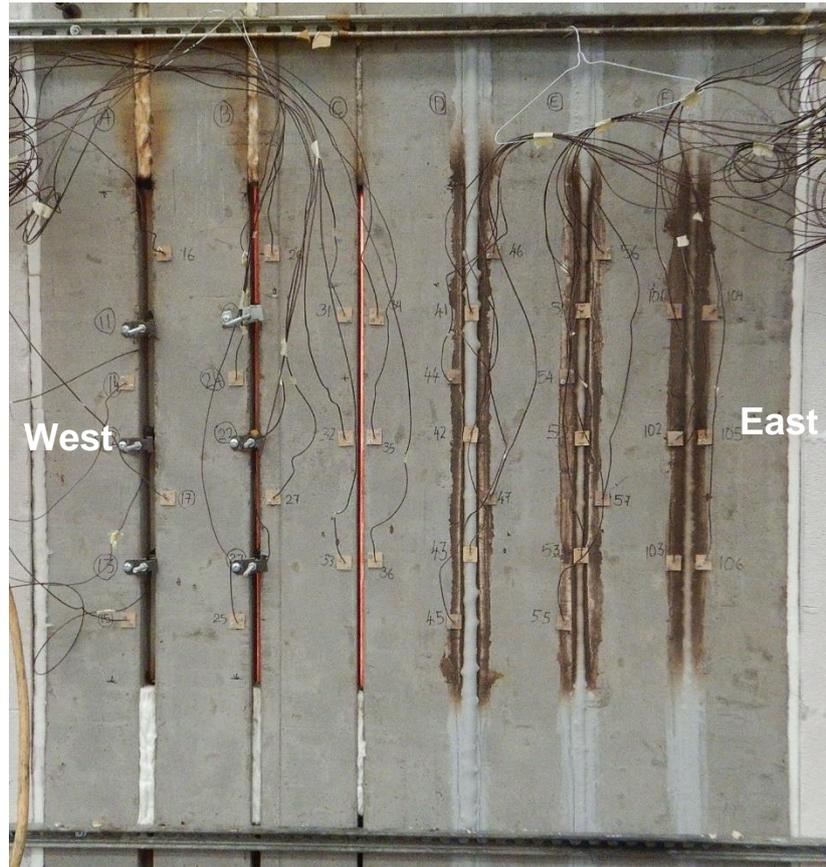
Figure 25 Unexposed face of specimen at the end of the fire-resistance test

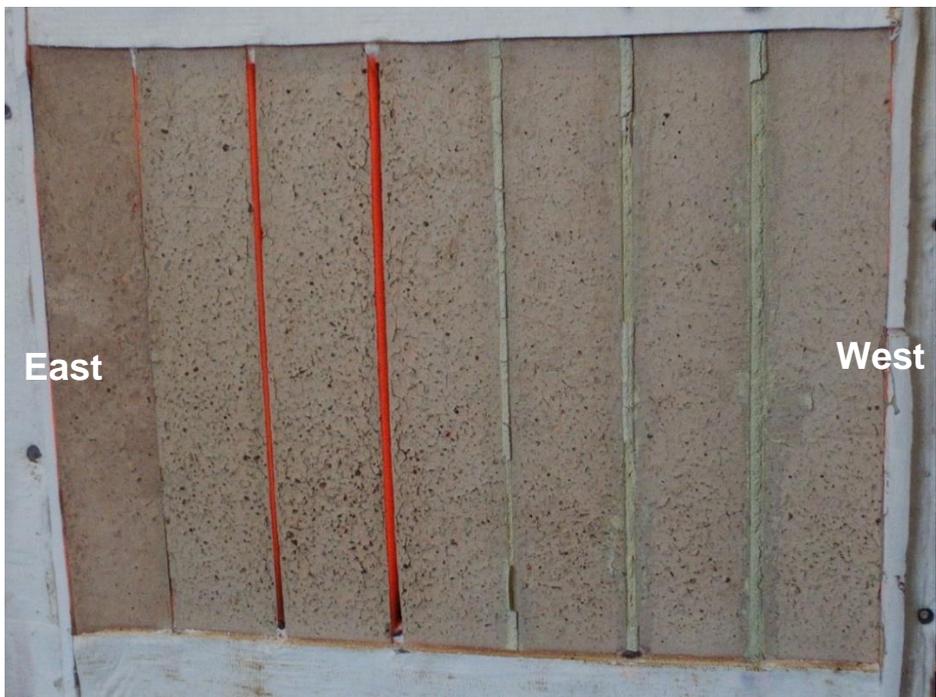
Figure 26 Exposed face of the specimen at the end of the fire-resistance test
