Fire resistance test report

Test standard: [Sections 2 and 10 of AS 1530.4:2014](#)

Test sponsor: [HB Fuller Aust P/L](#)

Job number: [FRT210008](#)

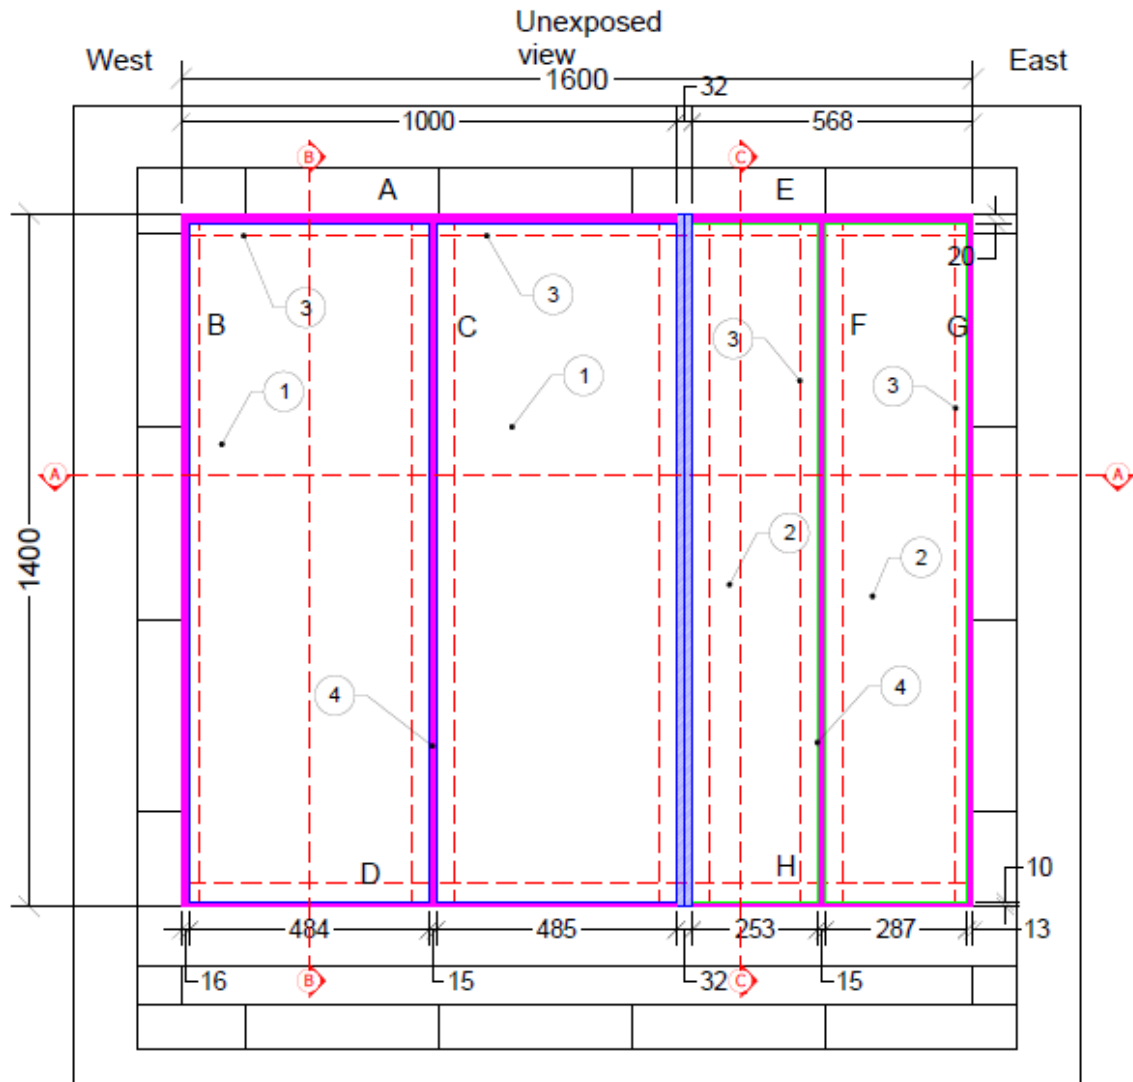
Figure 1 Elevation view of test specimen (unexposed side)

The leaders in the drawings represent the items listed in section 2.1. All measurements – unless indicated – are in millimetres.

3.	Item name	Steel frame
	Products	<ul style="list-style-type: none">• Rondo 64 mm × 36 mm steel stud with hem• Rondo 64 mm × 28 mm wall track with hem• Rondo 64 mm × 50 mm deflection head track
SE	Overall size	1600 mm wide × 1400 mm high × 128 mm / 116 mm thick
	Restraint conditions	Restrained on all edges
	Installation	The steel frame (item 3) consisted of steel studs installed vertically and a wall track and deflection head track installed horizontally. The edge frames were secured to the test frames with masonry anchors. The steel frames were sized to fit the varying control joint sizes – see Figure 1.

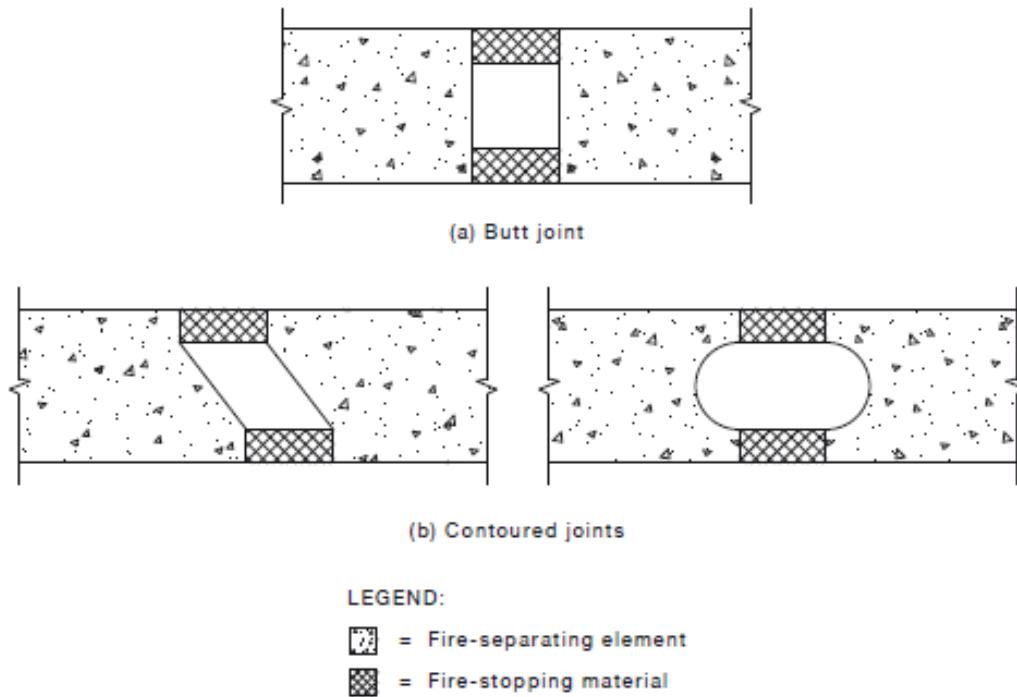
- Results obtained from single test on a butt joints may be applied to contoured joints, provided the joints have —
 - equal width and equal or greater depth of sealant; and
 - equal or greater thickness of fire-separating element.
 - Note: Examples of butt and contoured control joints are shown in figure 10.12.6 of AS 1530.4:2014.
- Facings may be applied to the surface of the fire-stopping system.

FIGURE 10.12.6 CONTOURED CONTROL JOINTS

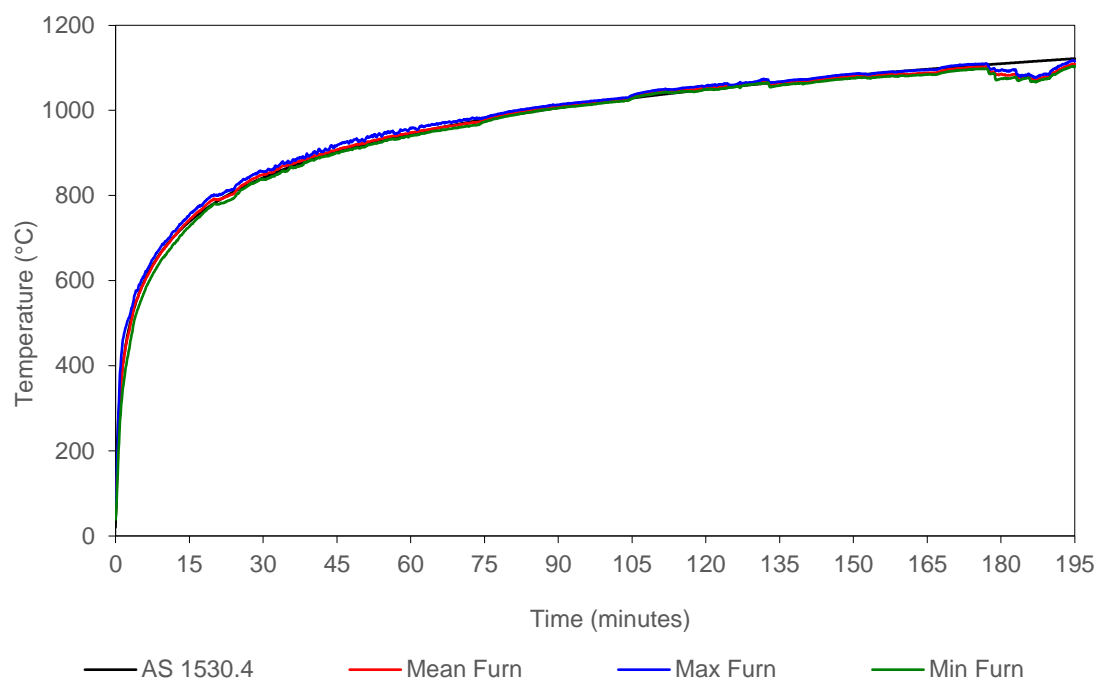
Figure 6 Furnace thermocouple temperature vs time

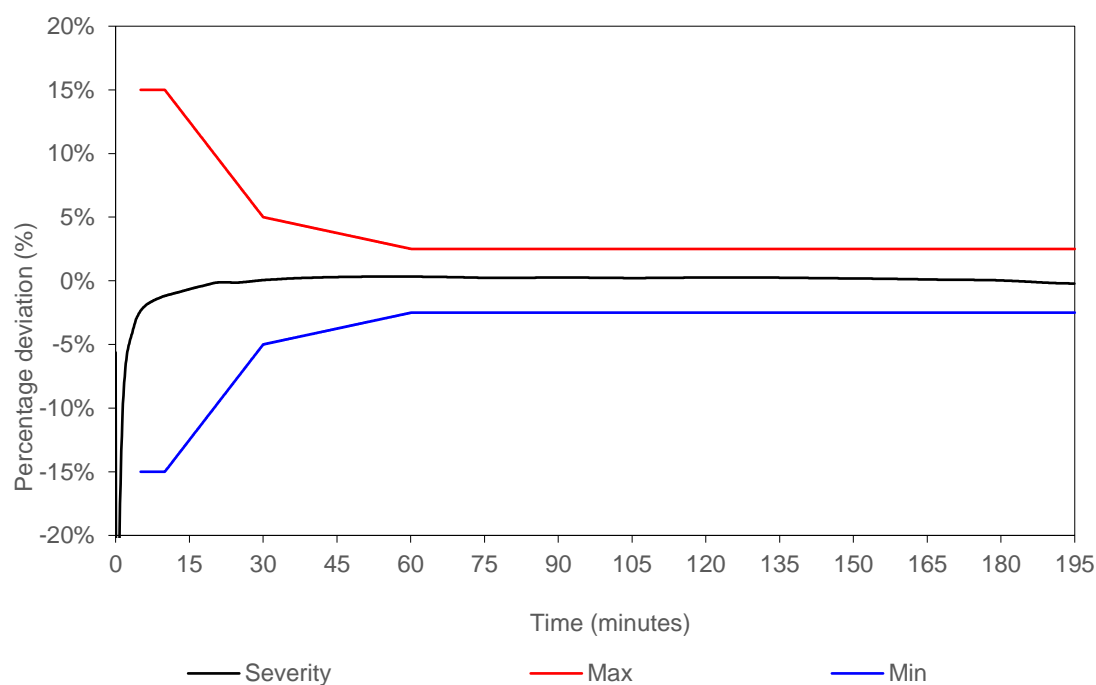
Figure 7 Percentage deviation of exposure severity vs time

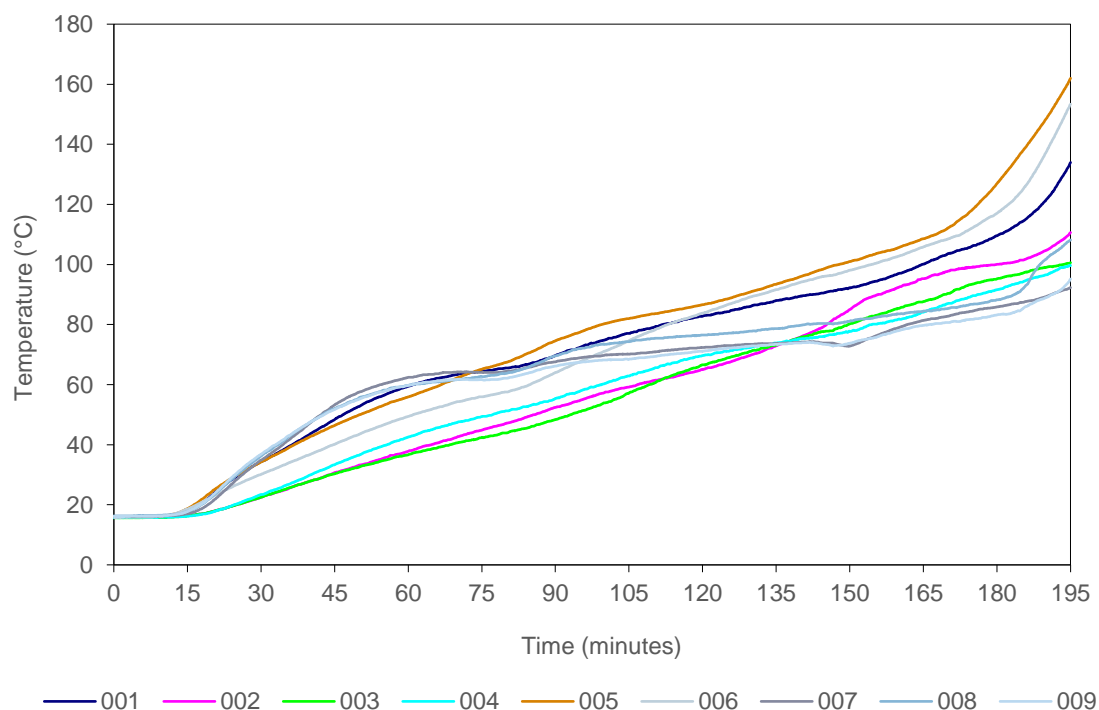
Figure 8 Control joint A – temperature vs time

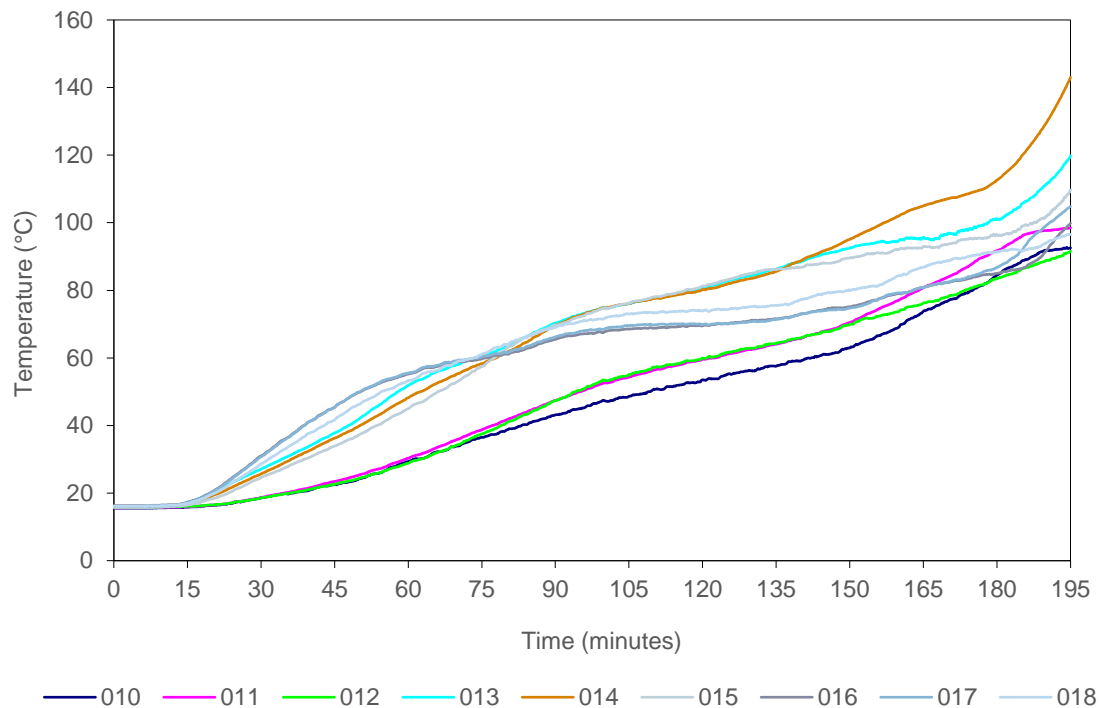
Figure 9 Control joint B – temperature vs time

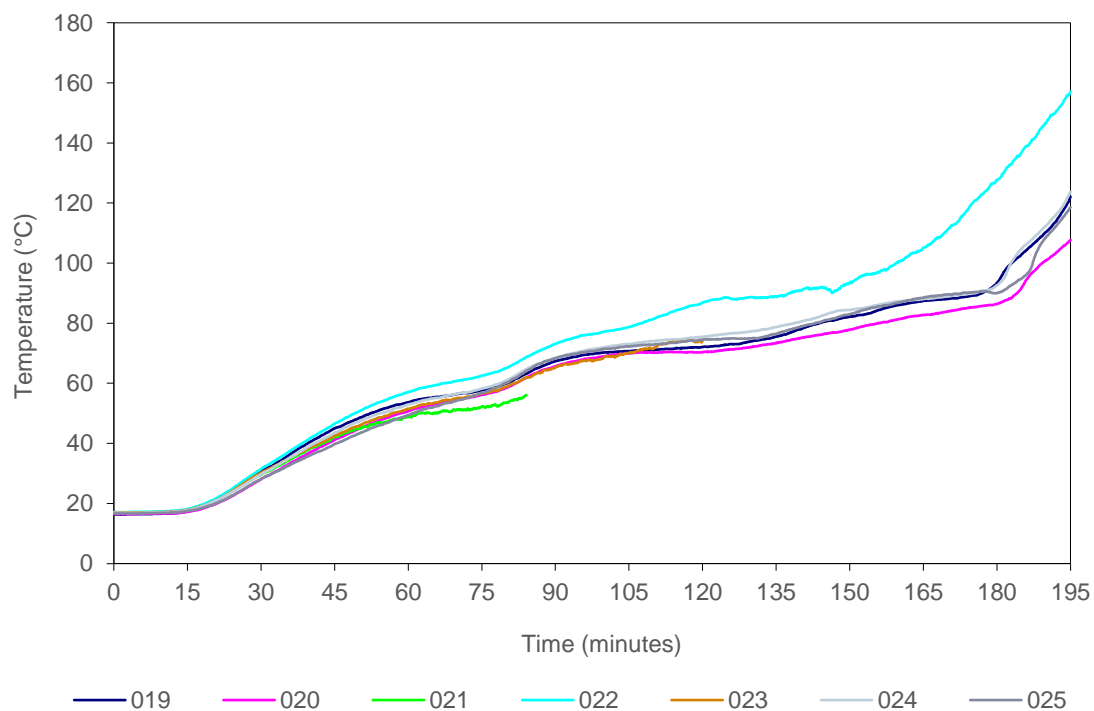
Figure 10 Control joint C – temperature vs time

- TC021 detached from the specimen at 84 minutes of the test period.
- TC023 detached from the specimen at 120 minutes of the test period.

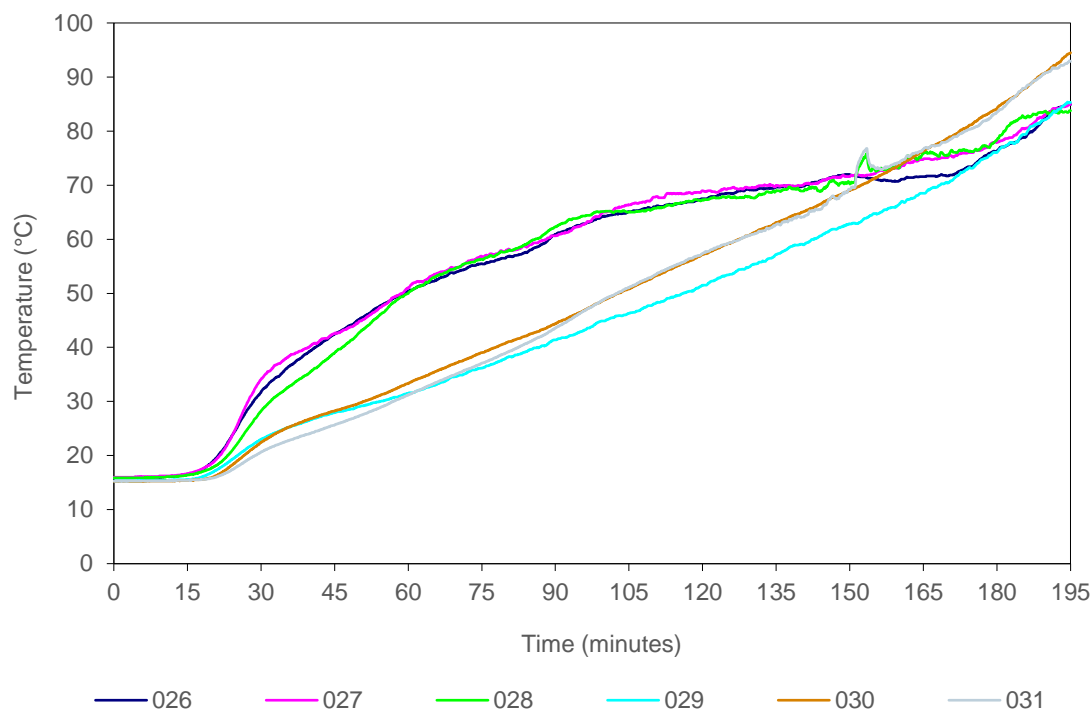
Figure 11 Control joint D – temperature vs time

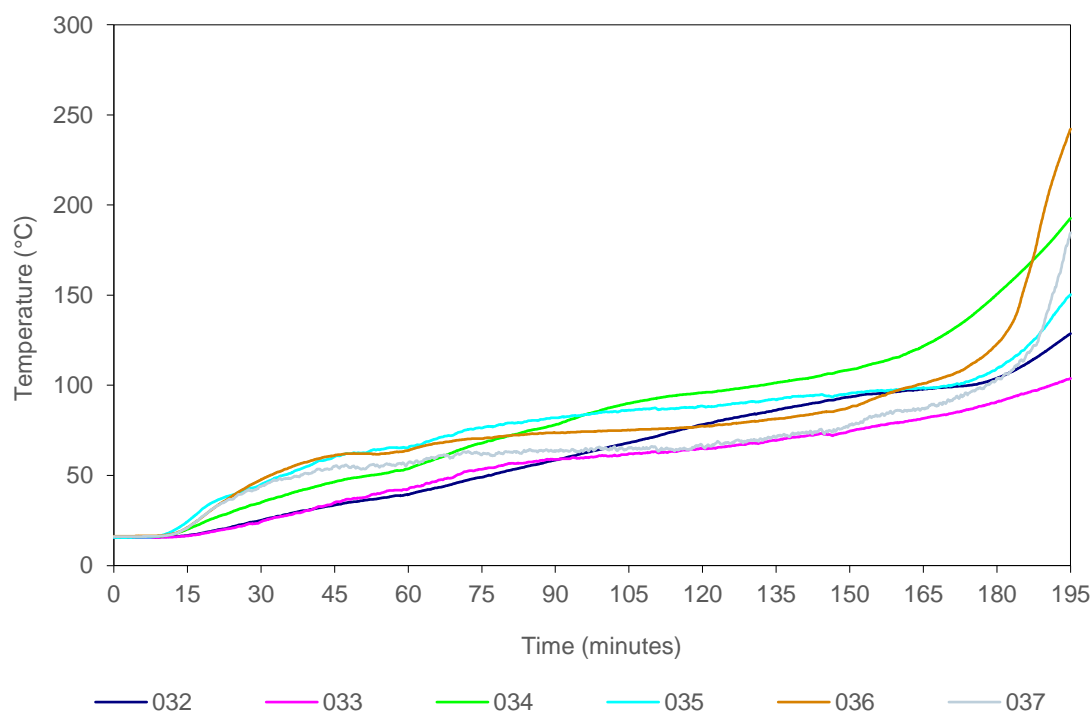
Figure 12 Control joint E – temperature vs time

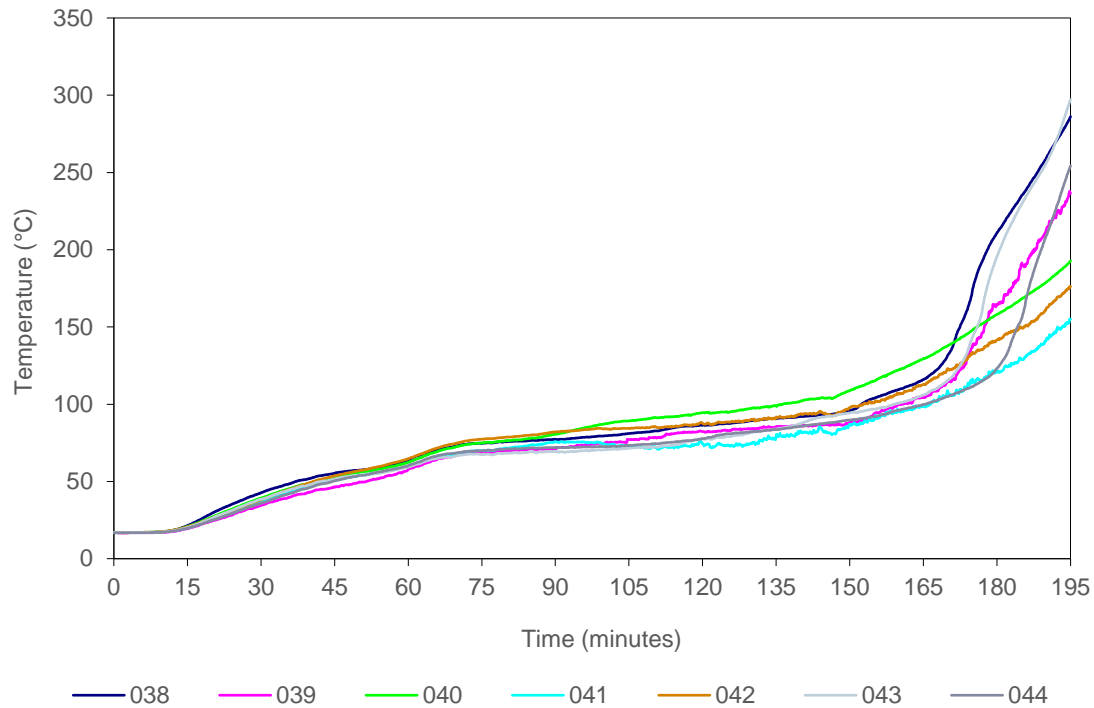
Figure 13 Control joint F – temperature vs time

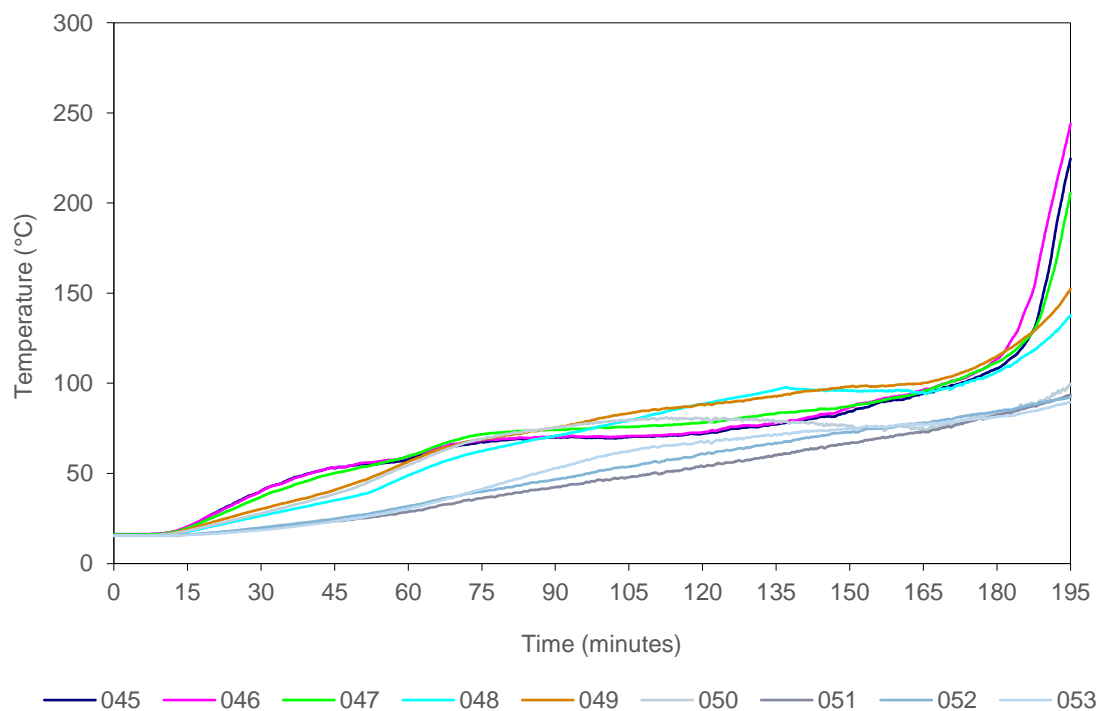
Figure 14 Control joint G – temperature vs time

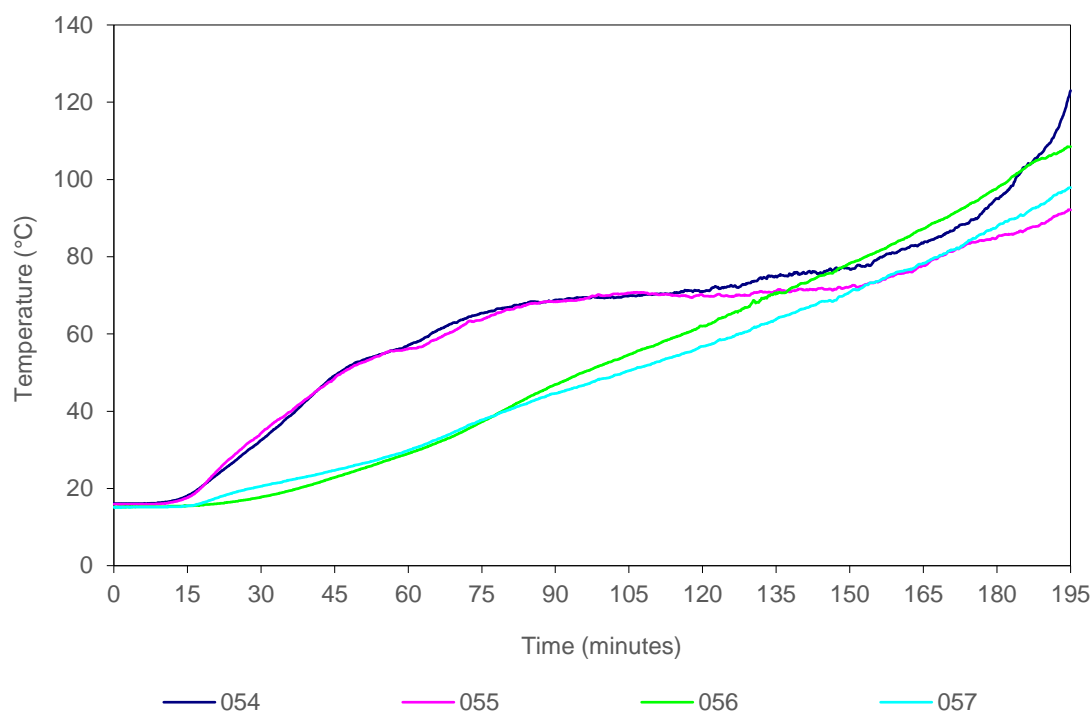
Figure 15 Control joint H – temperature vs time

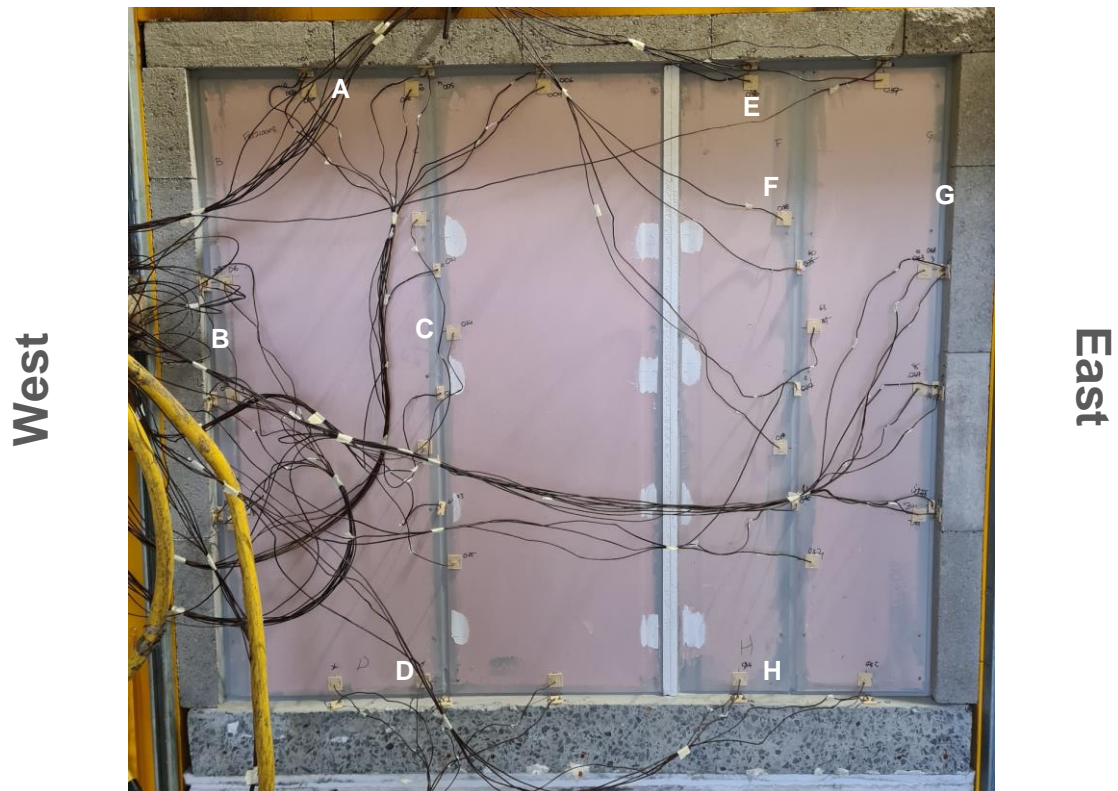
Figure 16 Unexposed face of the specimen before the start of the test

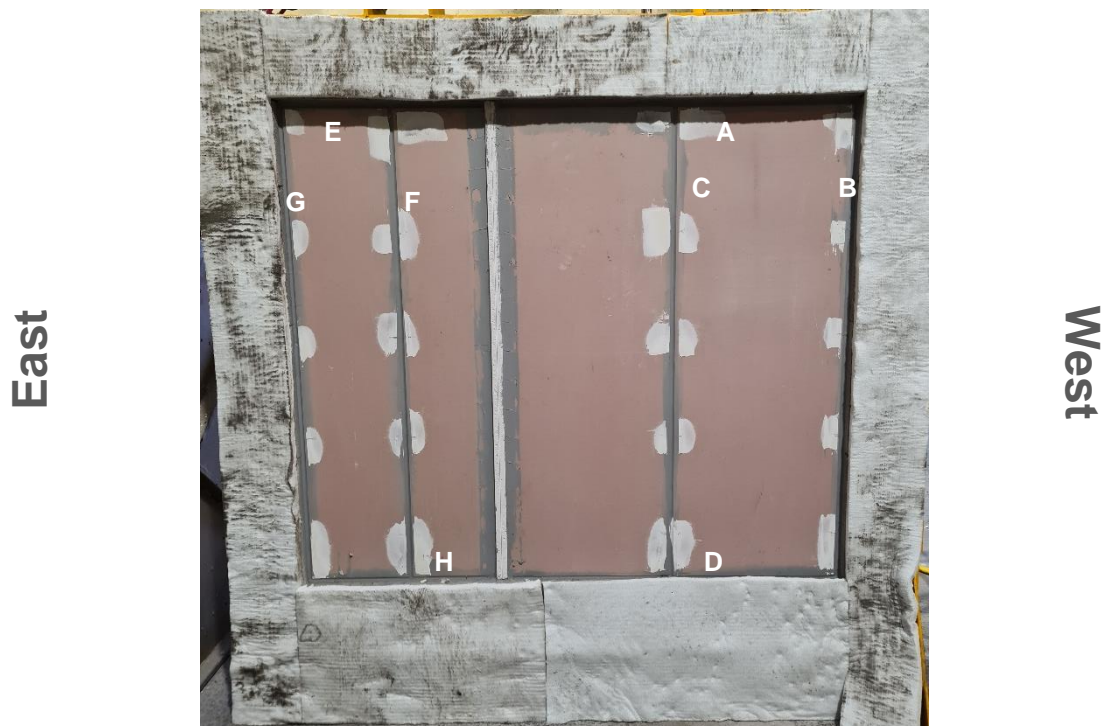
Figure 17 Exposed face of the specimen before the start of the test

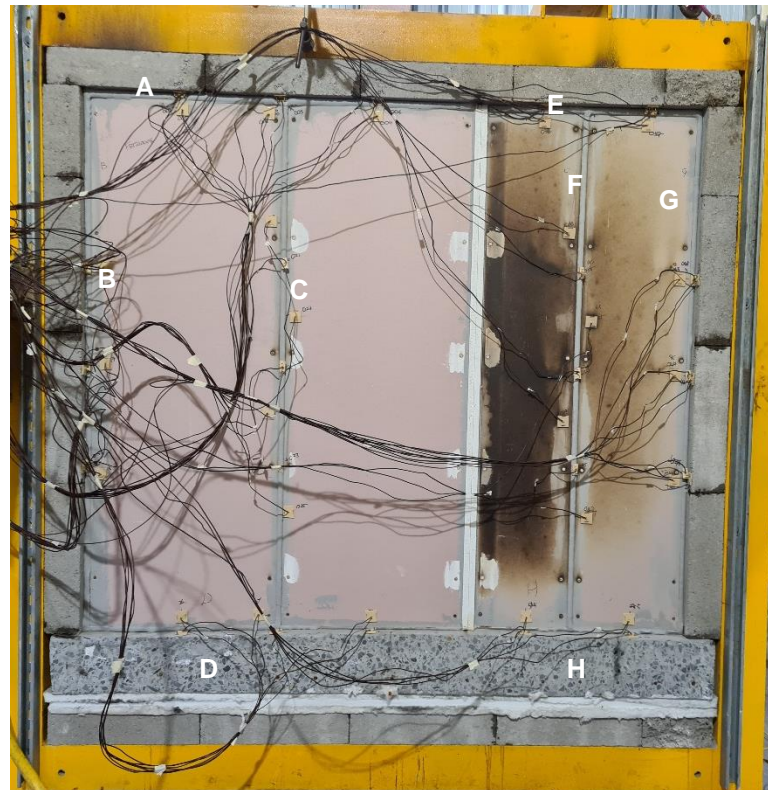
Figure 18 Unexposed face of the specimen at the end of the test

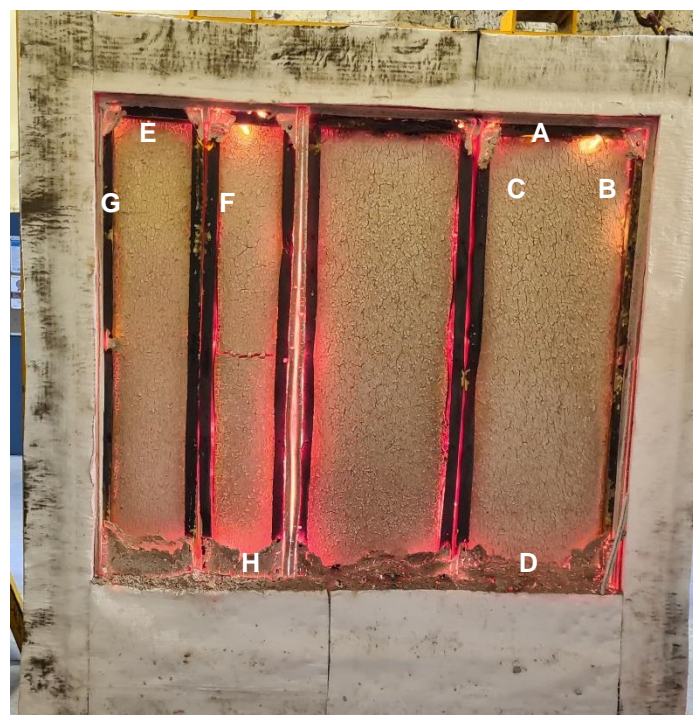
Figure 19 Exposed face of the specimen at the end of the test
