# Fire resistance test report

Test standard: Sections 2 and 10 of AS 1530.4:2014

Test sponsor: H.B. Fuller Australia Pty Ltd

Product: H.B. Fuller Firesound™

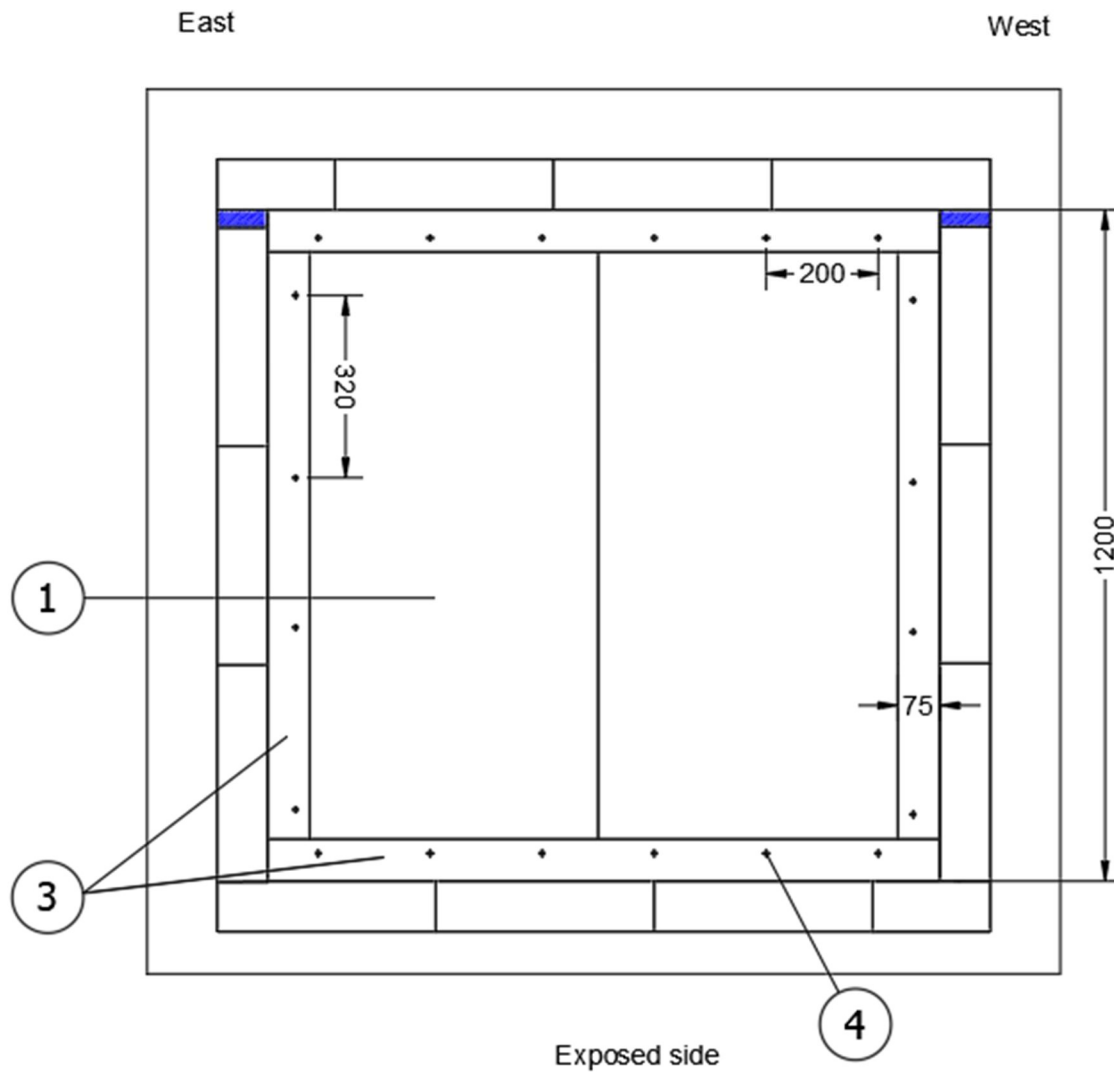
Figure 2 Elevation view / plan view of test specimen (exposed side)

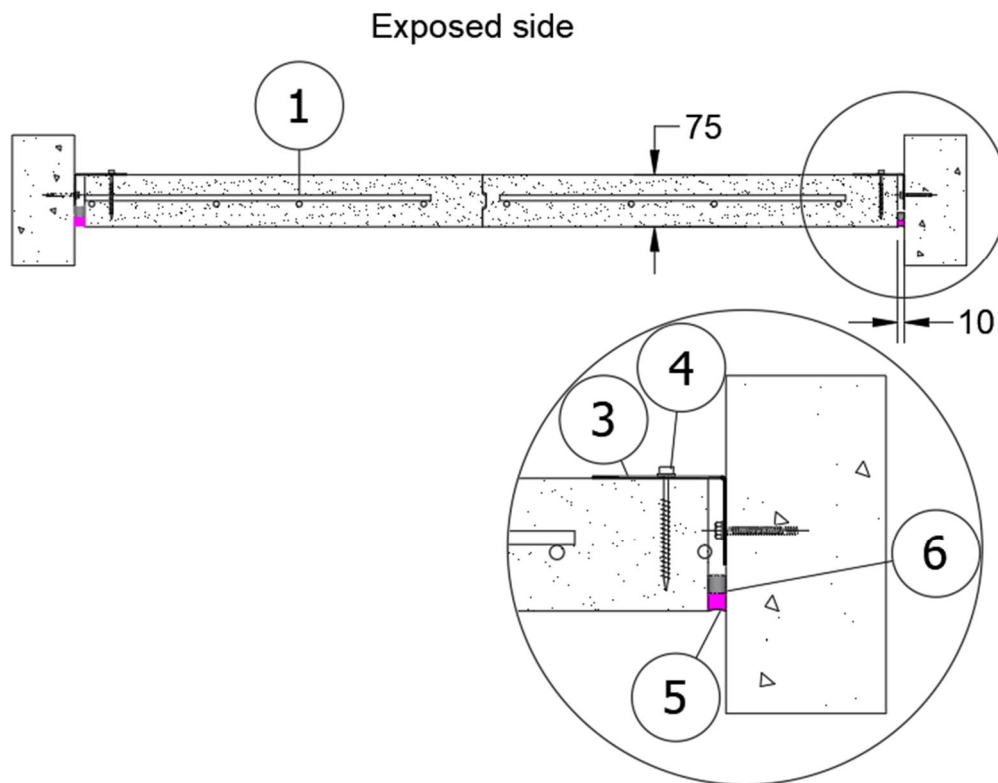
Figure 4 Cross-section B-B

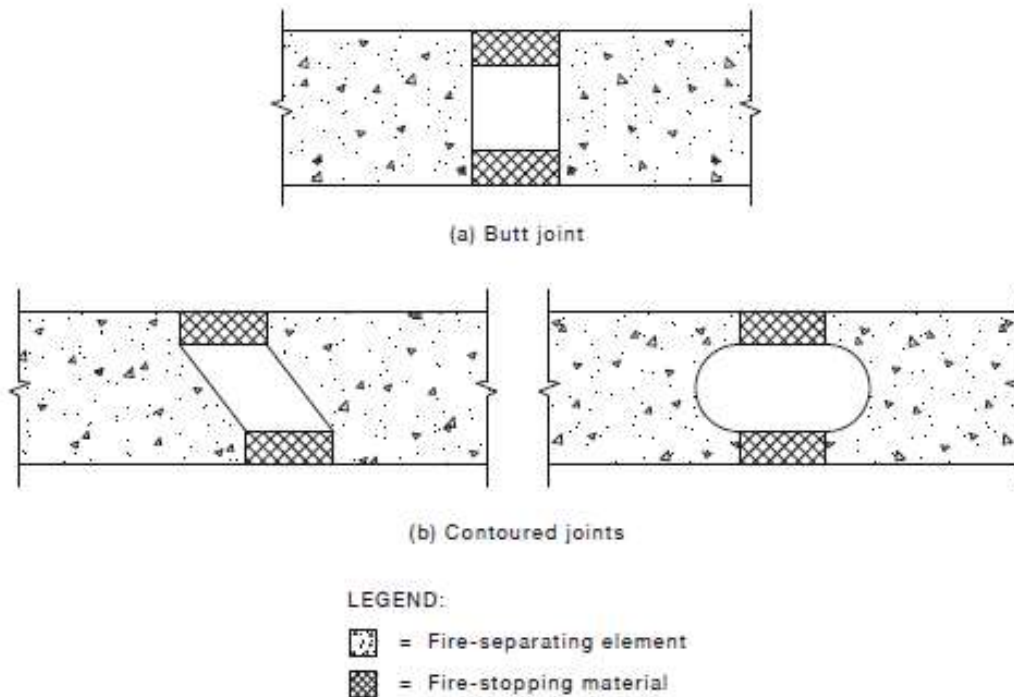
FIGURE 10.12.6 CONTOURED CONTROL JOINTS

- Results obtained from single test on a butt joints may be applied to contoured joints, provided the joints have —
  - equal width and equal or greater depth of sealant; and
  - equal or greater thickness of fire-separating element.
  - Note: Examples of butt and contoured control joints are shown in figure 10.12.6 of AS 1530.4:2014.
- Facings may be applied to the surface of the fire-stopping system.

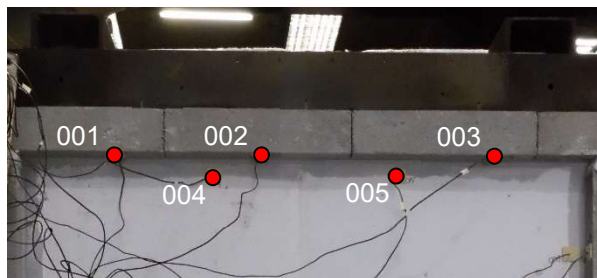
Figure 5 Upper horizontal control joint A

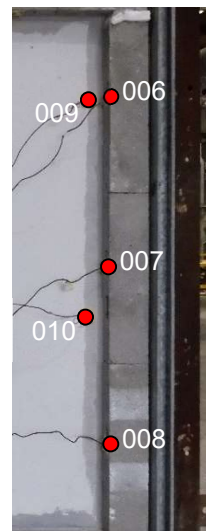
Figure 6 East vertical control joint B

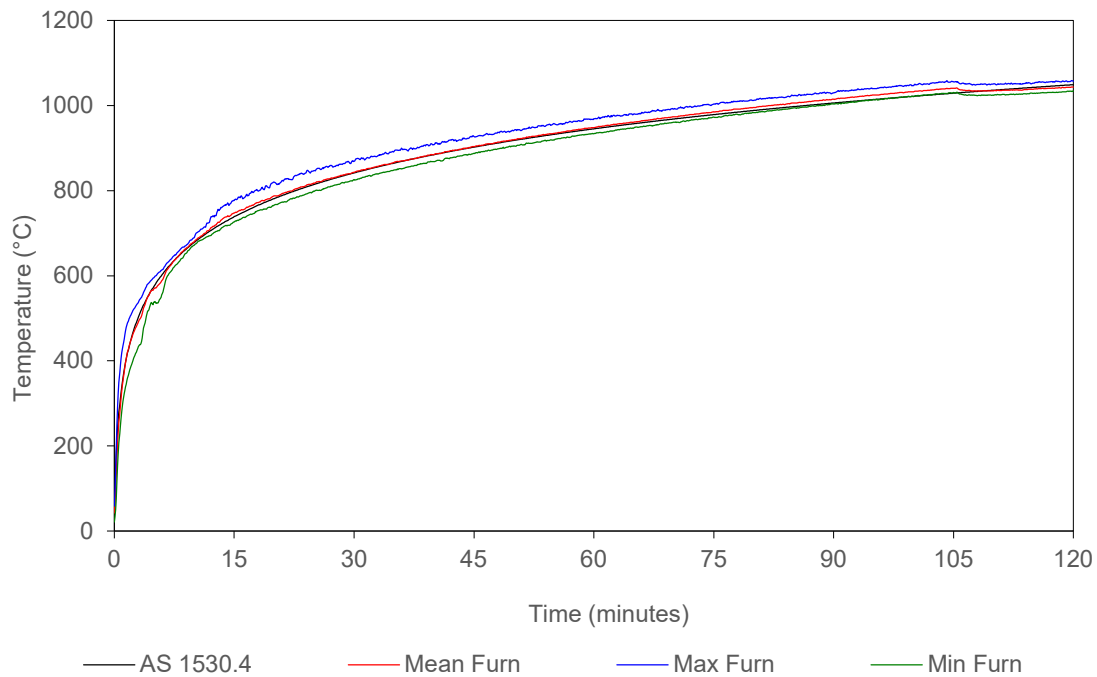
Figure 8 Furnace thermocouple temperature vs time

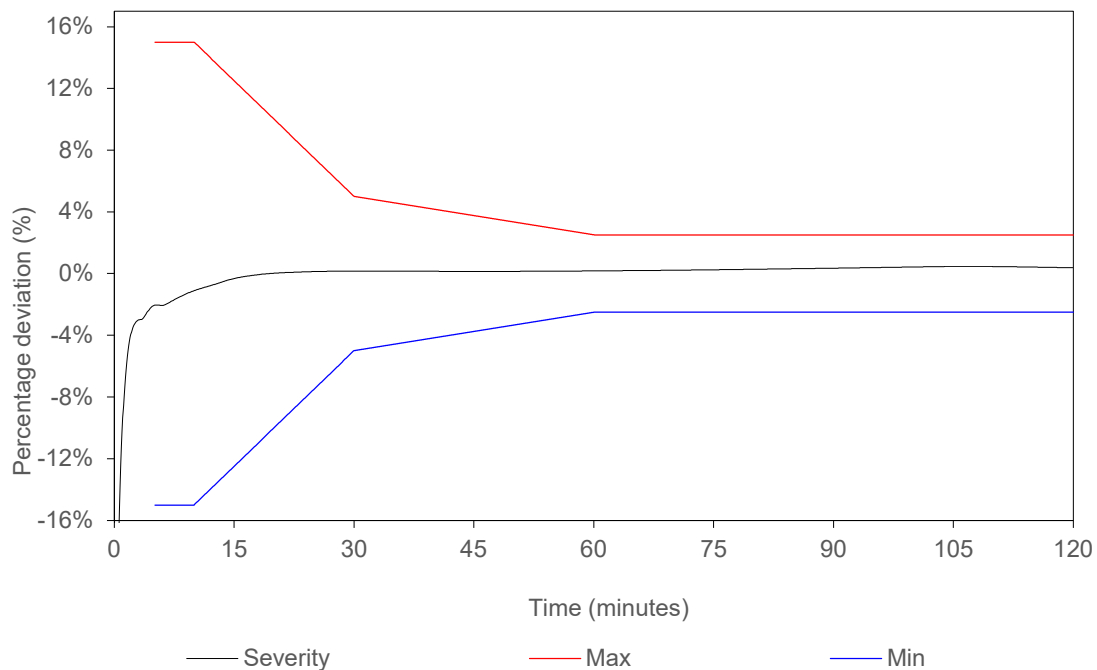
Figure 9 Percentage deviation of exposure severity vs time

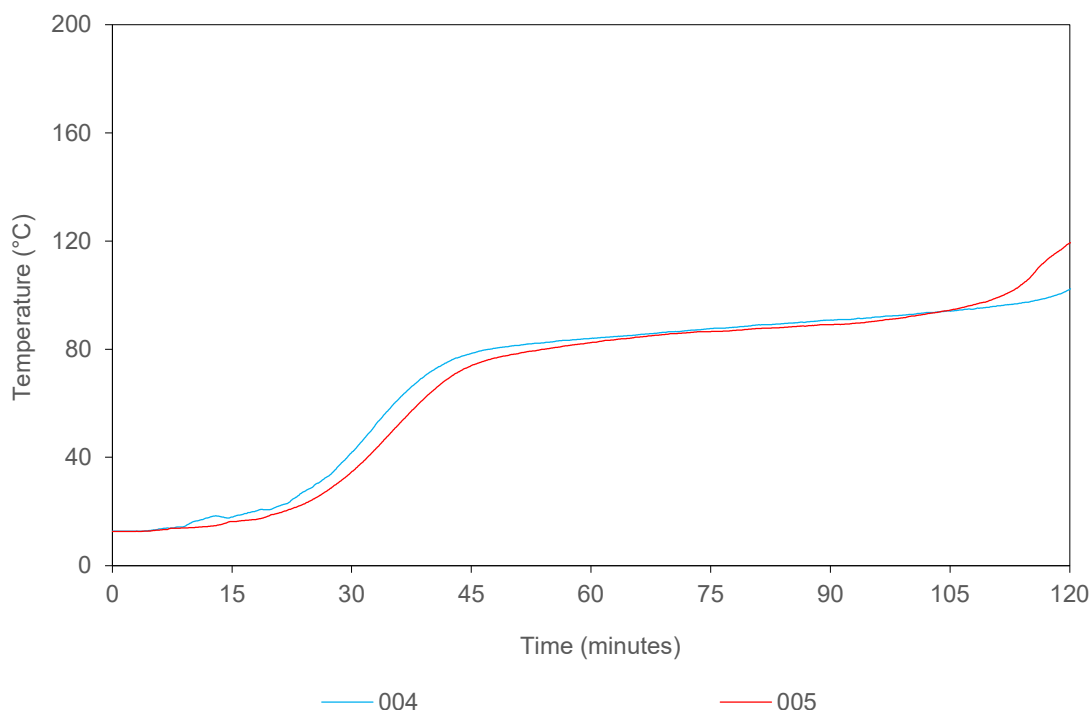
**Figure 10 Upper horizontal control joint A on the Hebel® wall – temperature vs time**

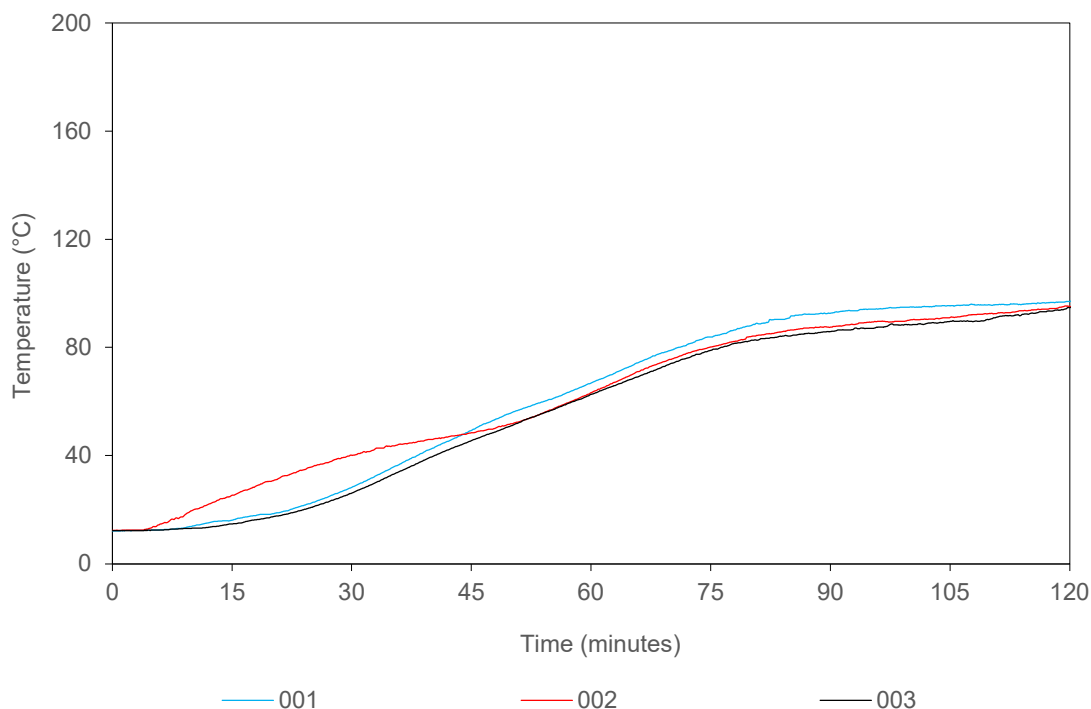
**Figure 11** Upper horizontal control joint A on the concrete blocks – temperature vs time

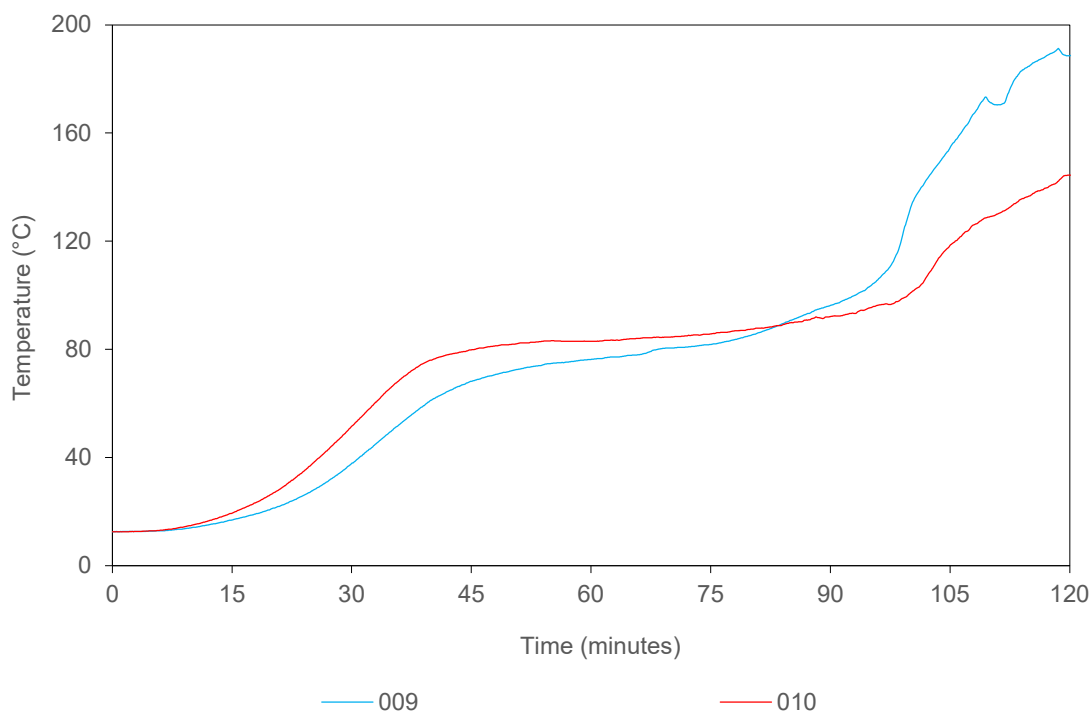
**Figure 12** East vertical control joint B on the Hebel® wall – temperature vs time

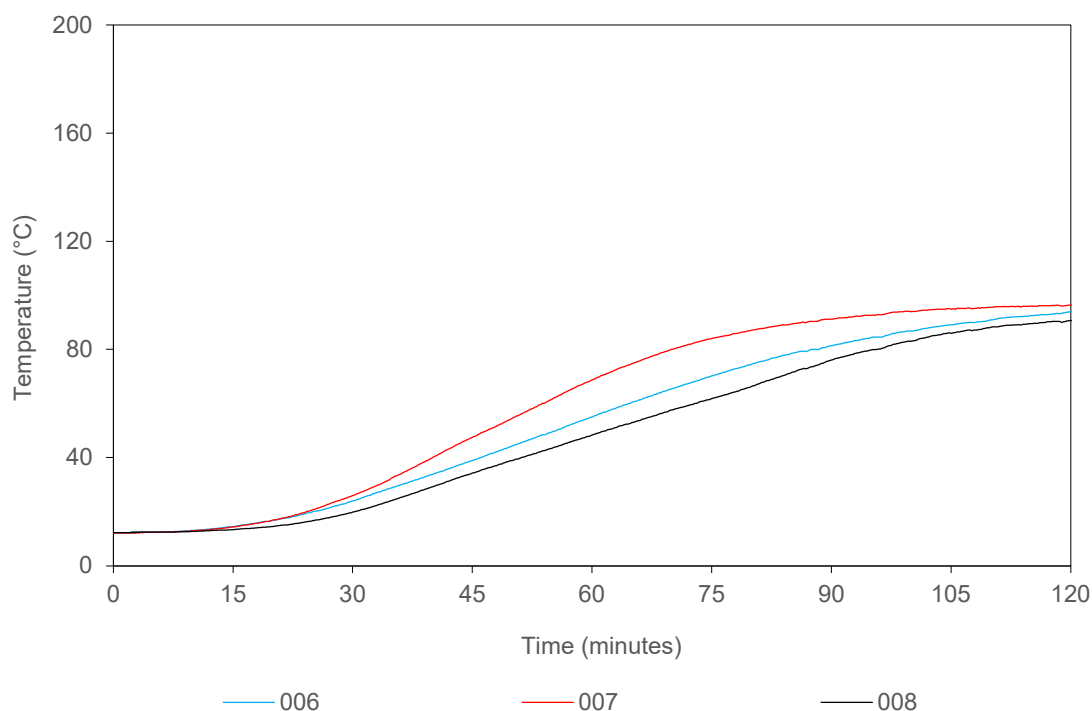
**Figure 13** East vertical control joint C on the concrete blocks – temperature vs time

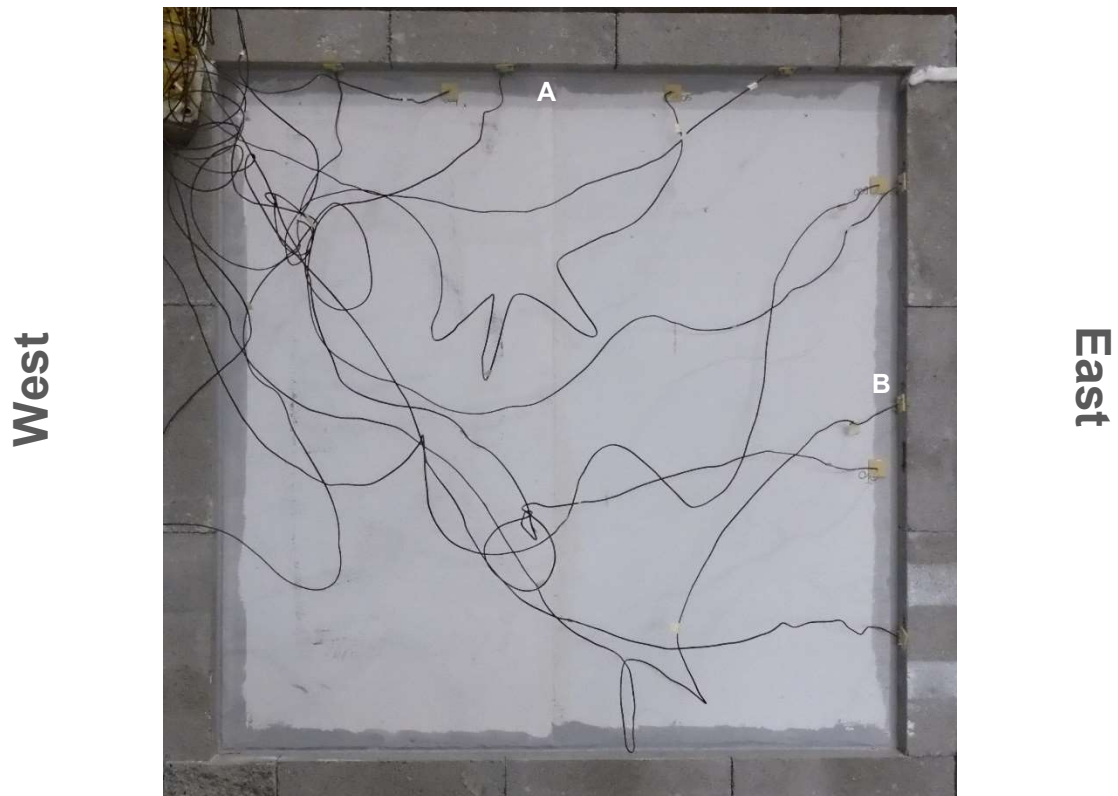
Figure 14 Unexposed face of the specimen before the start of the test

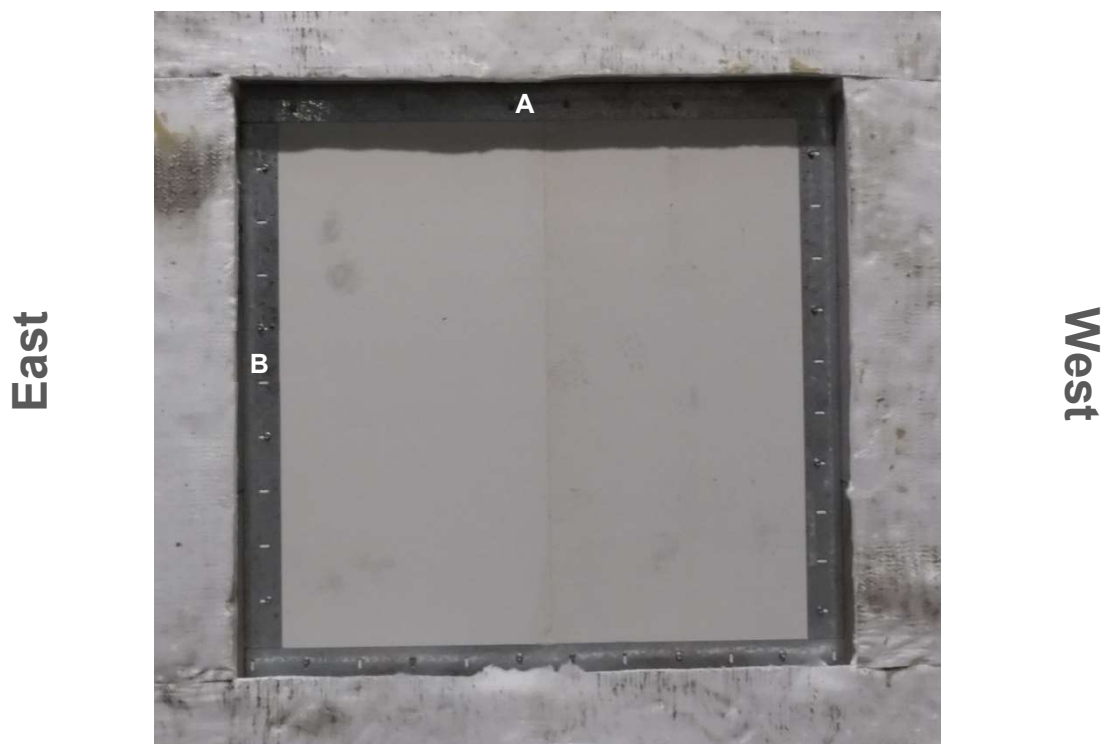
Figure 15 Exposed face of the specimen before the start of the test

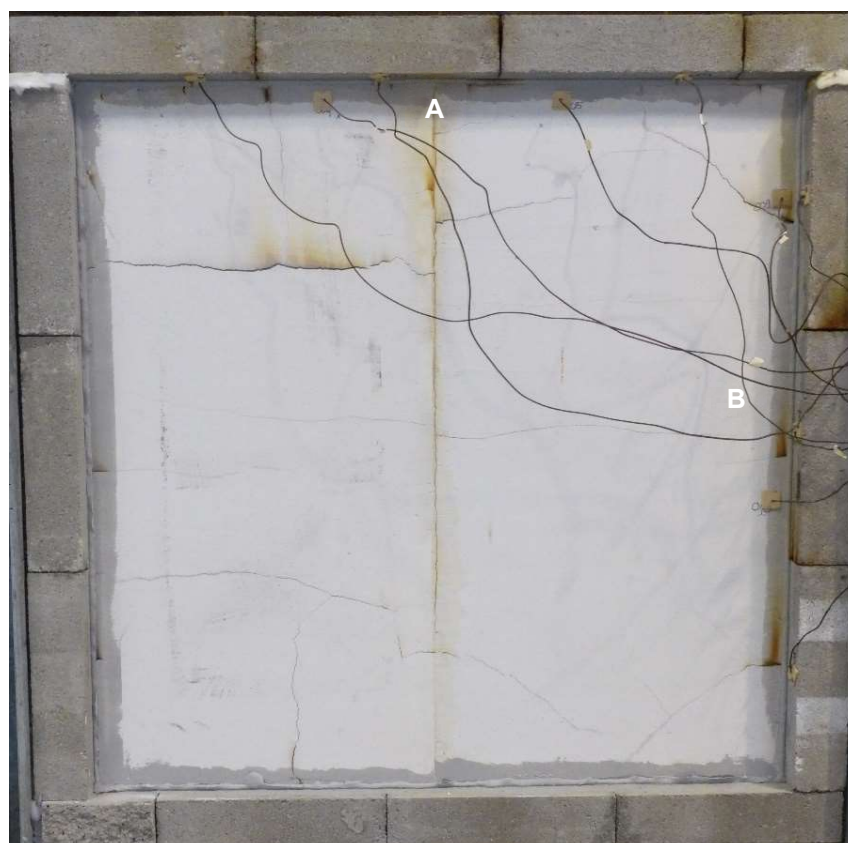
Figure 16 Unexposed face of the specimen at the end of the test

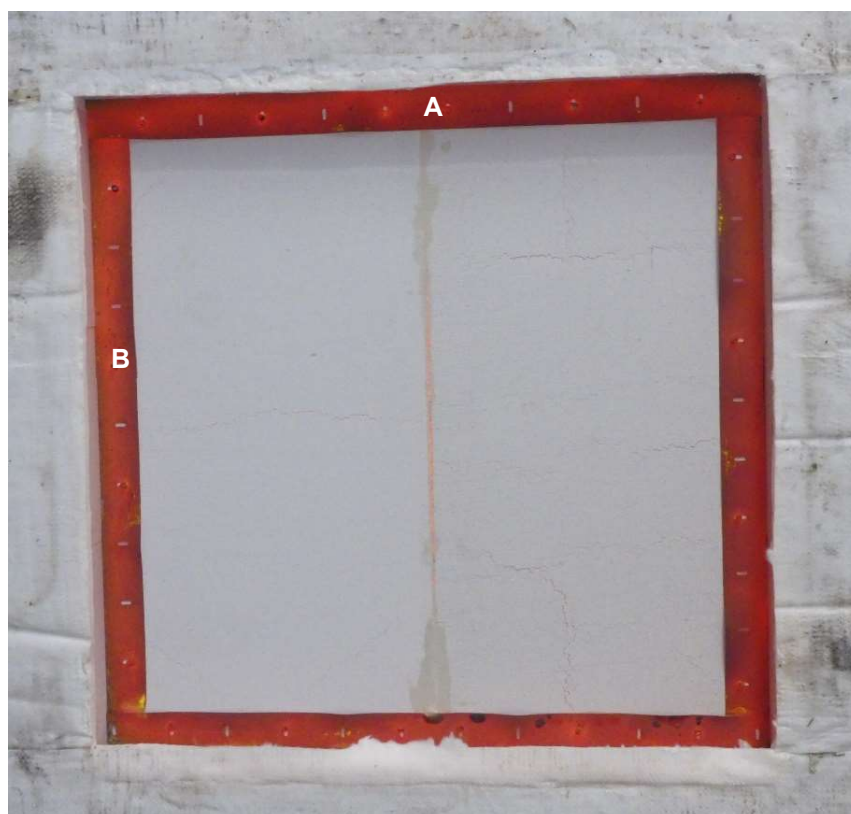
Figure 17 Exposed face of the specimen at the end of the test
