Fire resistance test report

Test standard: [Sections 2 and 10 of AS 1530.4:2014](#)

Test sponsor: [HB Fuller Aust Co P/L](#)

This report documents the findings of the fire resistance test of six control joints in accordance with sections 2 and 10 of AS 1530.4:2014. The testing was done on 21 June 2021.

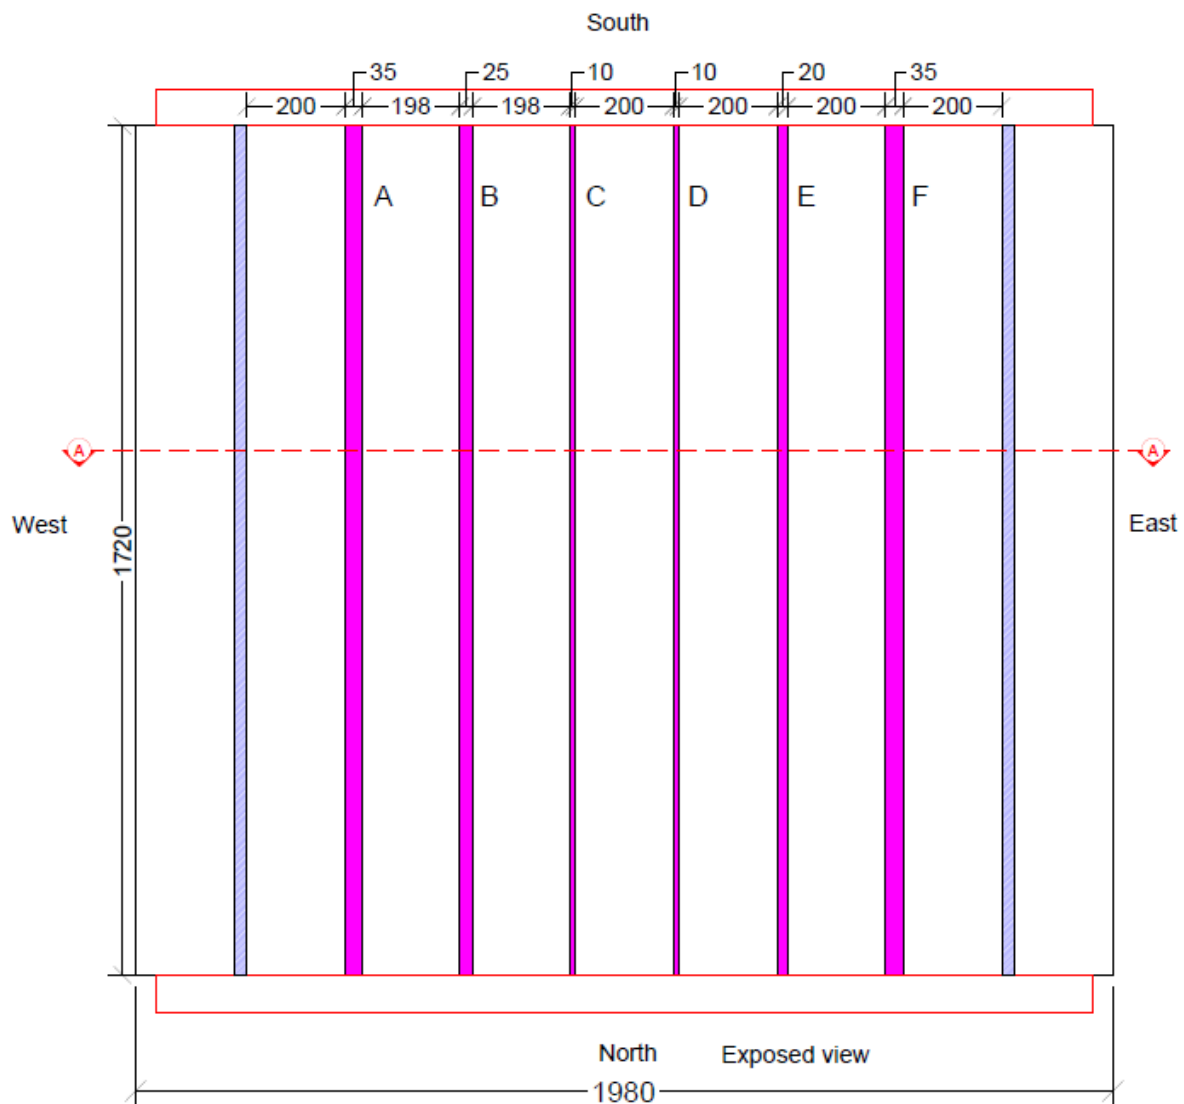
The leaders in the drawings represent the items listed in section 2.1. All measurements – unless indicated – are in millimetres.

Figure 1 Plan view of test specimen (exposed side)

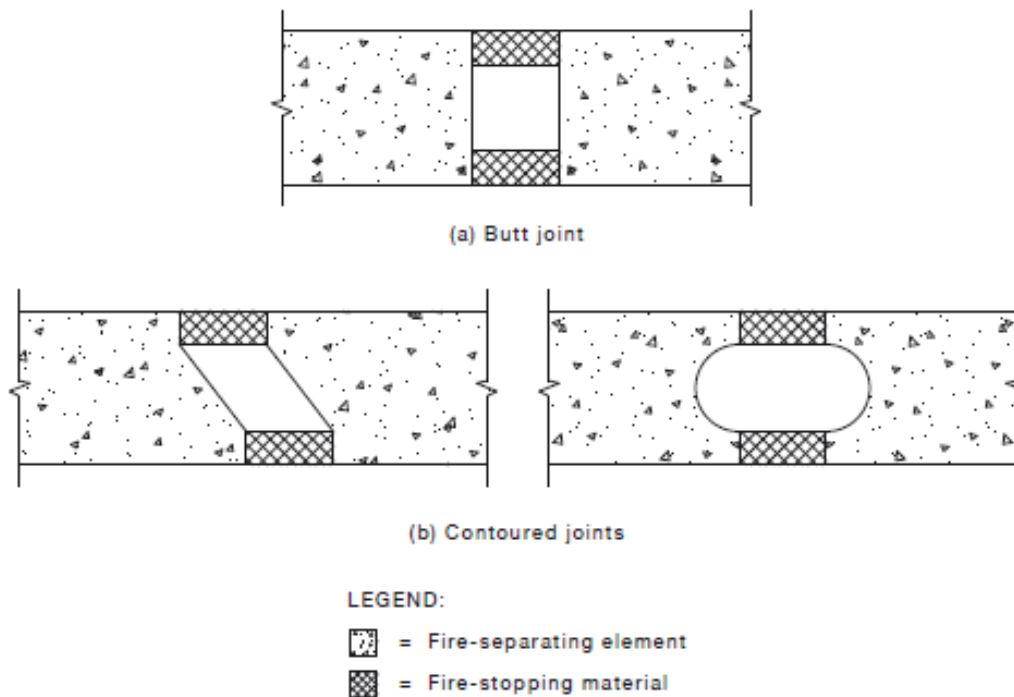
- Results obtained from single test on a butt joints may be applied to contoured joints, provided the joints have —
 - equal width and equal or greater depth of sealant; and
 - equal or greater thickness of fire-separating element.
 - Note: Examples of butt and contoured control joints are shown in figure 10.12.6 of AS 1530.4:2014.
- Facings may be applied to the surface of the fire-stopping system.

FIGURE 10.12.6 CONTOURED CONTROL JOINTS

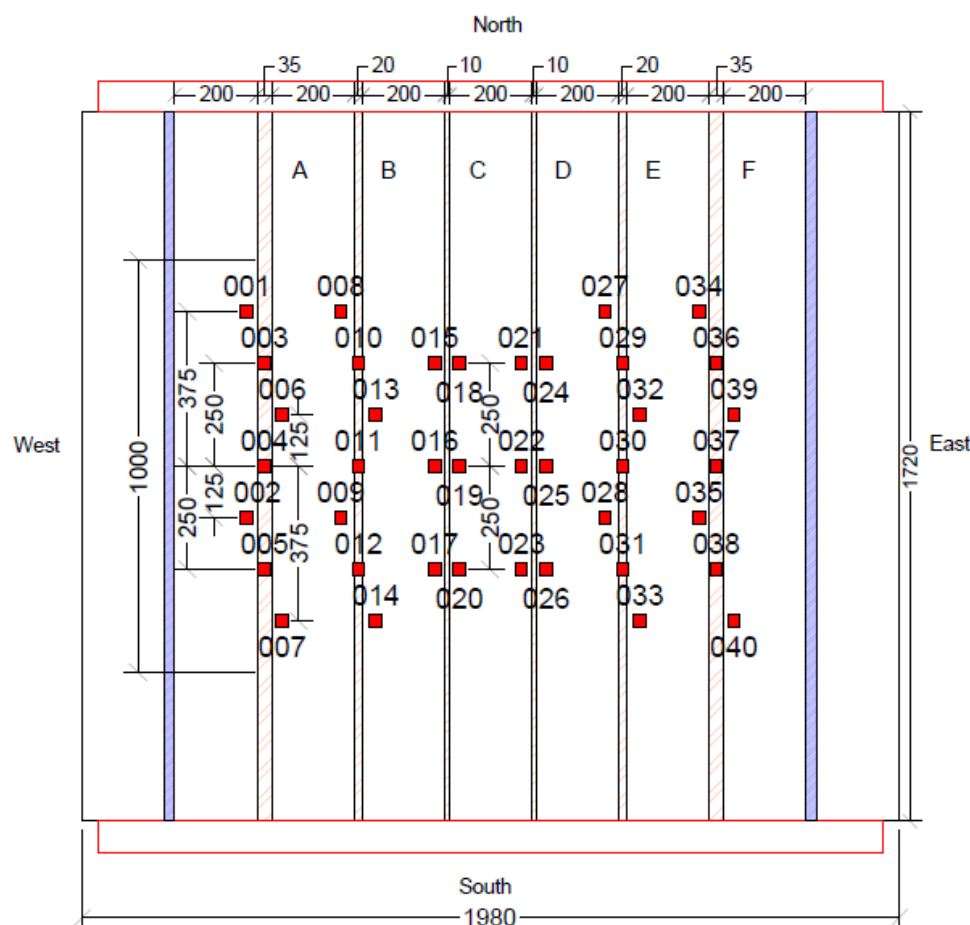
Figure 3 Instrumentation locations

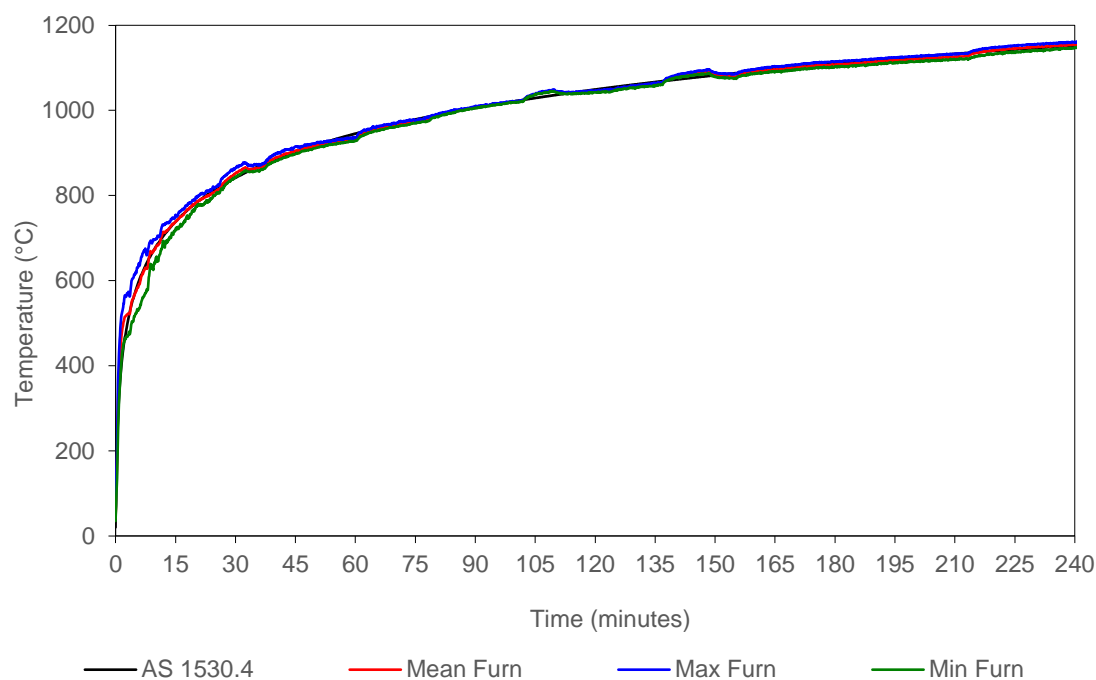
Figure 4 Furnace thermocouple temperature vs time

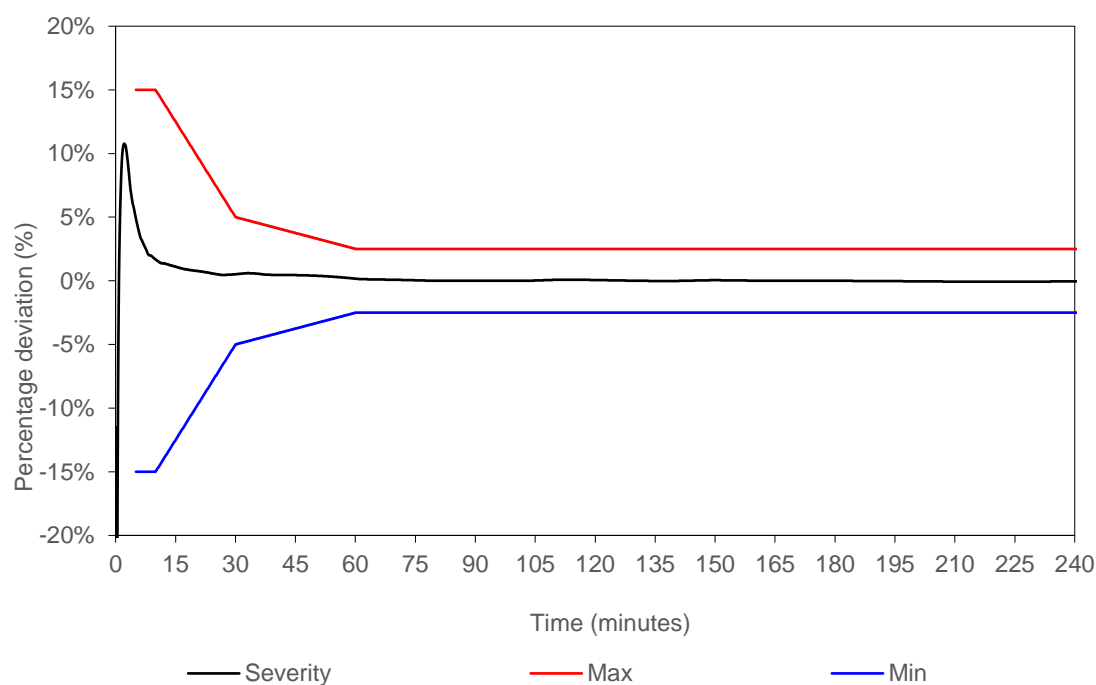
Figure 5 Percentage deviation of exposure severity vs time

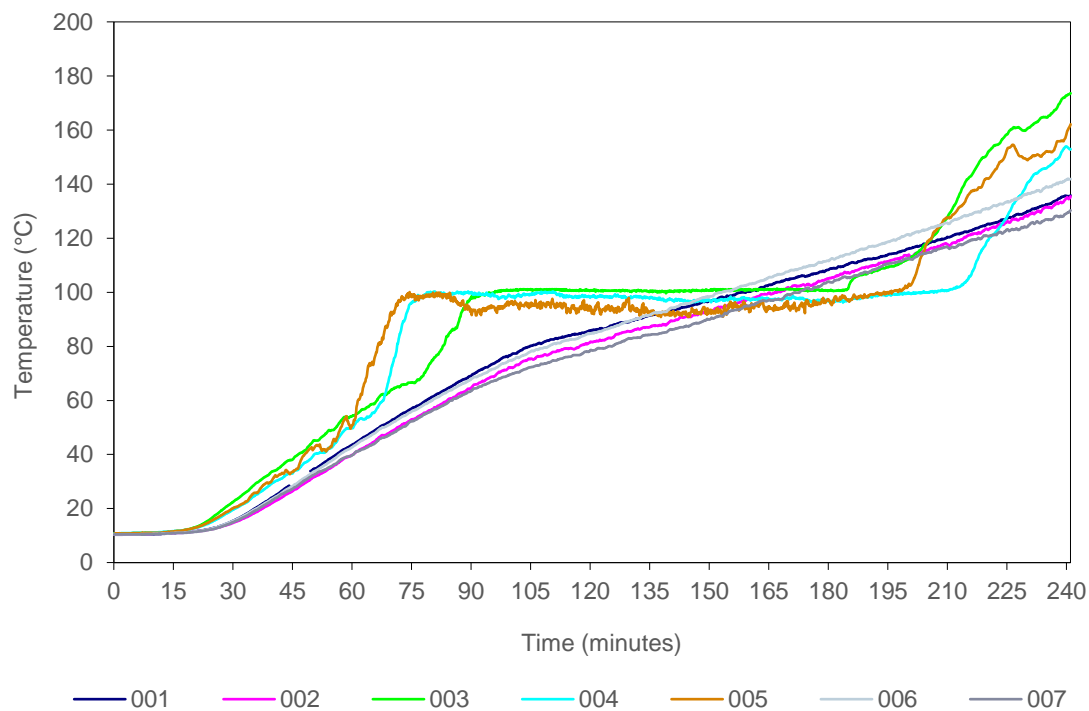
Figure 6 Control joint A – temperature vs time

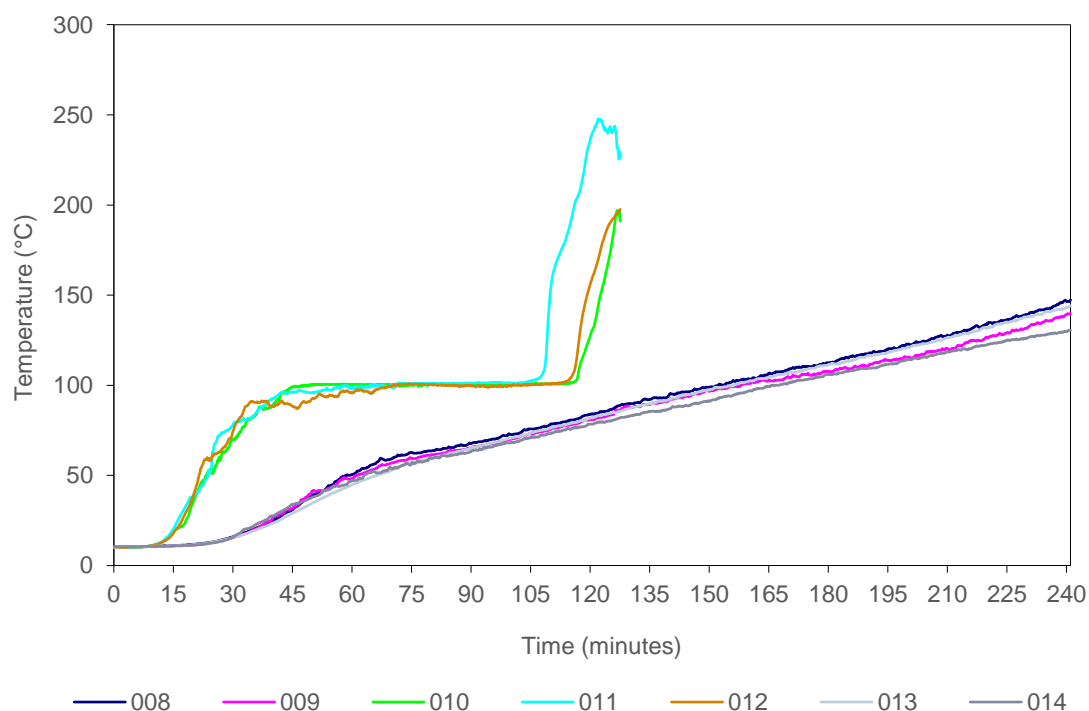
Figure 7 Control joint B – temperature vs time

Note: TC010 to 012 detached from the specimen at 127 minutes of the test period.

| Time | | Observation |
|---|---|---|
| 115 | 05 | TC011, on the control joint, at the centre recorded a temperature of 190 °C. Failure of insulation in accordance with clause 2.13.3(b) of AS 1530.4:2014, where the maximum temperature of thermocouple TC011 exceeded the initial temperature by more than 180 K. |

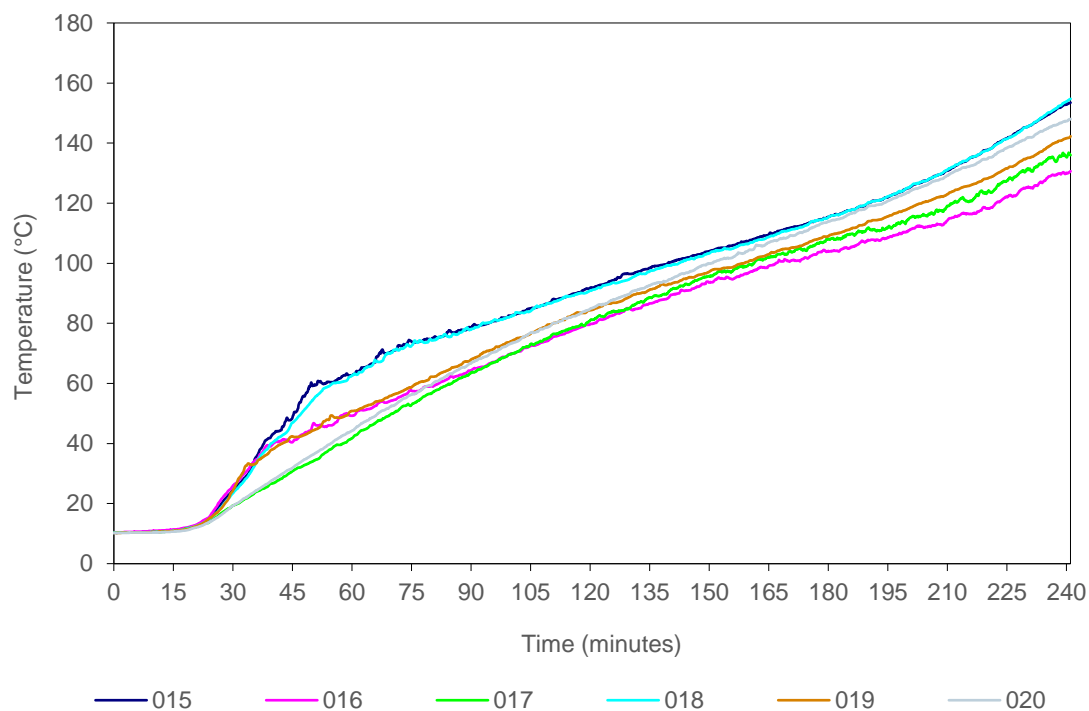
Figure 8 Control joint C – temperature vs time

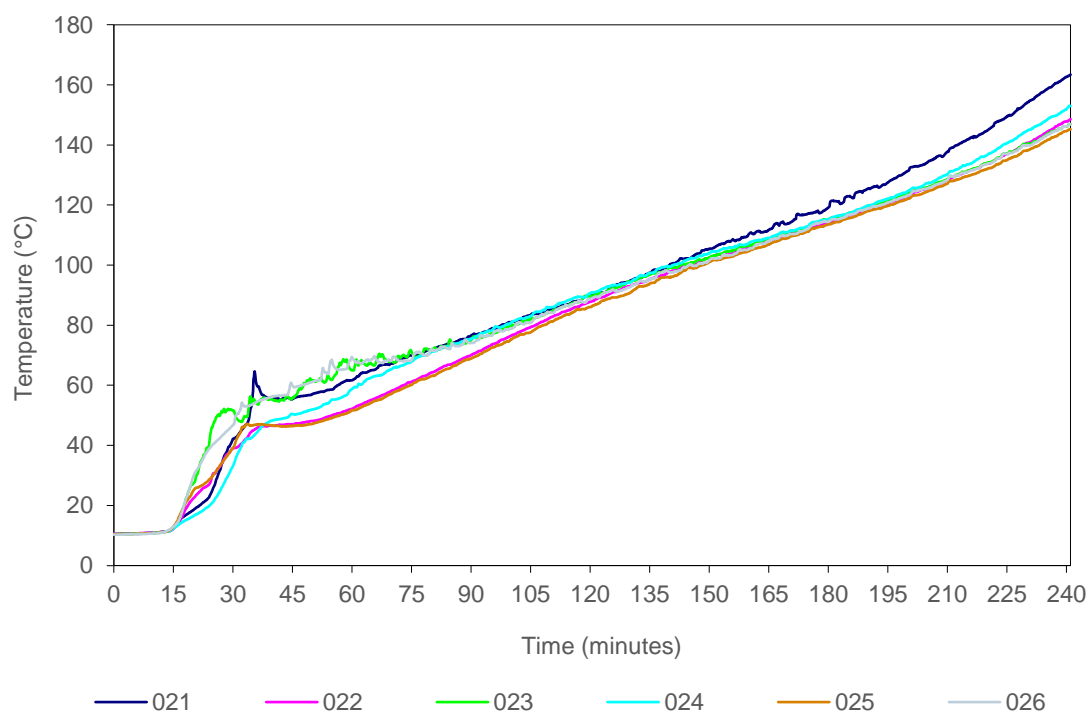
Figure 9 Control joint D – temperature vs time

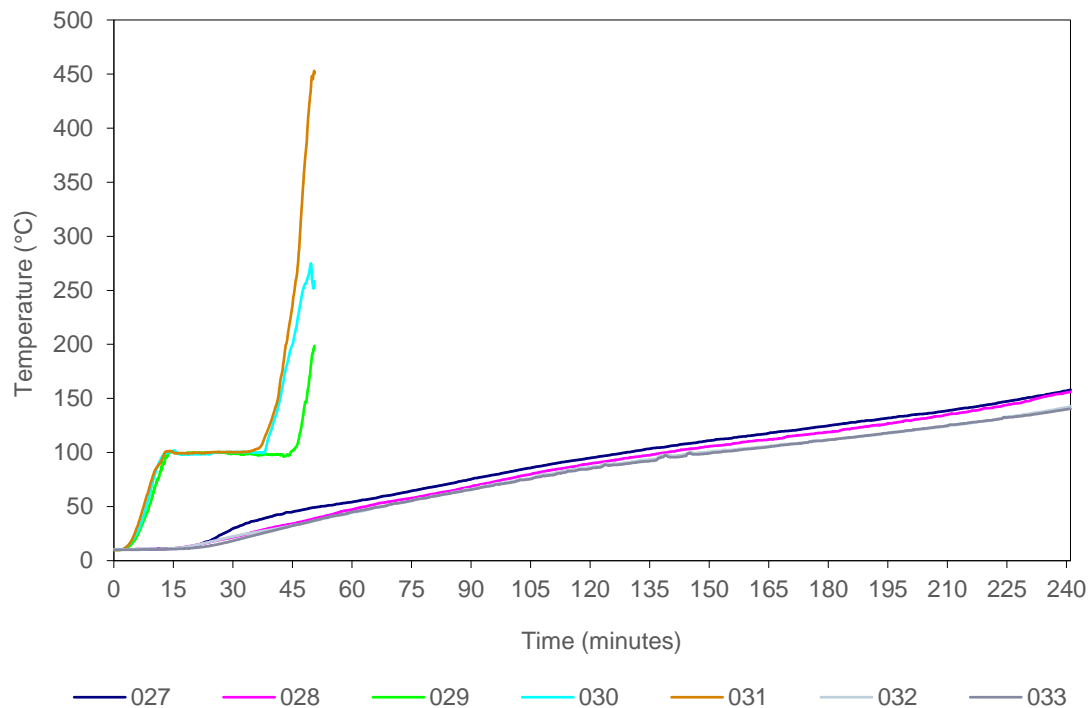
Figure 10 Control joint E – temperature vs time

Note: TC029 to 031 detached from the specimen at 55 minutes of the test period.

| Time | | Observation |
|---|---|---|
| 43 | 00 | TC031, on the control joint, 250 mm down from the centre recorded a temperature of 190 °C. Failure of insulation in accordance with clause 2.13.3(b) of AS 1530.4:2014, where the maximum temperature of thermocouple TC031 exceeded the initial temperature by more than 180 K. |

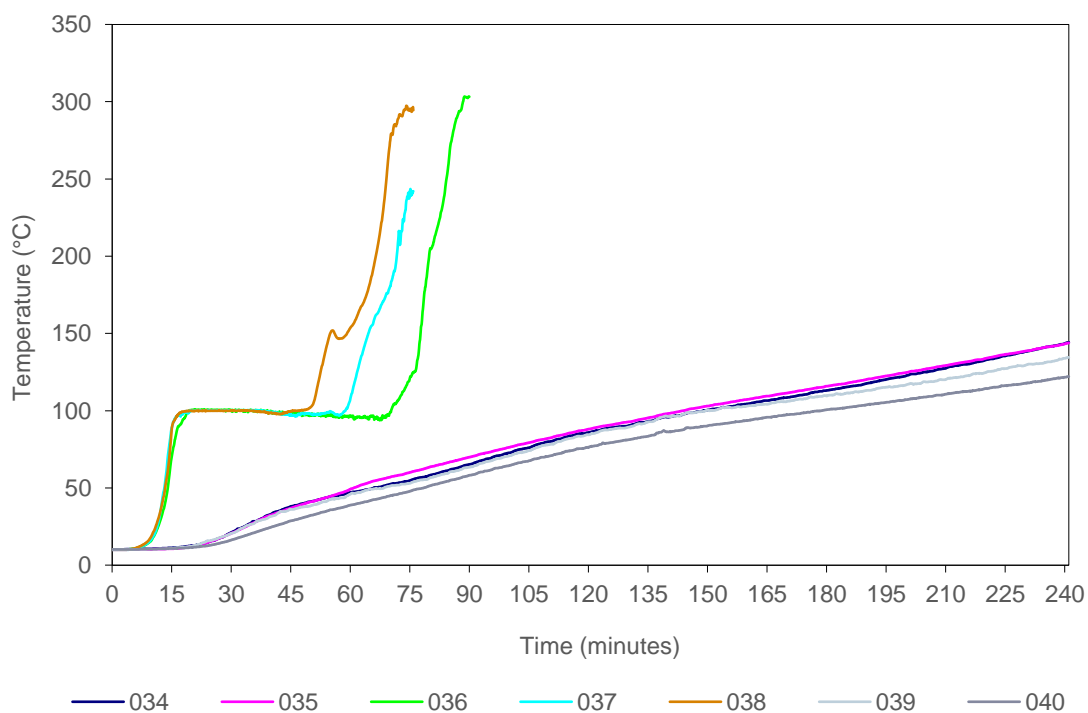
Figure 11 Control joint F – temperature vs time

| Time | | Observation |
|---|---|--|
| 65 | 40 | <p>TC038, on the control joint, 250 mm down from the centre recorded a temperature of 191 °C.</p> <p>Failure of insulation in accordance with clause 2.13.3(b) of AS 1530.4:2014, where the maximum temperature of thermocouple TC038 exceeded the initial temperature by more than 180 K.</p> |

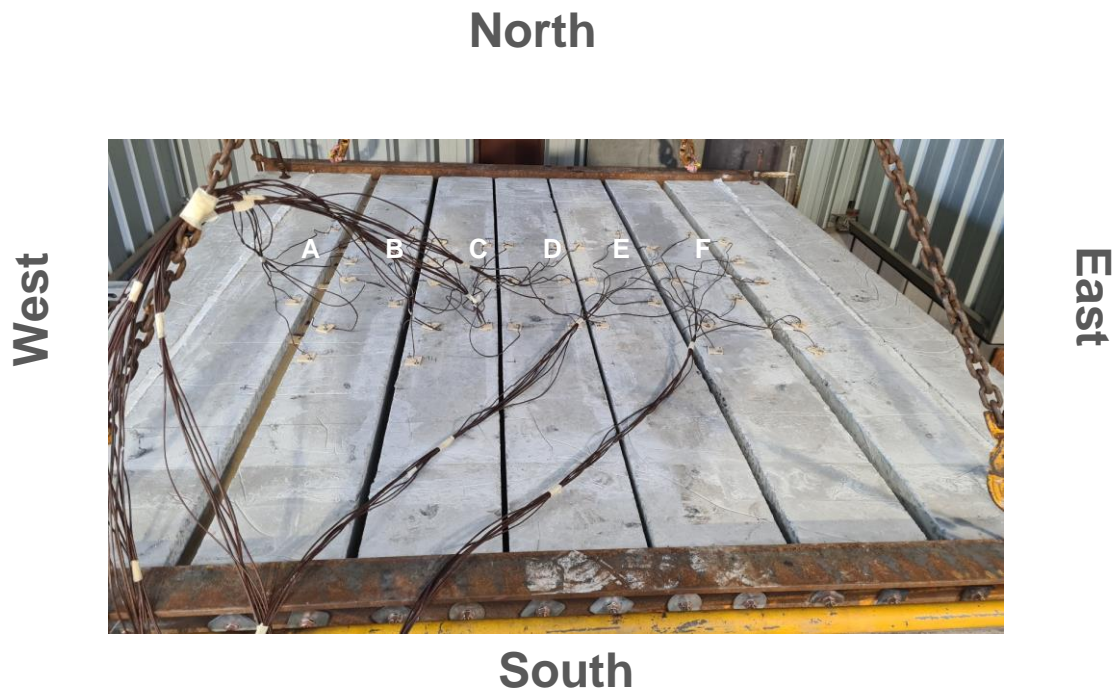
Figure 12 Unexposed face of the specimen before the start of the test

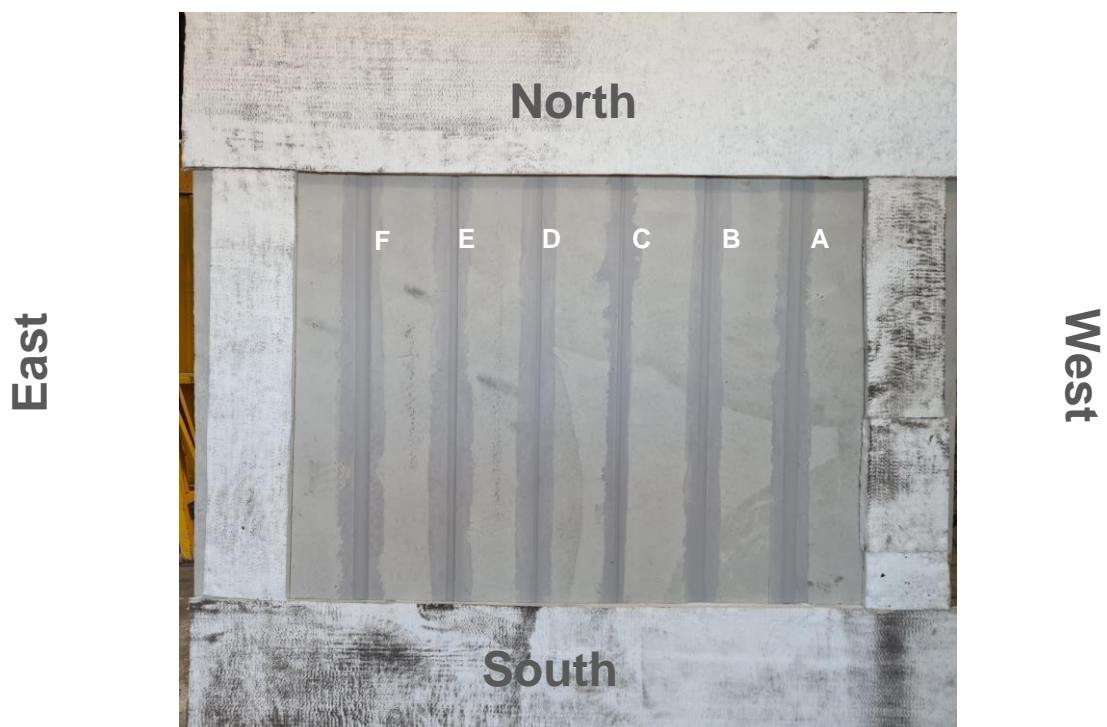
Figure 13 Exposed face of the specimen before the start of the test

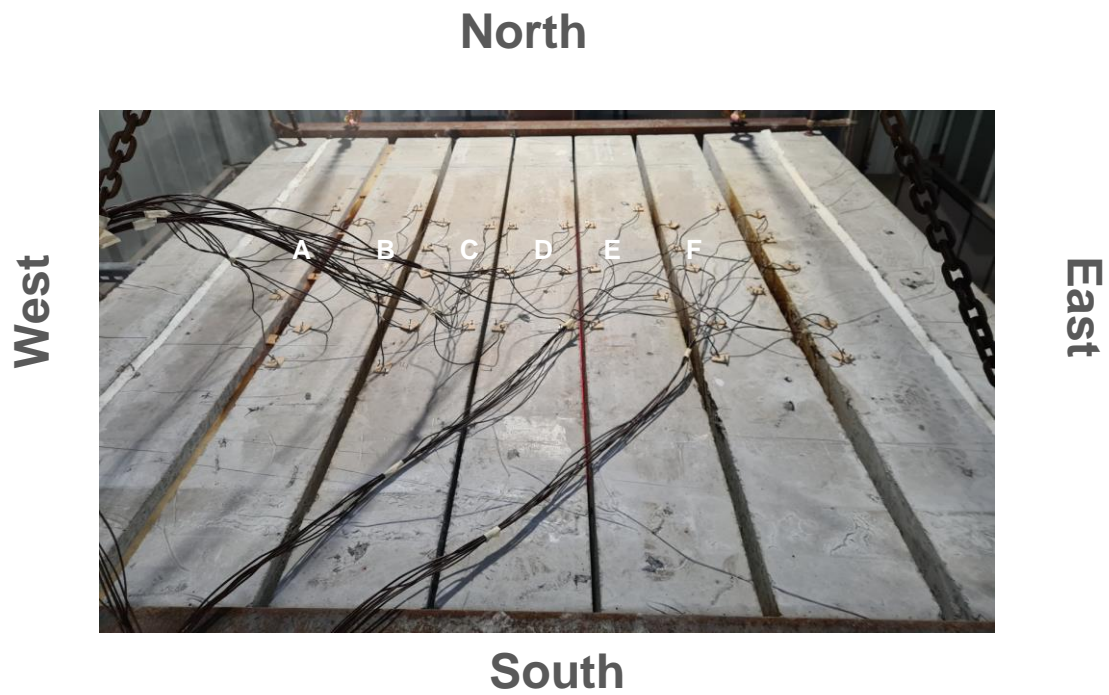
Figure 14 Unexposed face of the specimen at the end of the test

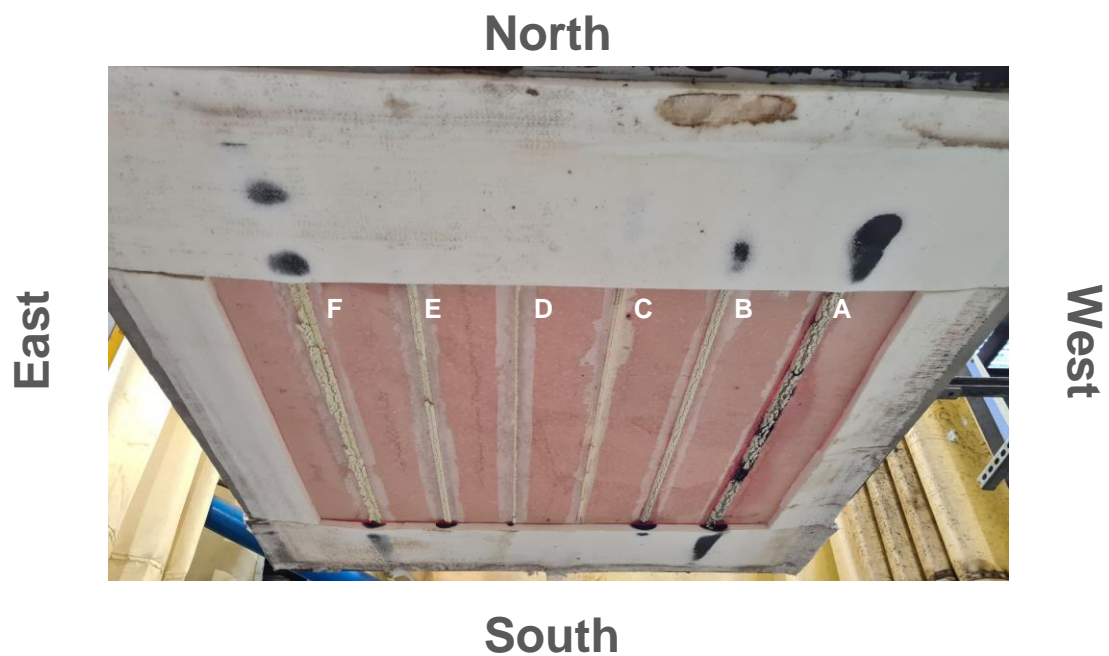
Figure 15 Exposed face of the specimen at the end of the test
