Fire resistance test report

Control joints tested in accordance with AS 1530.4:2014

Test sponsor: H.B. Fuller Australia

Job number: FRT180013

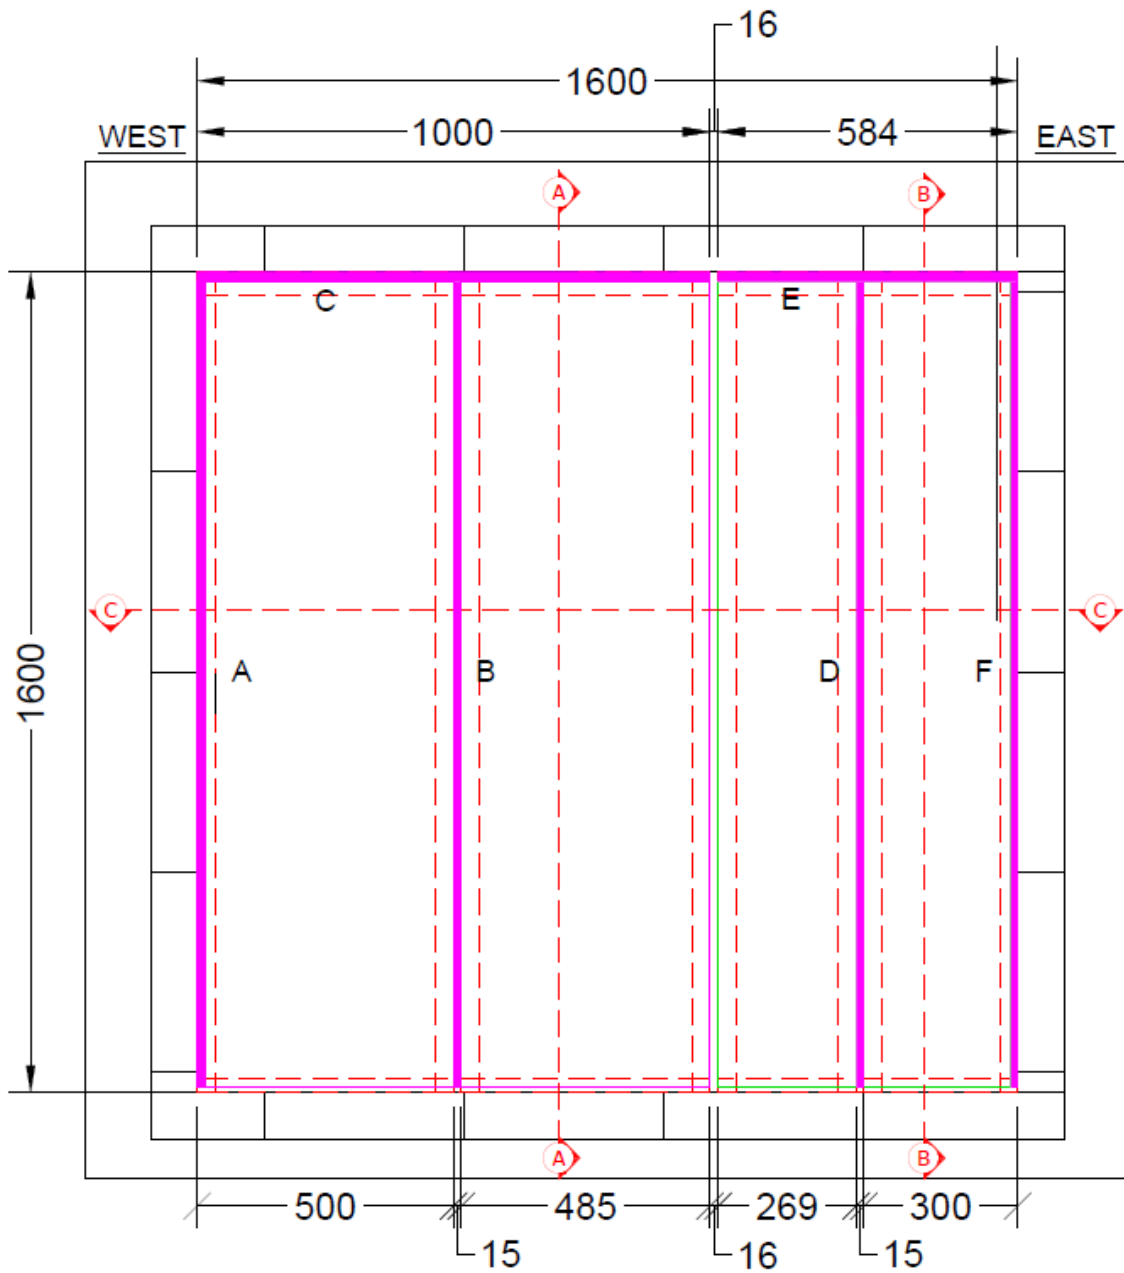
Figure 1 Elevation view of test specimen (unexposed side)

3.	Item name	Steel frame
	Product name	Rondo 64mm x 0.50BMT
	Installation	The steel frame comprises of eight studs and a top and bottom track. Item 6 used to secure the steel frame. The studs are placed next to each other in varying distance to create a control joint(s). Item 8 used to secure the steel frame at nominal 400mm centre on all four sides to the test frame. See Figure 1 and Figure 2 in Appendix A for more details
Fire-stopping protections		
Sealant

6.	Item name	8g x12mm button head needle point screws
7.	Item name	6g x 32mm long needle point laminated plasterboard screws
8.	Item name	M6 Dynabolt x 40mm long
Control joint A		
A	Service size	16mm wide x nominally 1570mm long; 16mm deep.
	Main fire-stopping protection	
	Protection details	Backing rod (item 5) was installed into the control joint at a depth of 16mm from both exposed and unexposed faces of the wall. The sealant (item 4) was applied into the control joint to the depth of backing rod and finished flush with both the exposed & unexposed faces of wall. See Figure 1 to Figure 6 in Appendix A for more details.
Control joint B		
B	Service size	15mm wide x nominally 1570mm long; 16mm deep.
	Main fire-stopping protection	
	Protection details	Backing rod (item 5) was installed into the control joint at a depth of 16mm from both exposed and unexposed faces of the wall. The sealant (item 4) was applied into the control joint to the depth of backing rod and finished flush with both the exposed & unexposed faces of wall. See Figure 1 to Figure 6 in Appendix A for more details.

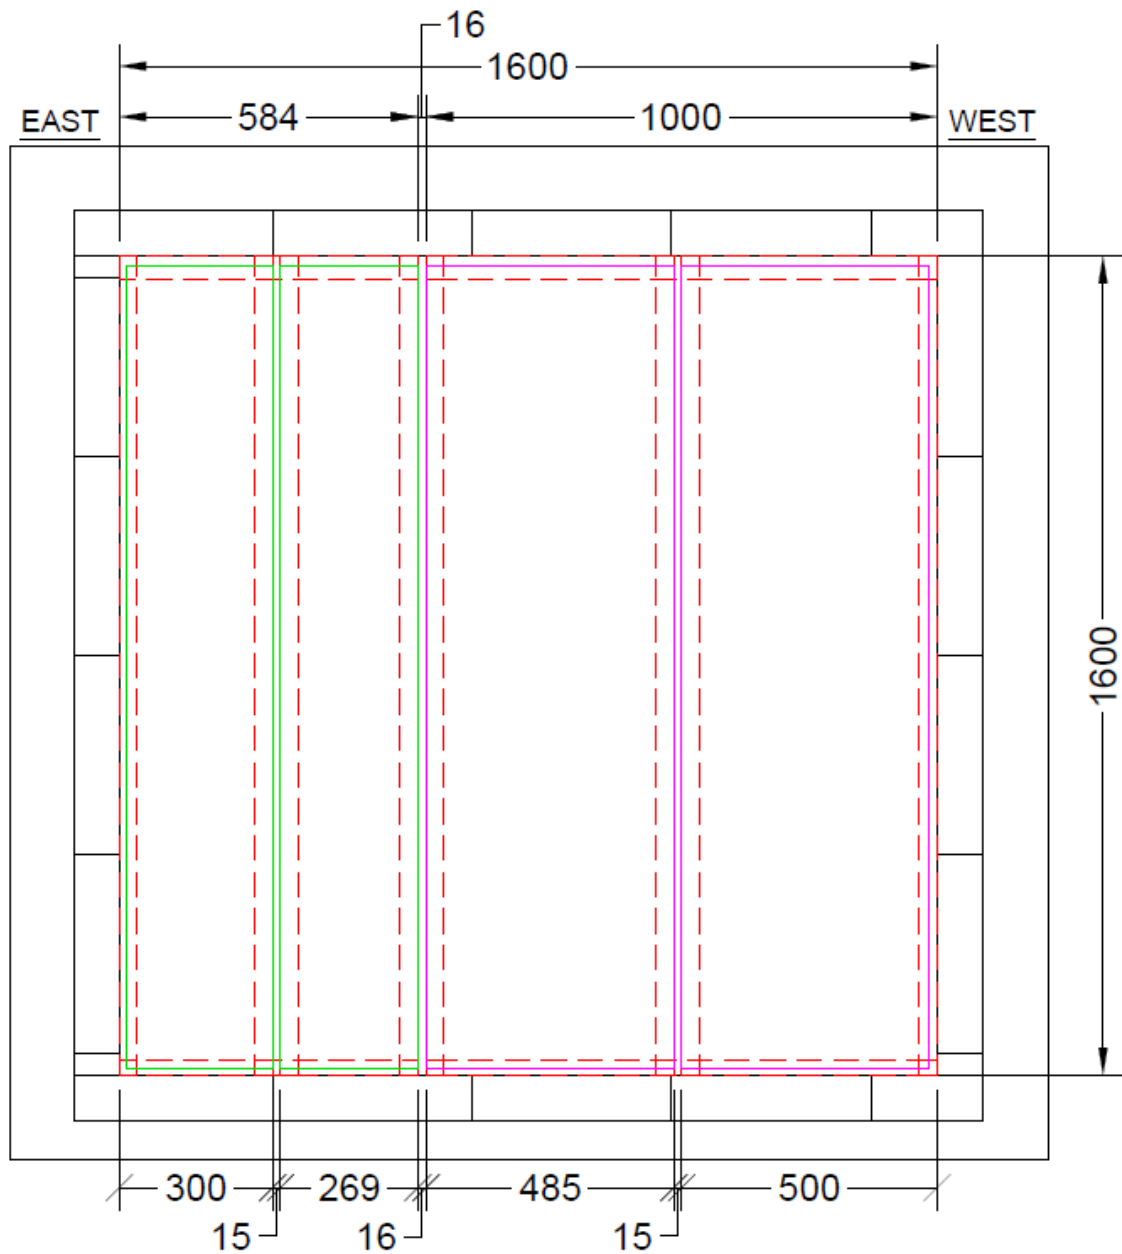
Figure 2 Elevation view of test specimen (exposed side)

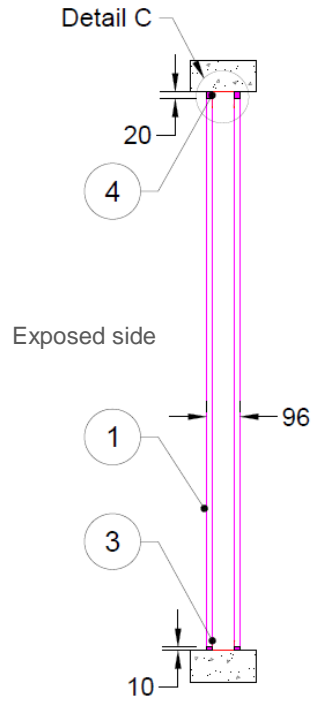
Figure 3 Cross-section A-A

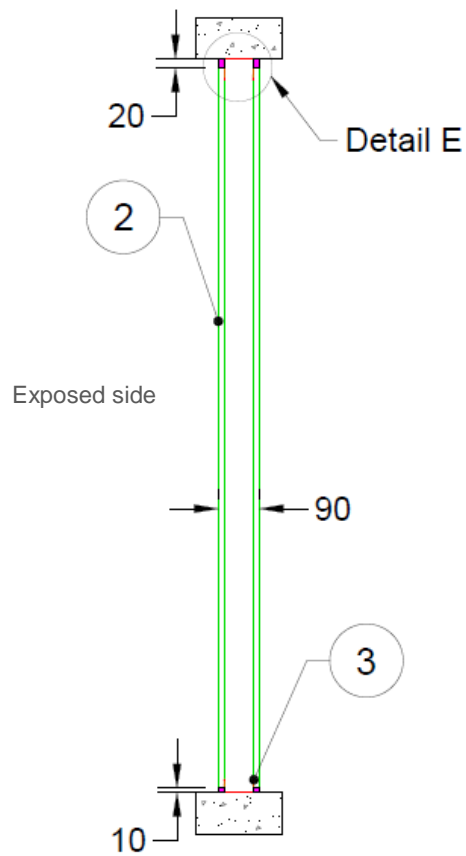
Figure 4 Cross-section B-B

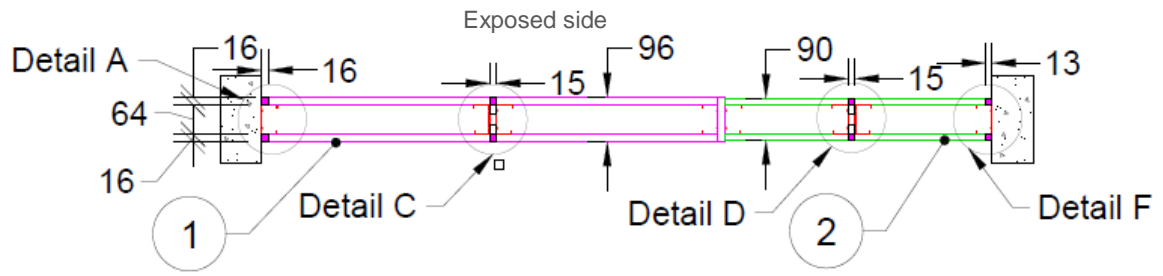
Figure 5 Cross-section C-C

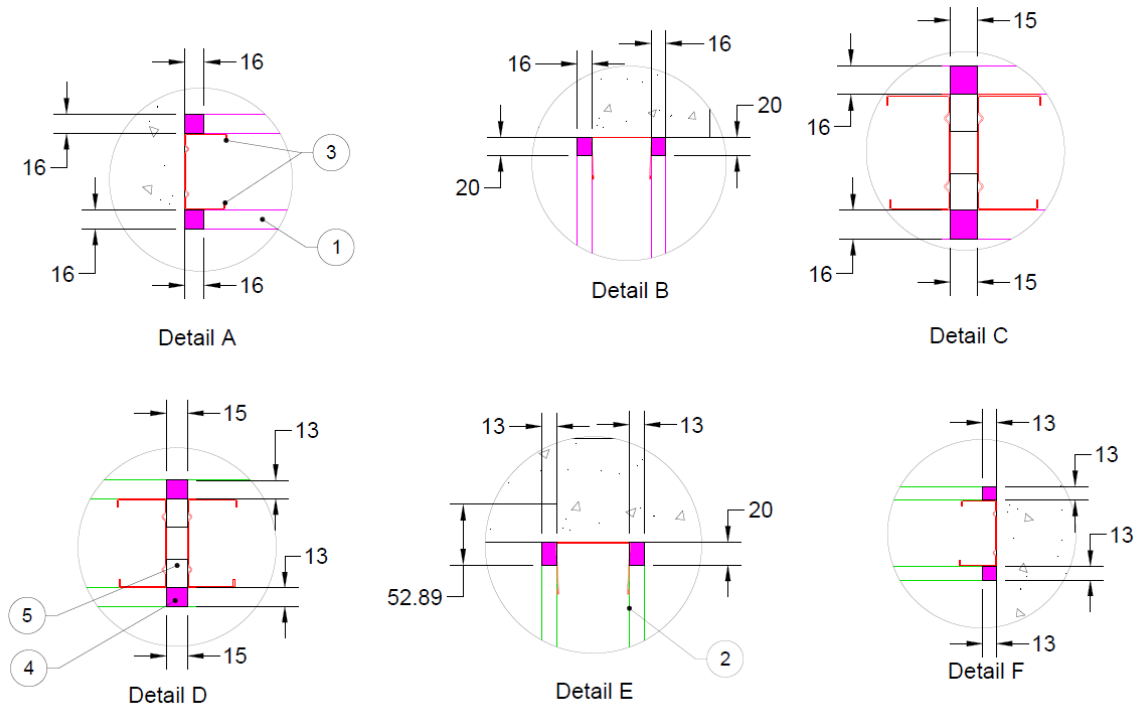
Figure 6 Detail view

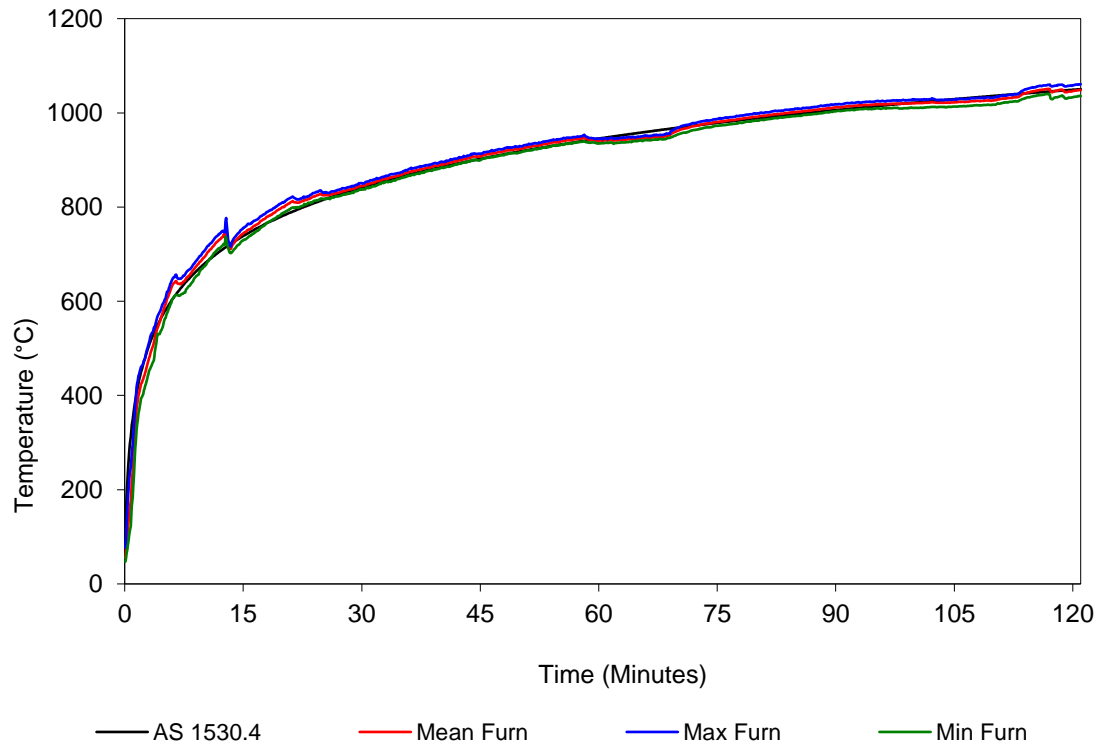
Figure 8 Furnace thermocouple temperature vs time

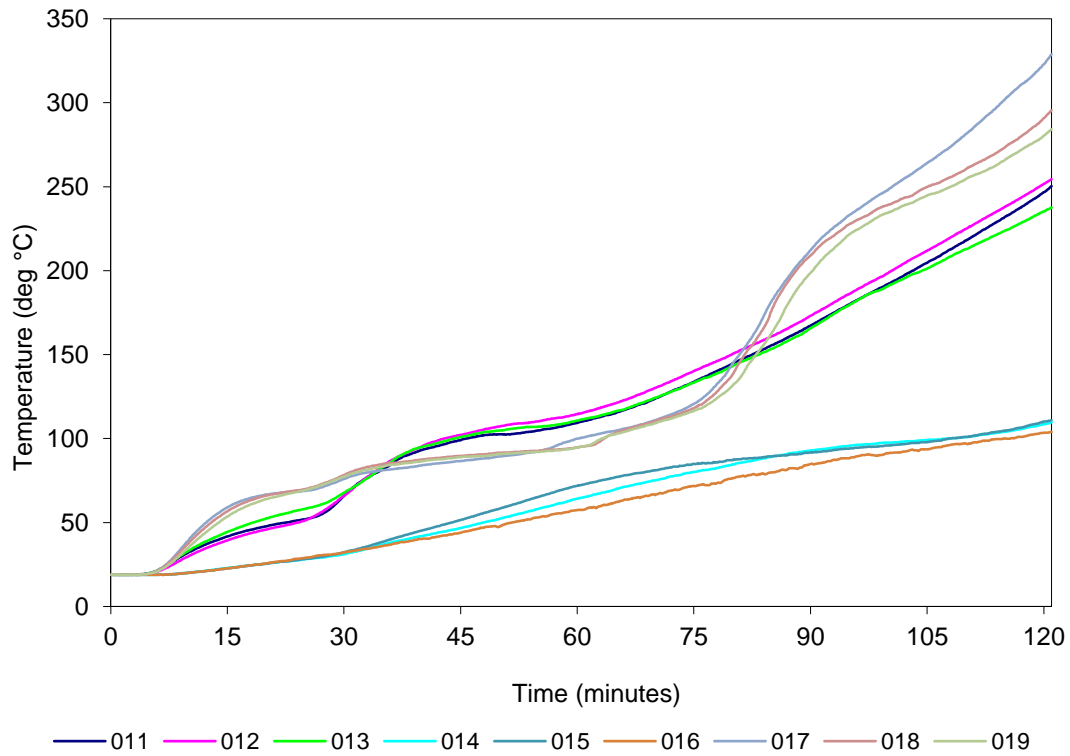
Figure 9 Control joint A – temperature vs time

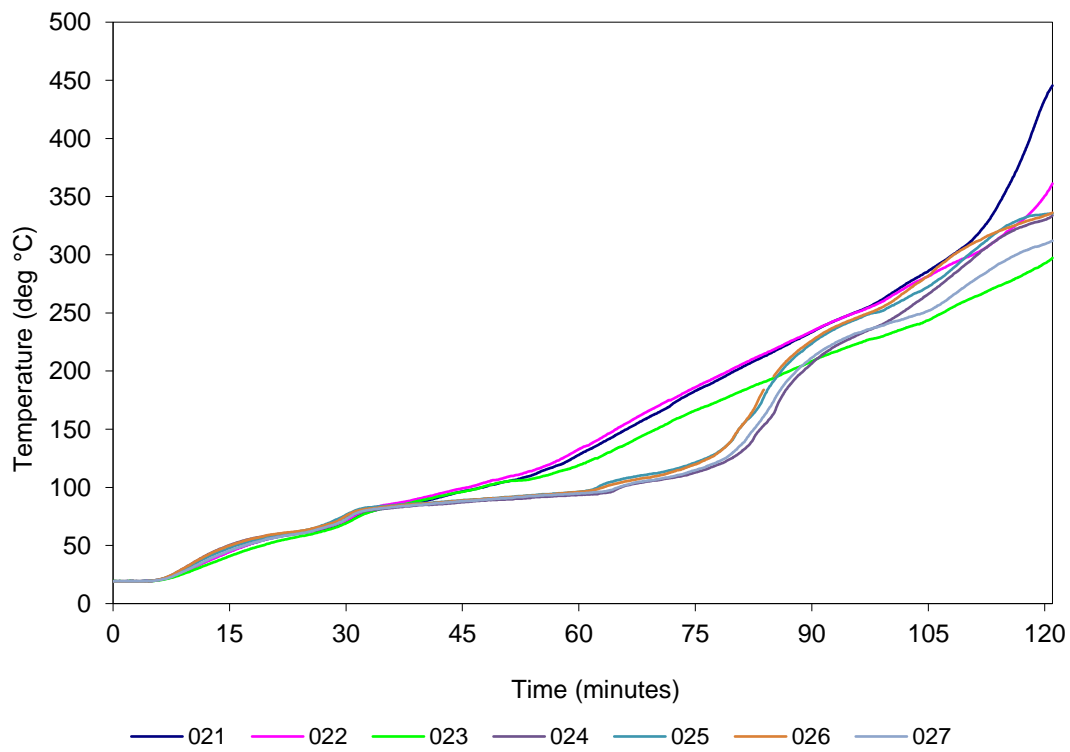
Figure 10 Control joint B – temperature vs time

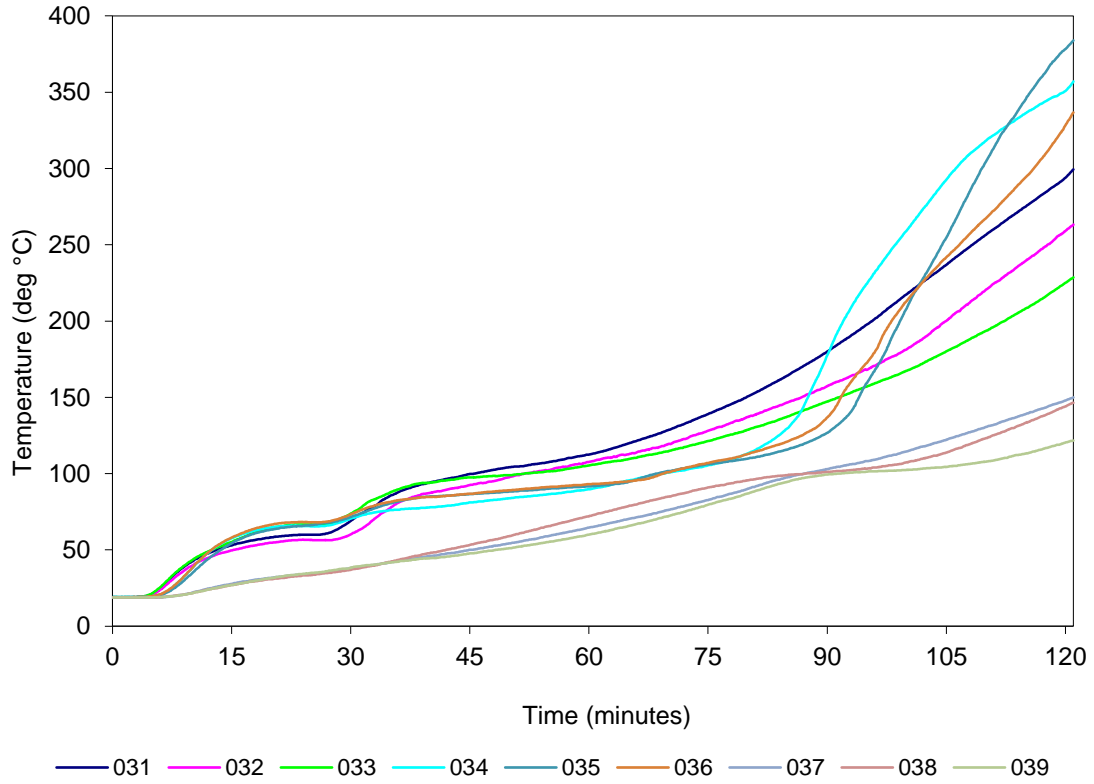
Figure 11 Control joint C – temperature vs time

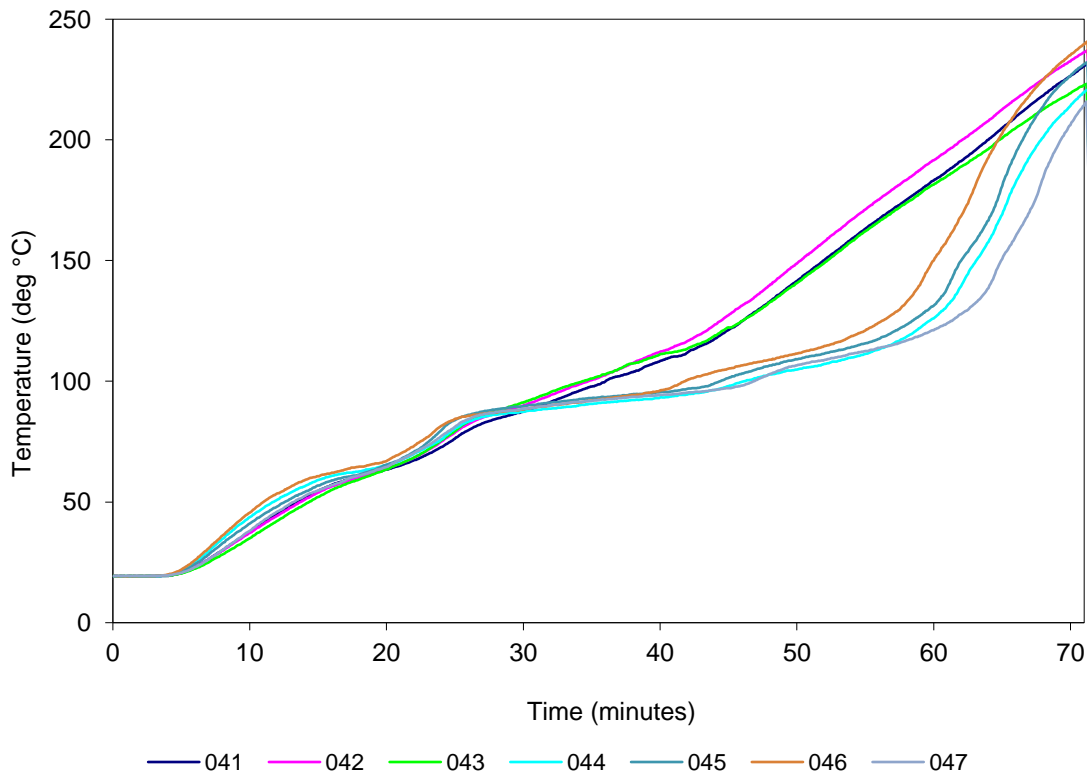
Figure 12 Control joint D – temperature vs time

Note – thermocouples were removed at 71 minutes

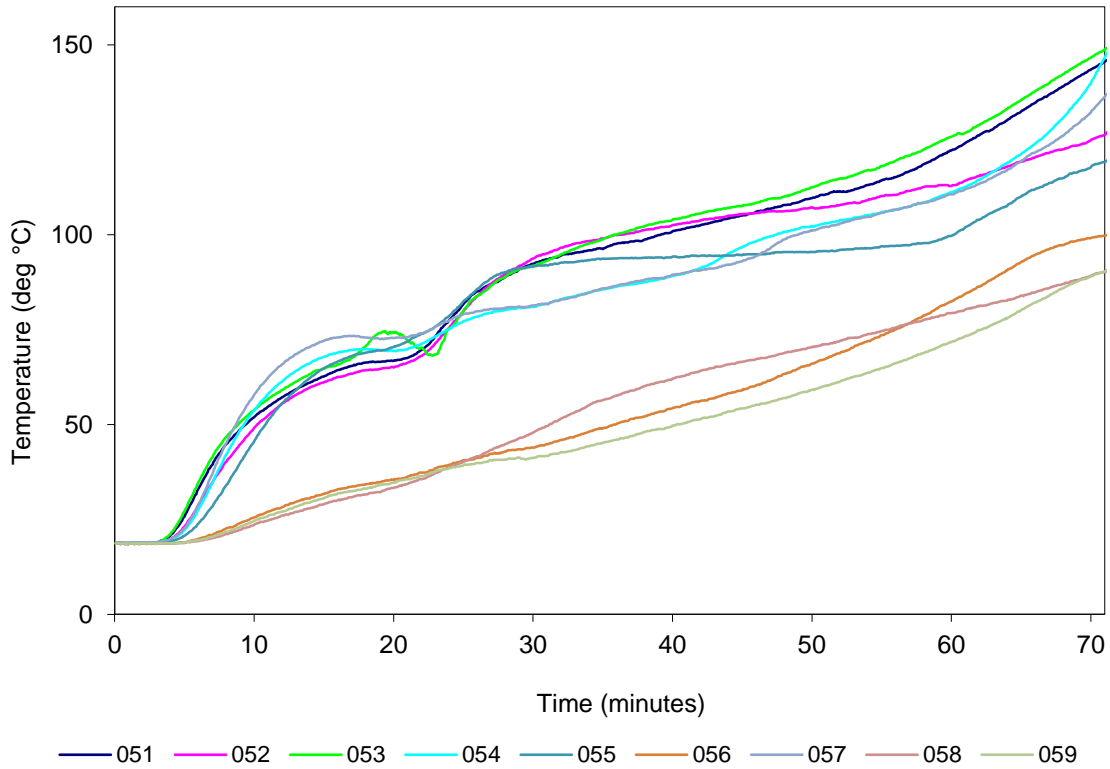
Figure 13 Control joint E – temperature vs time

Note – thermocouples were removed at 71 minutes

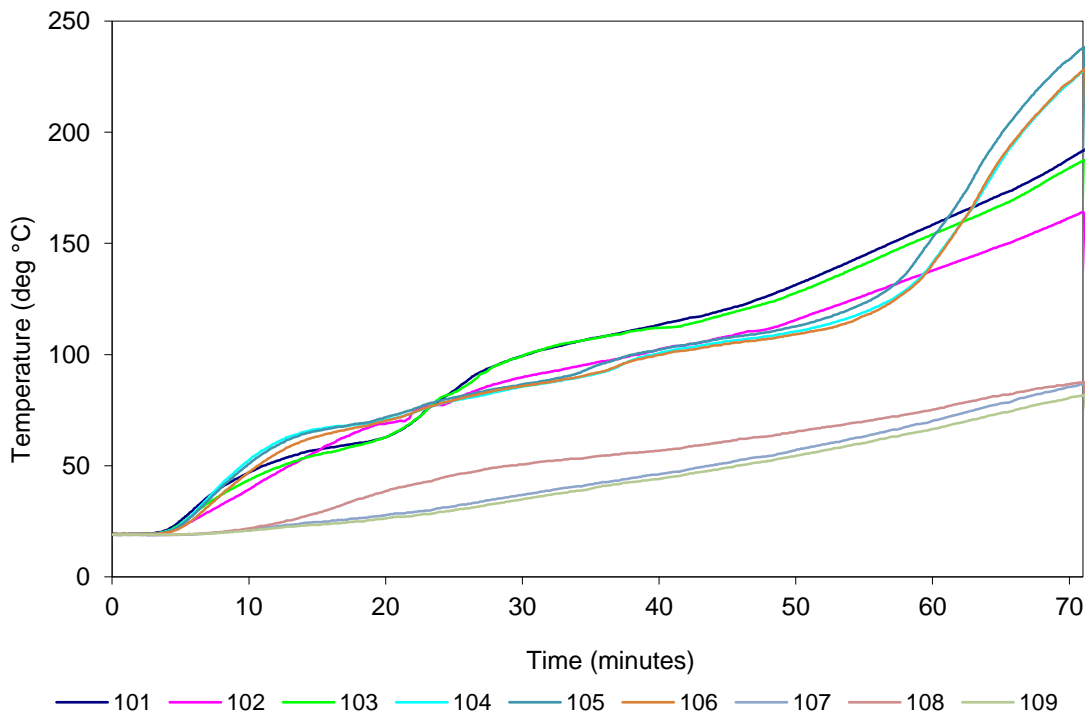
Figure 14 Control joint F – temperature vs time

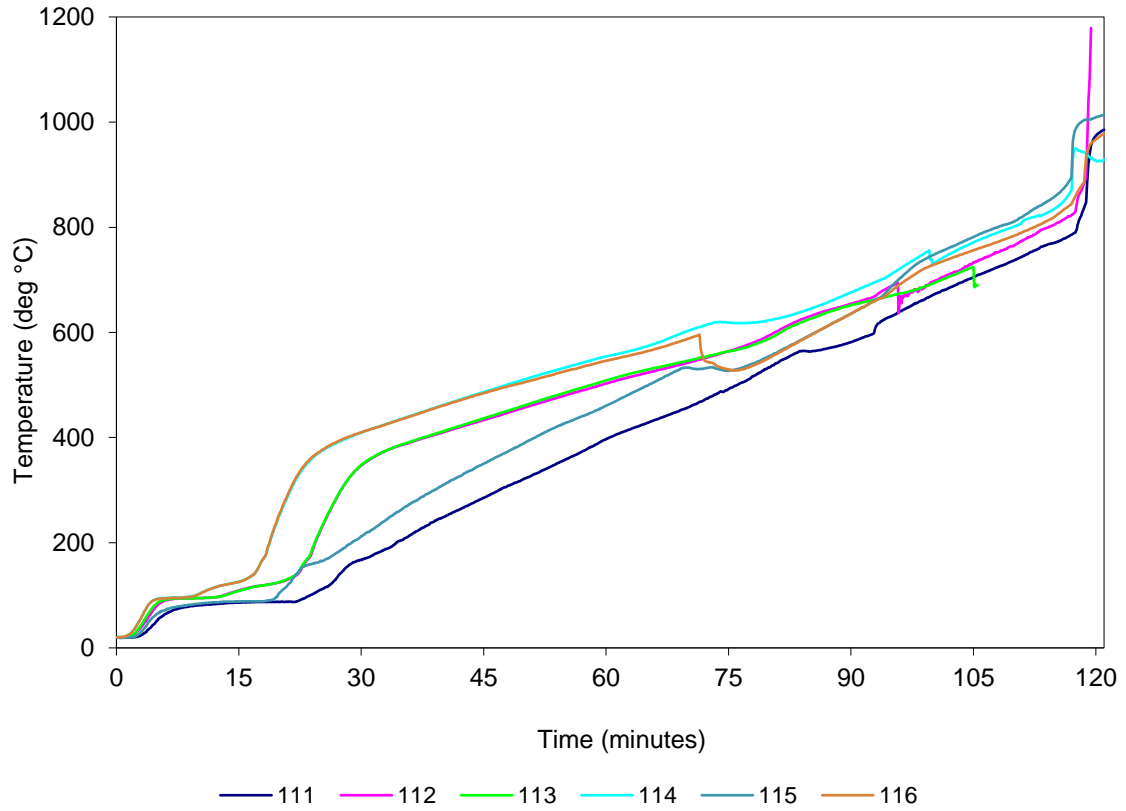
Figure 15 Internal thermocouples – temperature vs time

Note – Thermocouple 113 failed at 105 minutes and 112 failed at 119 minutes.

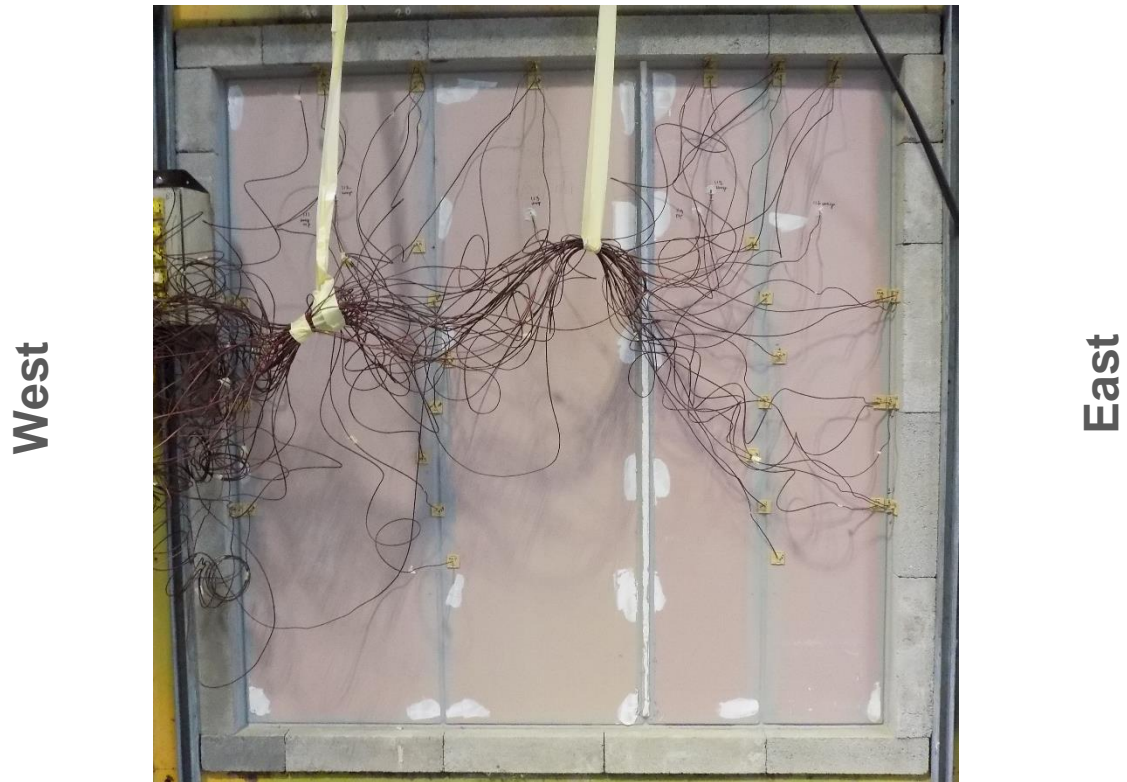
Figure 16 Unexposed face of specimen before the start of test

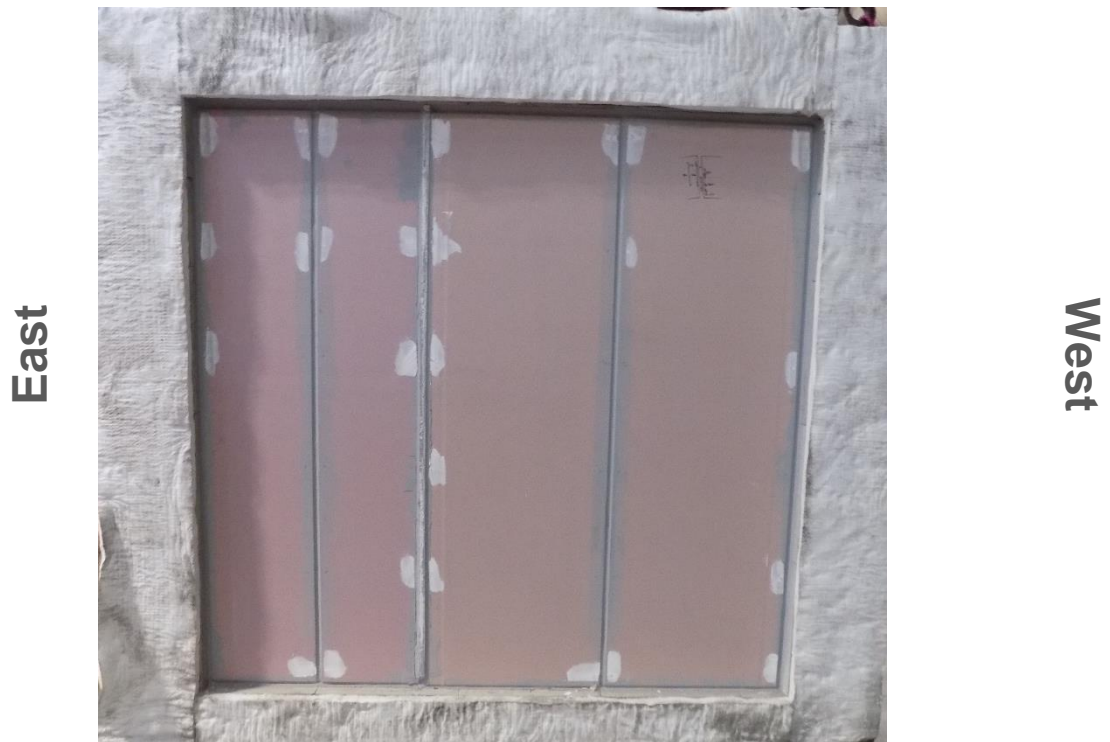
Figure 17 Exposed face of the specimen before the start of test

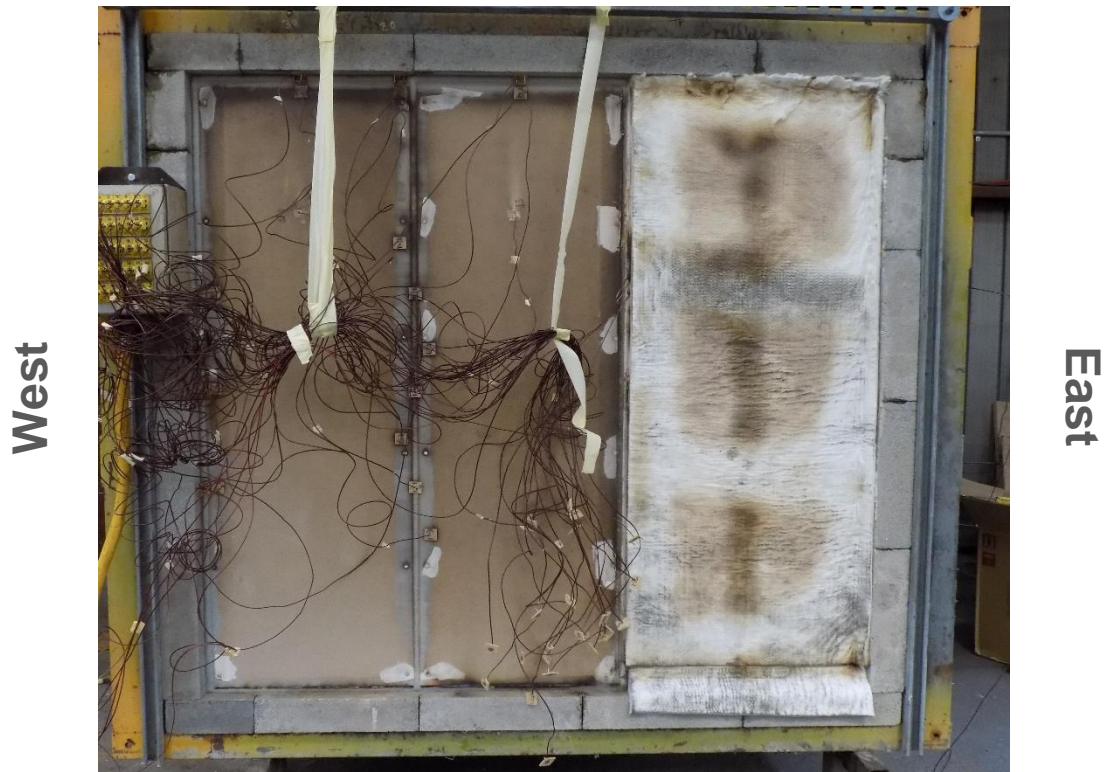
Figure 18 Unexposed face of specimen at the end of test

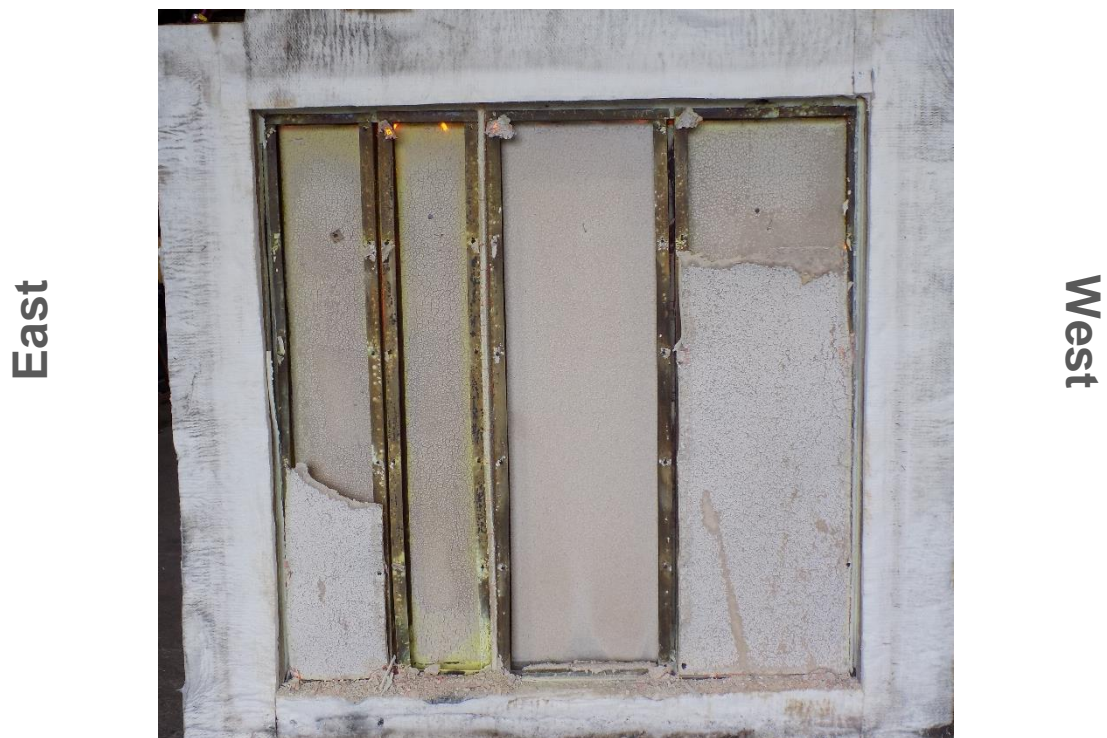
Figure 19 Exposed face of the specimen at the end of test
