# FIRE TEST REPORT

## FP20542-01-1

**THE FIRE RESISTANCE IN ACCORDANCE WITH  
AS 1530.4:2014 OF A CONTROL JOINT AND THREE  
PERIMETER EDGE SEALS INSTALLED IN A 75 MM  
THICK HEBEL POWERPANEL SINGLE MESH WALL**

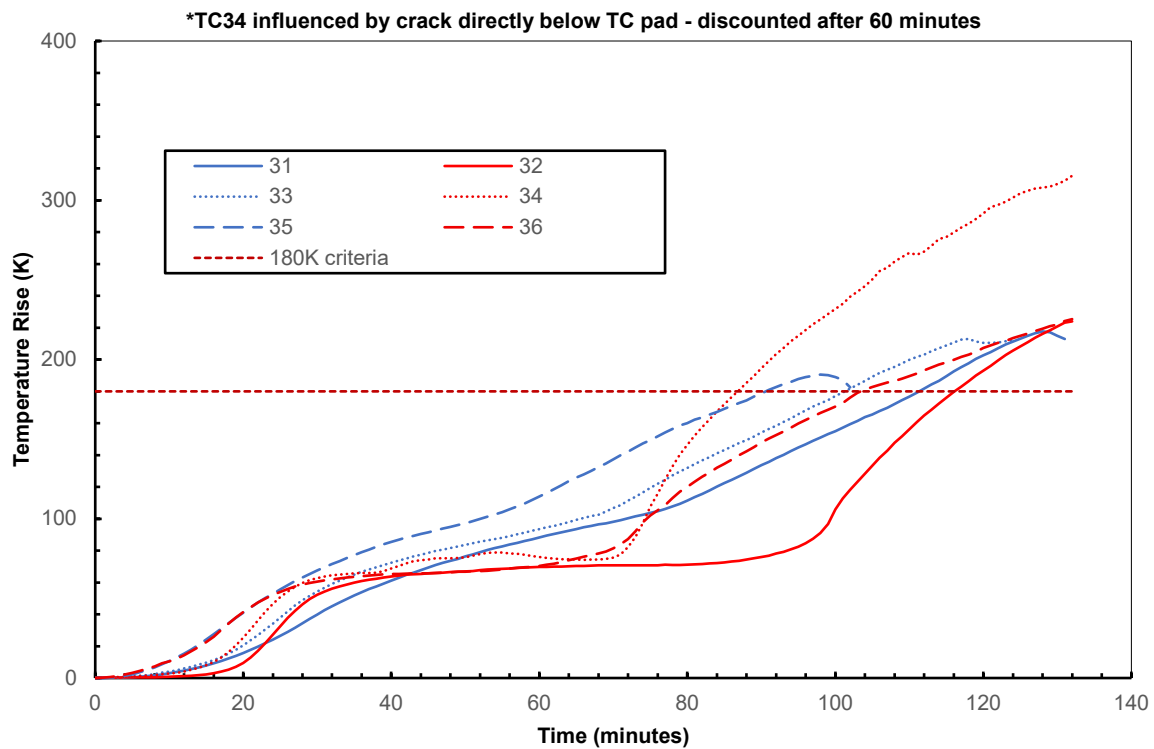
Figure 9 to Figure 12 show the temperature rise of each specimen.

**Figure 9: Specimen A - Temperature Rise**

Specimen Ref	Time (minutes) Until Failure Occurred (T>180K)
A	90 - TC35
B	118 - TC32
C	109 - TC74
D	94 - TC110

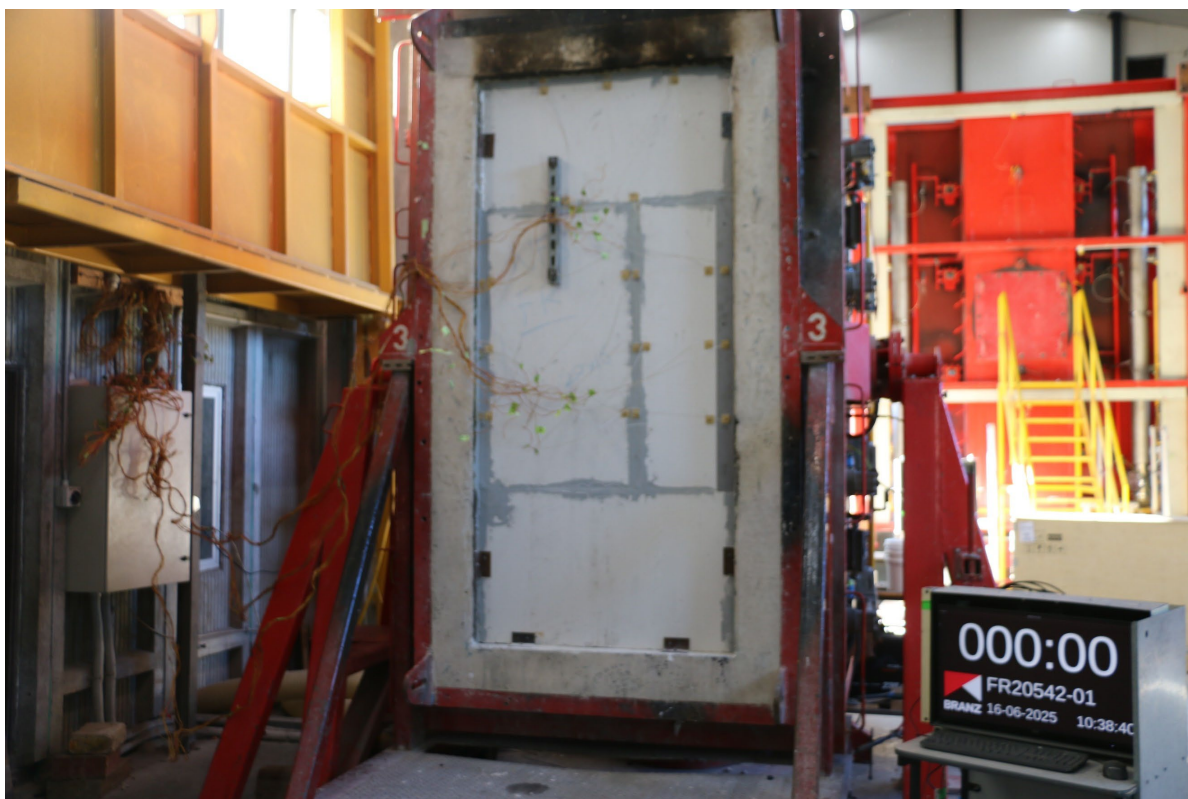
**Photo 1: The Unexposed Face of the Assembly Prior to Testing**

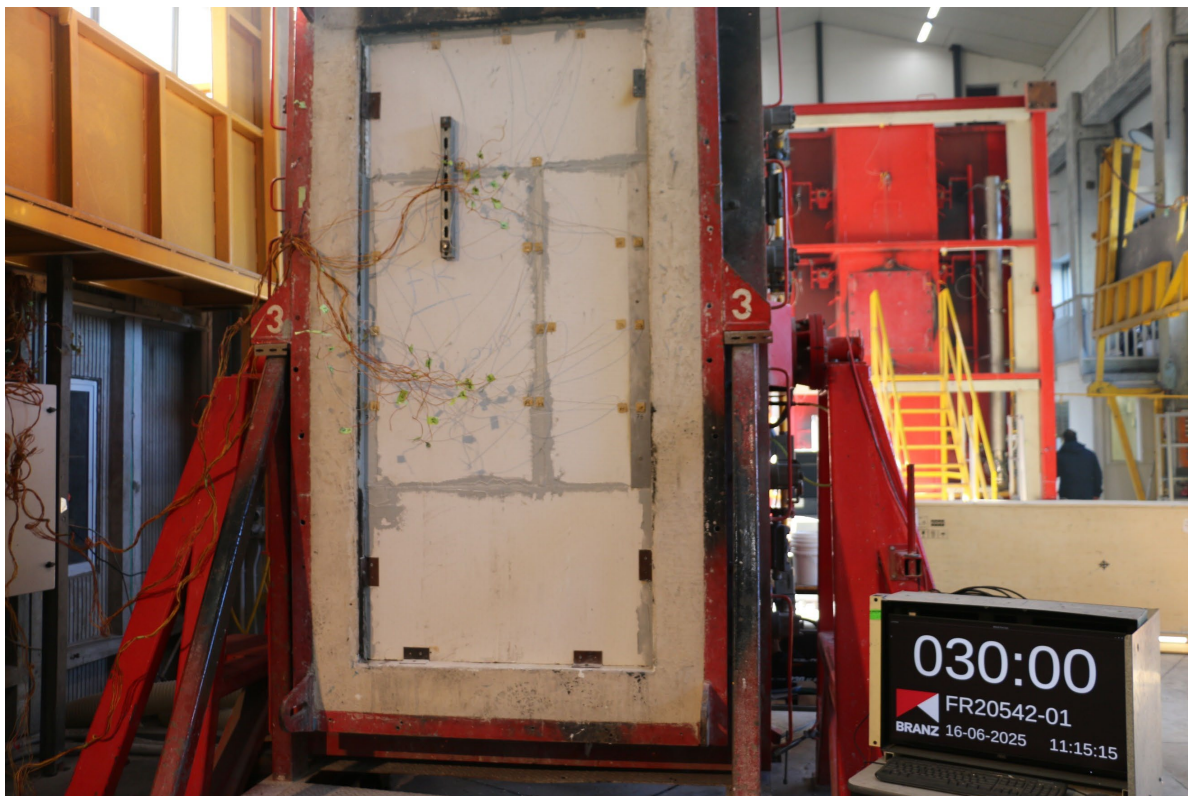
**Photo 2: The Unexposed Face of the Test Assembly After a Duration of 30 Minutes**

Time (Min:Sec)	Test Face	Observations
00:00	-	The test commences.
25:00	U	The sealant near to TC35 (Specimen A) is beginning to swell/expand.
40:00	U	Swelling of the sealant on Specimen A continues to swell/expand over the length of the joint.
50:00	U	Cracks are forming in the Hebel panel below Specimen A, one of the cracks has spread below the pad of TC34.
55:00	U	The sealant on Specimen B and Specimen C has started to swell/expand.
60:00	U	Horizontal cracks have formed in the Hebel panel between Specimen C and Specimen D. One of the cracks, beginning near to TC104 (Specimen C) runs across the panel and below the pad of TC39 (Specimen D)
69:00	U	A small vertical crack is visible, starting from the lower edge of the joint of Specimen A, 100 mm from the right-hand edge which extends down by approximately 50 mm.

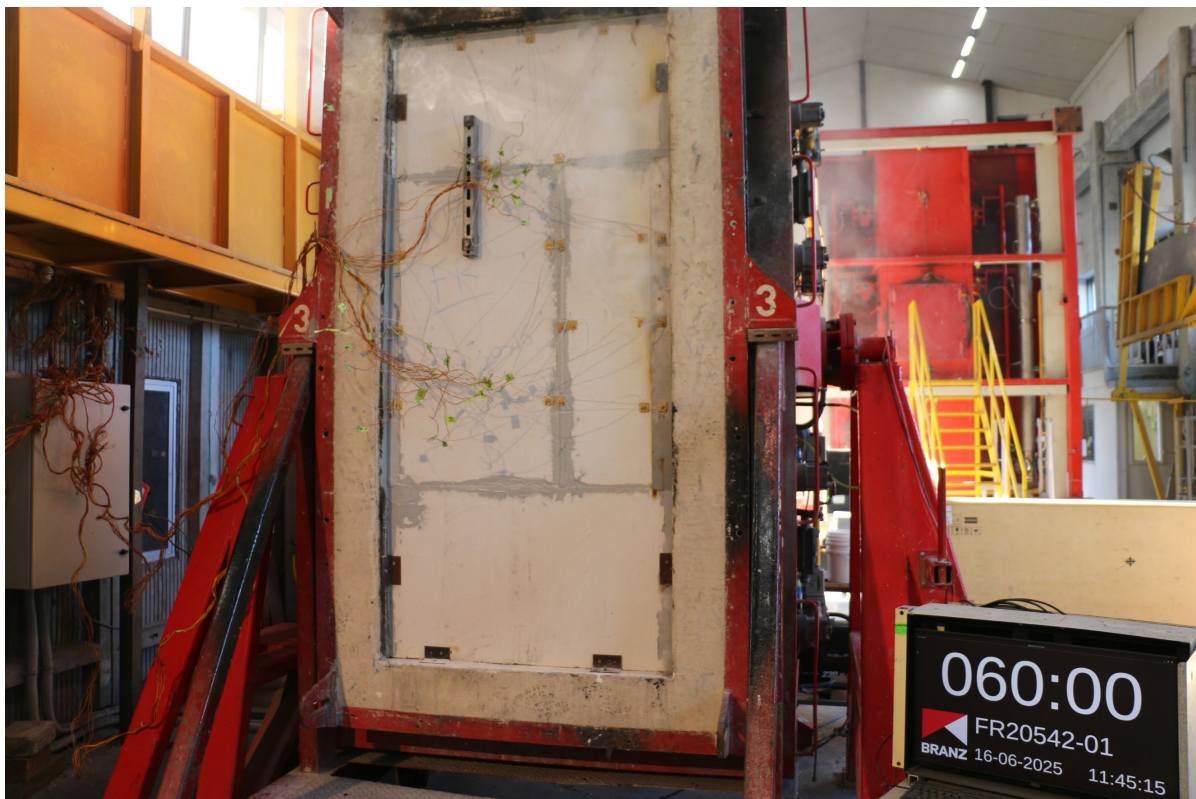
**Photo 3: The Unexposed Face of the Test Assembly After a Duration of 60 Minutes**

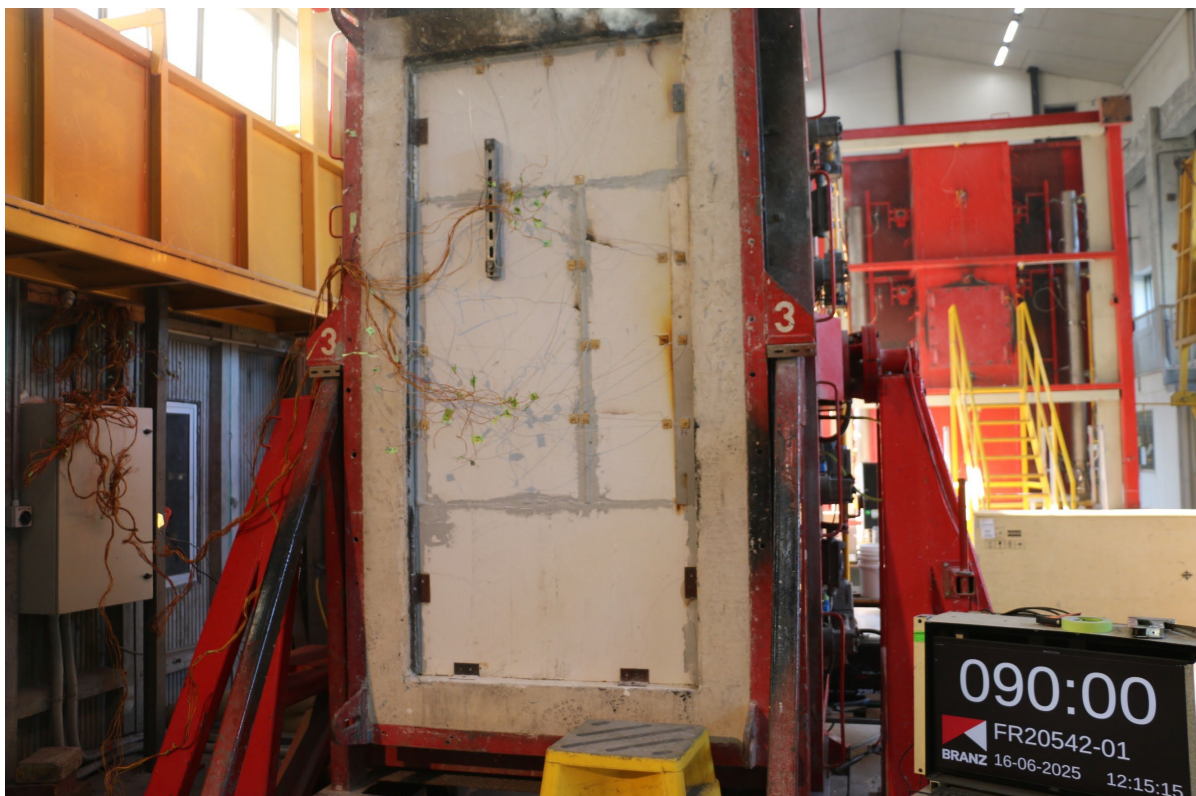
**Photo 4: The Unexposed Face of the Test Assembly After a Duration of 90 Minutes**

Time (Min:Sec)	Test Face	Observations
76:00	U	A cotton wool pad was applied over the vertical crack below Specimen A but did not ignite.
88:00	U	A cotton wool pad was applied over the vertical crack below Specimen A but did not ignite.
90:00	-	The specimens continue to maintain Integrity.
92:00	U	Swollen sealant is starting to detach from Specimen A, near to TC35.
118:00	-	A cotton wool pad was applied over the vertical crack below Specimen A but did not ignite.
130:00	-	A cotton wool pad was applied over the vertical crack below Specimen A but did not ignite.
132:10	-	The test is discontinued.

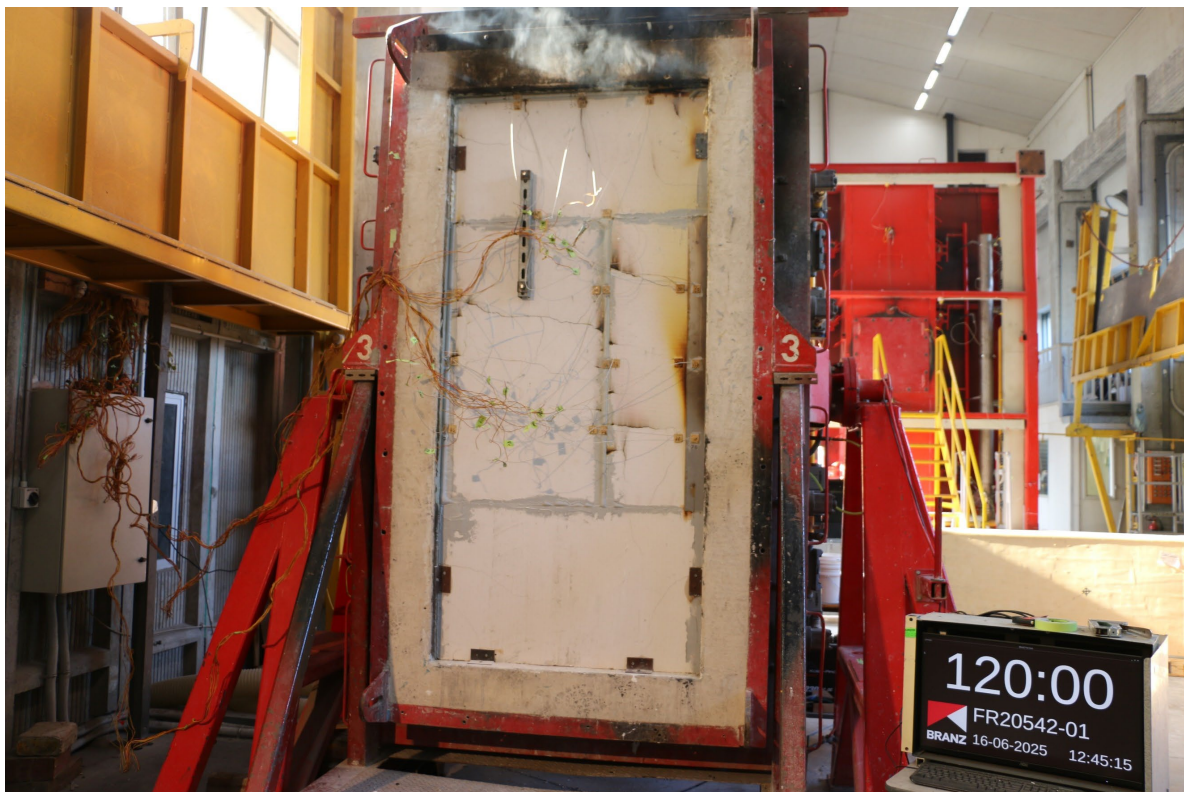
**Photo 5: The Unexposed Face of the Test Assembly After a Duration of 120 Minutes**

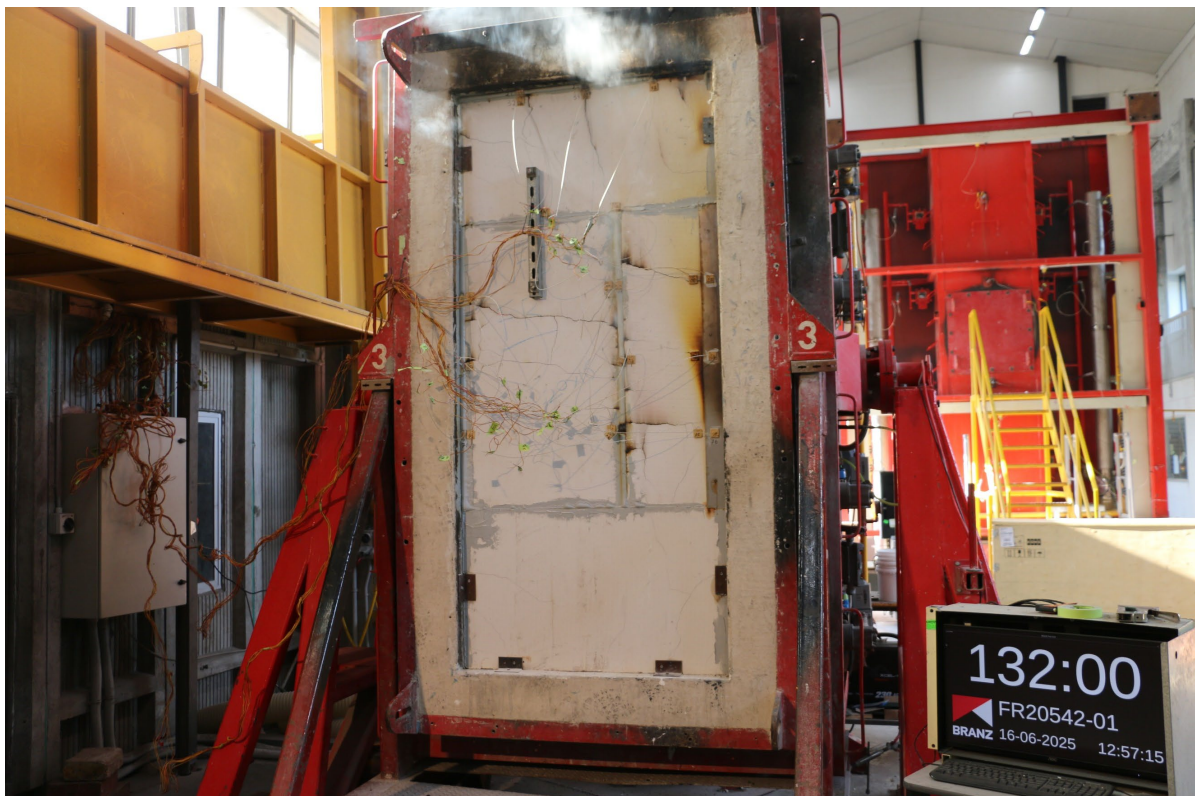
**Photo 6: The Unexposed Face of the Test Assembly After a Duration of 132 Minutes**

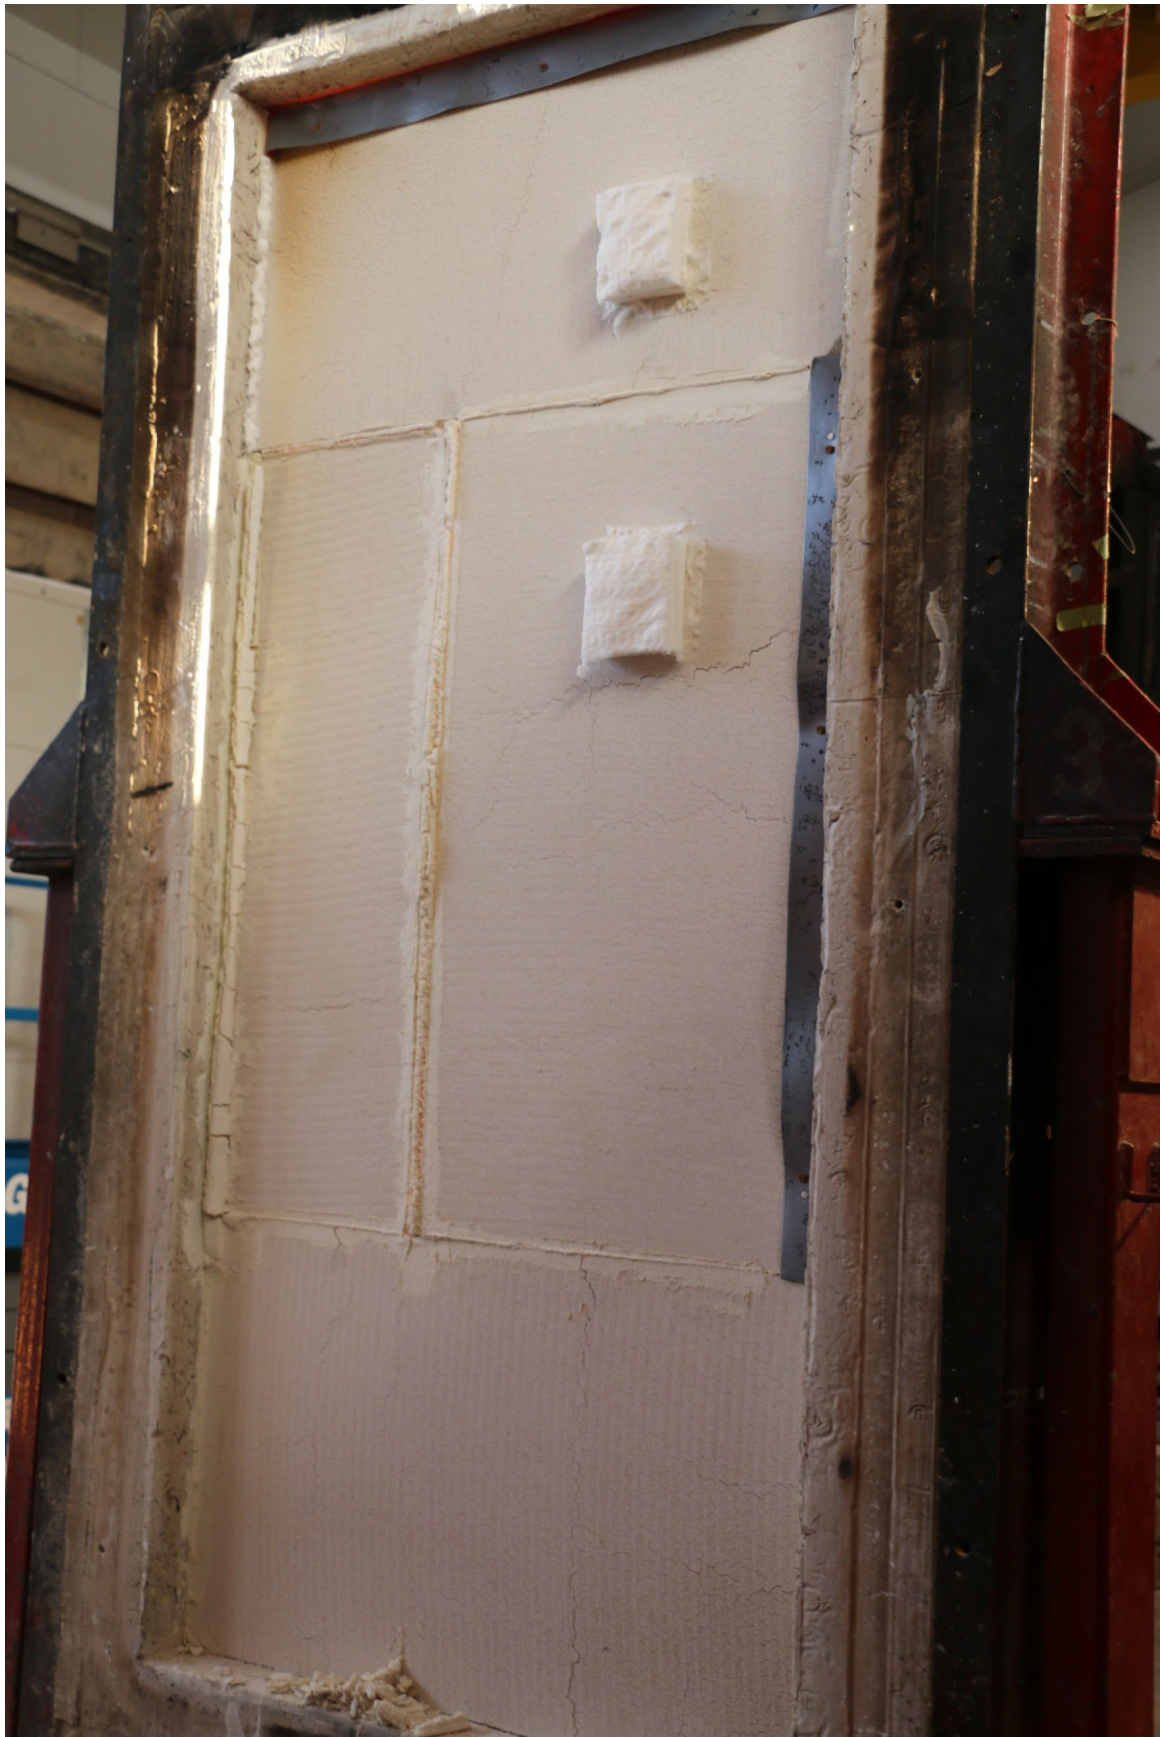
**Photo 7: The Exposed Face of the Test Assembly Immediately After Testing**
