# FIRE RESISTANCE TEST REPORT

Test standard: Sections 2 and 10 of AS 1530.4:2014  
Reference Standard: AS 4072.1-2005 AMDT 1 (Rec:2016)  
Test sponsor: H.B. Fuller Australia  
Products: HB Fuller – Fulaflex FR hybrid  
Job number: FRT190398  
Revision: R1.1 Test date: 25 November 2019

This report documents the findings of the fire resistance test of control joints in accordance with sections 2 and 10 of AS 1530.4:2014 with reference to AS 4072.1–2005 AMDT 1 (Rec:2016). The testing was done on 25 November 2019.

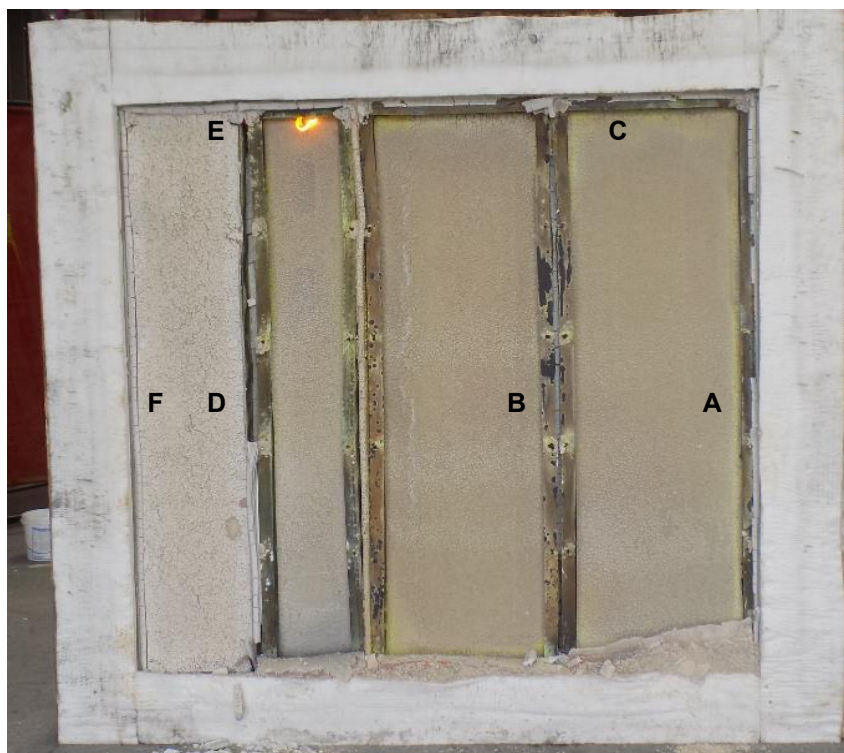
Figure 18 Exposed face of the specimen at the end of the test
