H B FULLER AUSTRALIA PTY LTD AND USG BORAL

FIRE RESISTANCE TEST REPORT

Test standard: Sections 2 and 10 of AS 1530.4:2014
Reference Standard: AS 4072.1-2005 AMDT 1 (Rec:2016)
Test sponsors: H B Fuller Australia PTY LTD and USG Boral
Products: HB Fuller Firesound Sealant
Job number: 48763900
Revision: R1.1 Test date: 31 May 2017

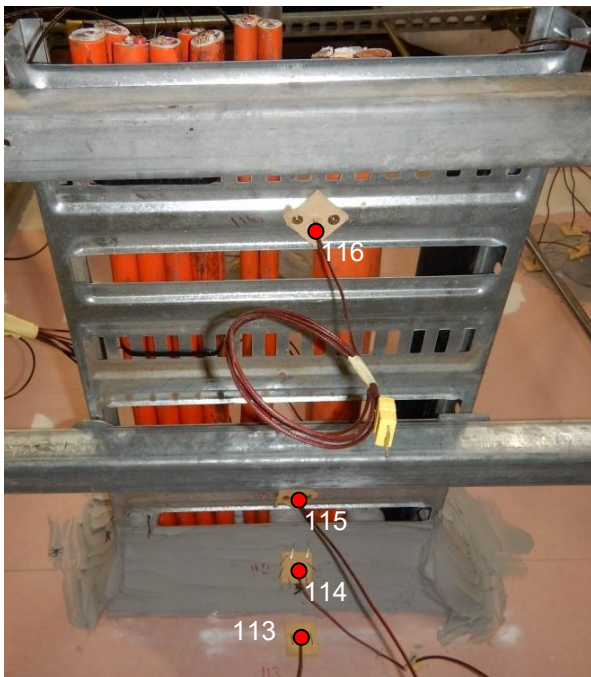
*Figure 12 Penetration system E bottom*

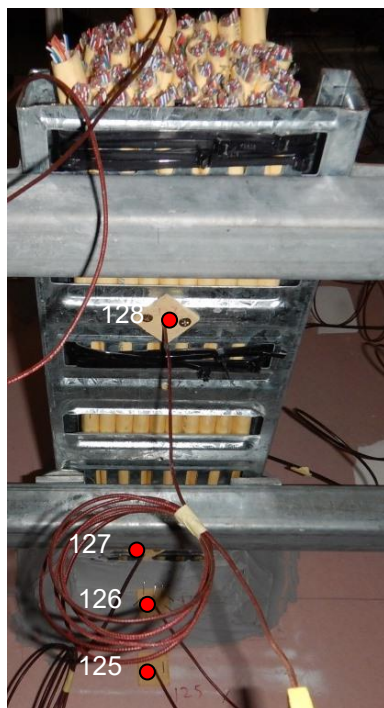
*Figure 14 Penetration system F bottom*

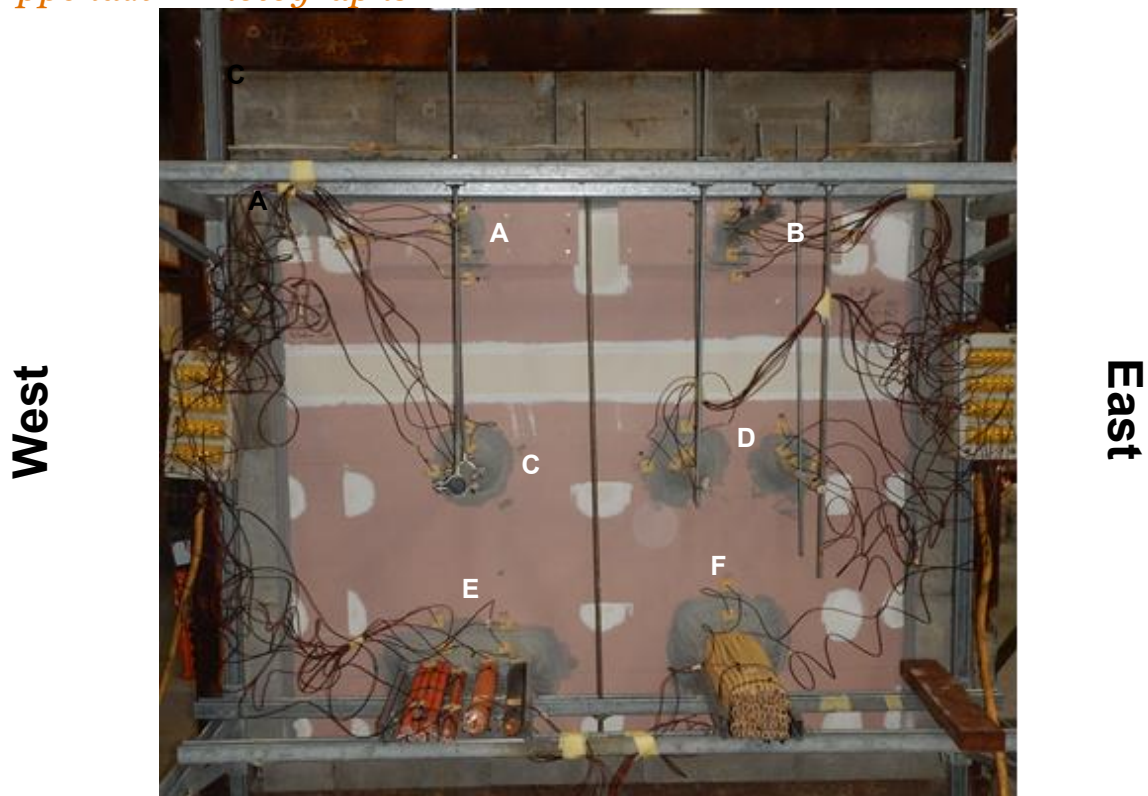
Figure 29 Unexposed face of the specimen before the start of the test

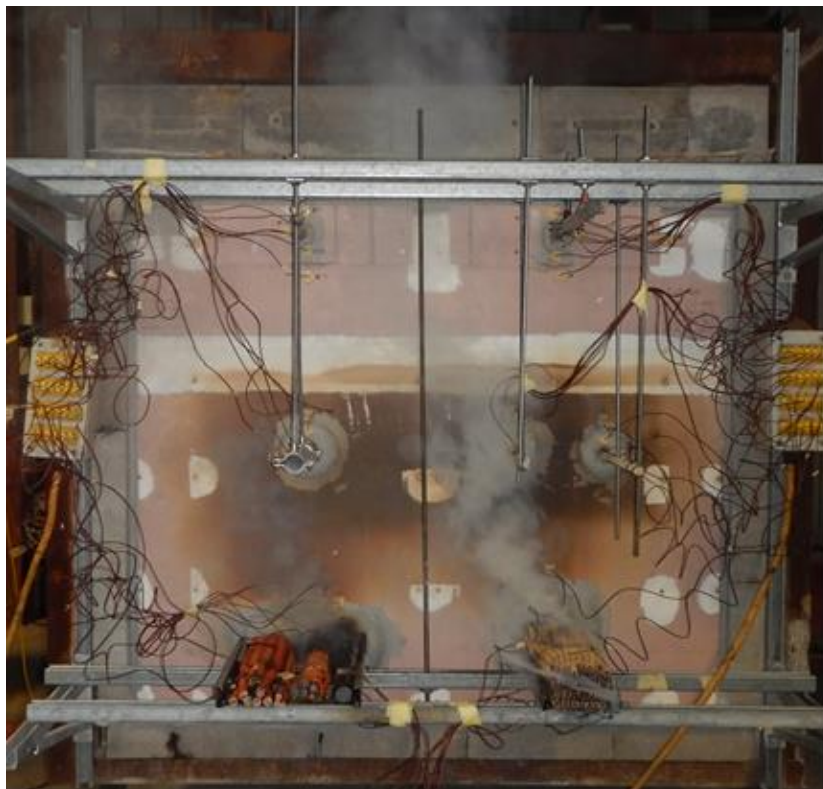
Figure 31 Unexposed face of the specimen at the end of the test

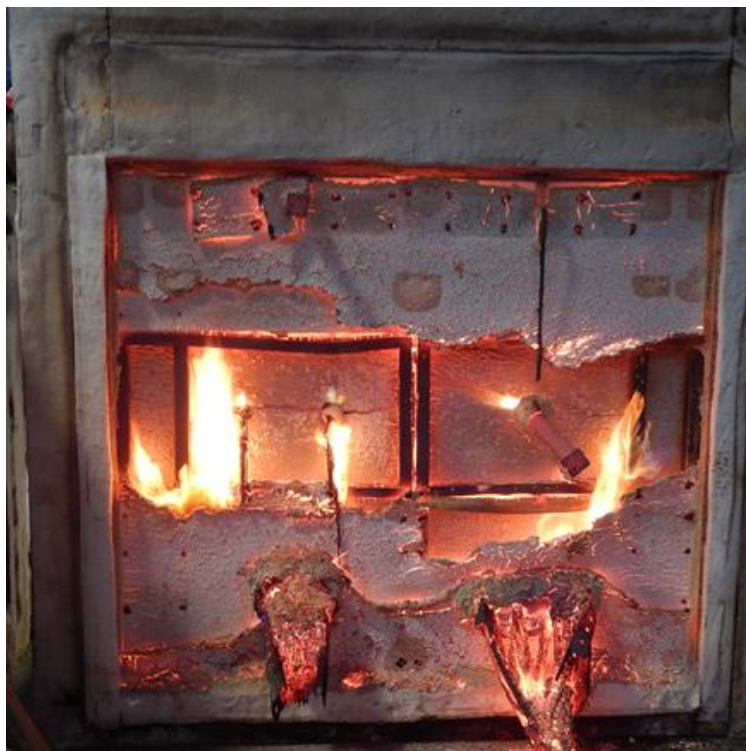
Figure 32 Exposed face of the specimen at the end of the test
