**FIRE RESISTANCE TEST IN ACCORDANCE
WITH AS1530.4-1997, SECTIONS 2, 4 AND 10
AND AS4072.1-1992 AS APPROPRIATE ON
FIRESOUND GREY TRIAL ACRYLIC SEALANT
PROTECTING FOUR (4-OFF) JOINTS
IN A CONCRETE FLOOR SLAB**

HB Fuller Australia Company Pty Ltd,
16-20 Red Gum Drive
Dandenong South
VIC 3175

A1.1.7 Details of the test construction are shown schematically on Drawing No. 40869-TS-01.

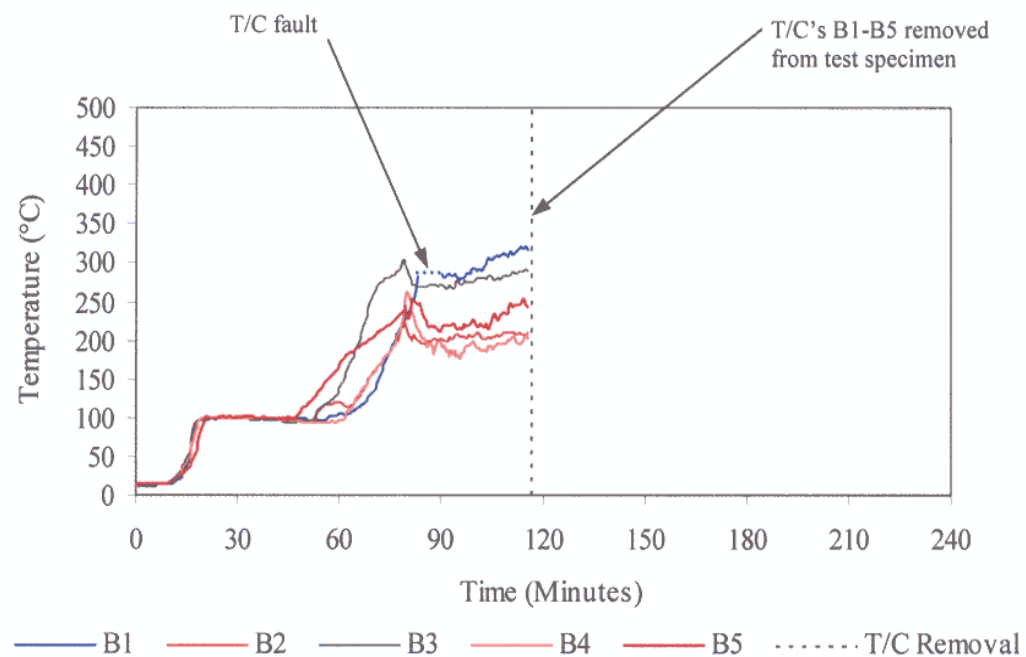
Figure A2.2: Control Joint #1 Sealant Temperatures versus Time

Control Joint Ref	T/C No.	Surface	DESCRIPTION	TEMP (°C) at t (minutes)					LIMIT (mins)*
				t=0	t=60	t=120	t=180	t=240	
1	B1	Sealant	200mm from western edge of slab on C/L of backing rod	13	105	#	#	#	75
	B2	Sealant	400mm from western edge of slab on C/L of backing rod	13	120	#	#	#	75
	B3	Sealant	600mm from western edge of slab on C/L of backing rod	13	136	#	#	#	65
	B4	Sealant	800mm from western edge of slab on C/L of backing rod	13	95	#	#	#	76
	B5	Sealant	1000mm from western edge of slab on C/L of backing rod	13	166	#	#	#	66
	C4	Slab	25mm from northern edge of slot, 400mm from western edge of slab	12	77	122	185	220	188
	C5	Slab	25mm from northern edge of slot, 1075mm from western edge of slab	12	74	124	190	225	182
	C6	Slab	25mm from southern edge of slot, 475mm from western edge of slab	12	79	127	191	226	180
	C7	Slab	25mm from southern edge of slot, 875mm from western edge of slab	12	79	133	197	231	173

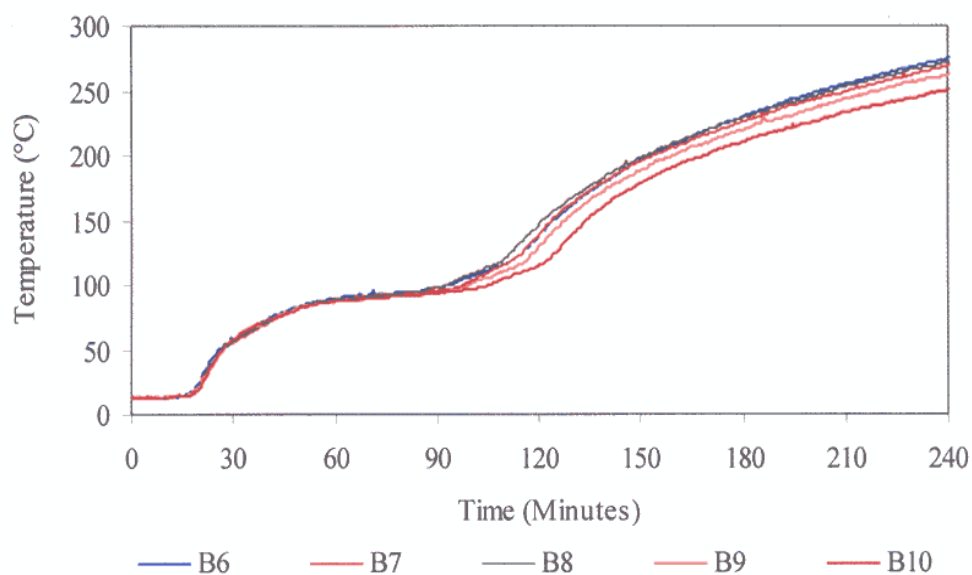
Figure A2.4: Control Joint #2 Sealant Temperatures versus Time

C8	Slab	25mm from southern edge of slot, 1275mm from western edge of slab	12	78	126	198	234	172
2	B6	Sealant	475mm from western edge of slab on C/L of bead	12	89	137	229	274	147
	B7	Sealant	675mm from western edge of slab on C/L of bead	12	88	138	226	268	147
	B8	Sealant	875mm from western edge of slab on C/L of bead	12	88	146	229	272	145
	B9	Sealant	1075mm from western edge of slab on C/L of bead	12	86	129	220	262	153
	B10	Sealant	1275mm from western edge of slab on C/L of bead	12	87	114	210	250	161
	C9	Slab	25mm from northern edge of slot, 675mm from western edge of slab	12	87	132	229	280	151
	C10	Slab	25mm from northern edge of slot, 1075mm from western edge of slab	12	81	136	228	279	152
	C11	Slab	25mm from southern edge of slot, 475mm from western edge of slab	12	85	133	226	276	153
	C12	Slab	25mm from southern edge of slot, 875mm from western edge of slab	12	85	137	232	281	149
	D1	Slab	25mm from southern edge of slot, 1275mm from western edge of slab	12	86	133	231	284	152
