**FIRE-RESISTANCE TEST ON  
FIRESOUND GREY TRIAL ACRYLIC SEALANT  
PROTECTING FOUR (4-OFF) JOINTS  
IN A PLASTERBOARD PARTITION  
IN ACCORDANCE WITH AS1530.4-1997,  
SECTIONS 2, 4 AND 10 AND AS4072.1-1992  
AS APPROPRIATE**

HB Fuller Australia Company Pty Ltd,  
16-20 Red Gum Drive  
Dandenong South  
VIC 3175

Test Duration	181 minutes.

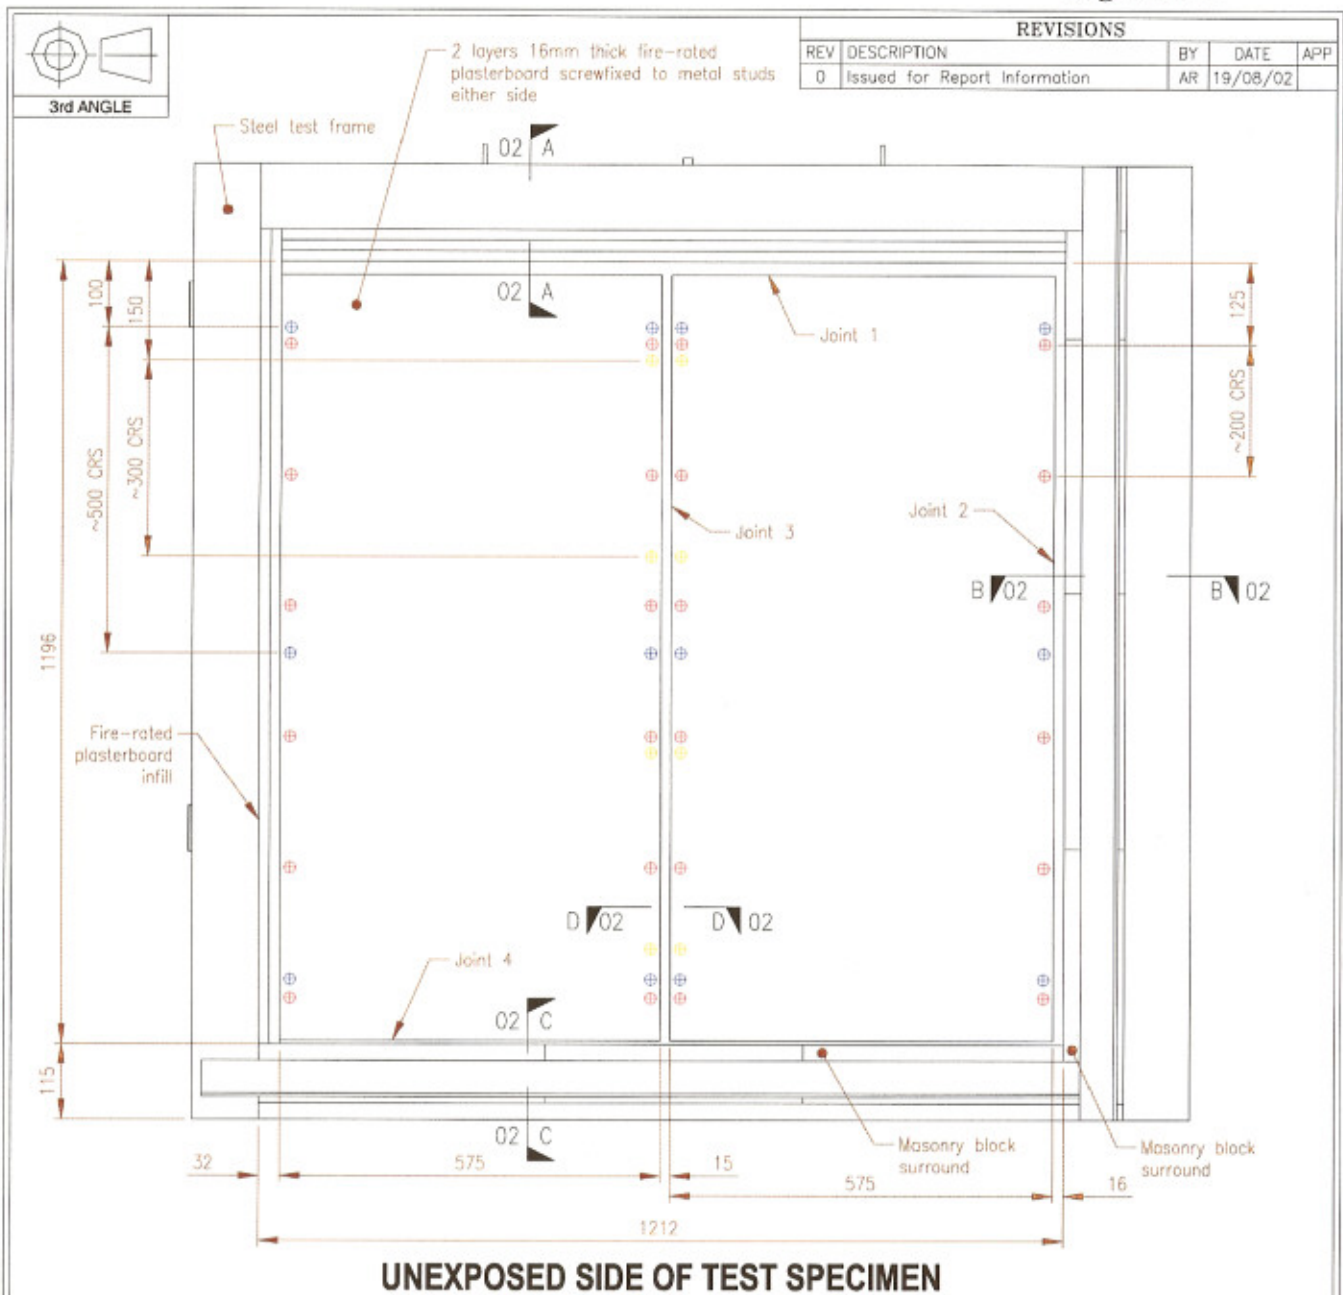
<b>Drawing Designation</b>	<b>Description</b>
40922-TS-01	Construction Details
40922-TS-02	Construction Details
40922-TS-03	Thermocouple locations

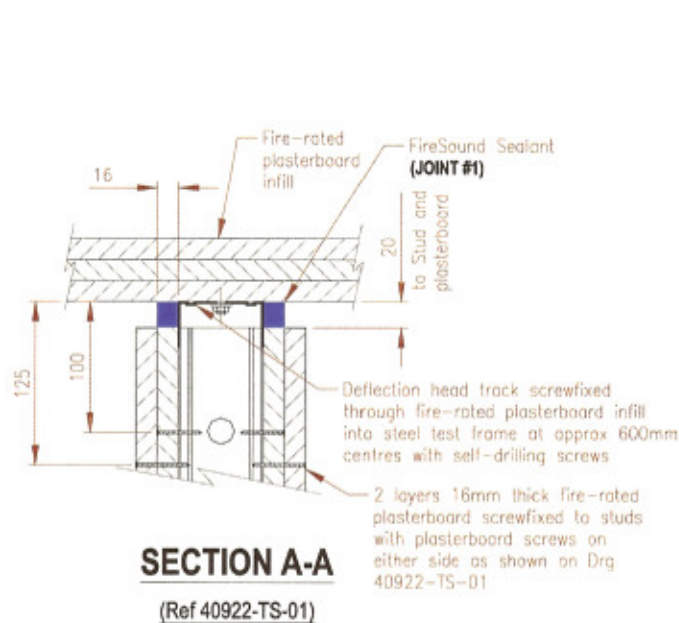
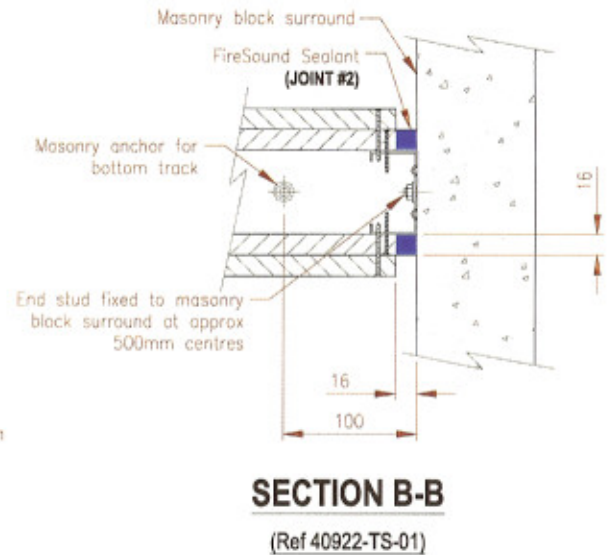
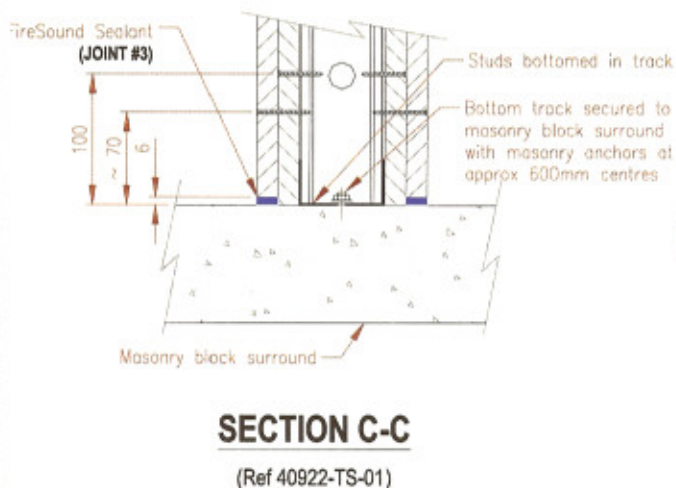
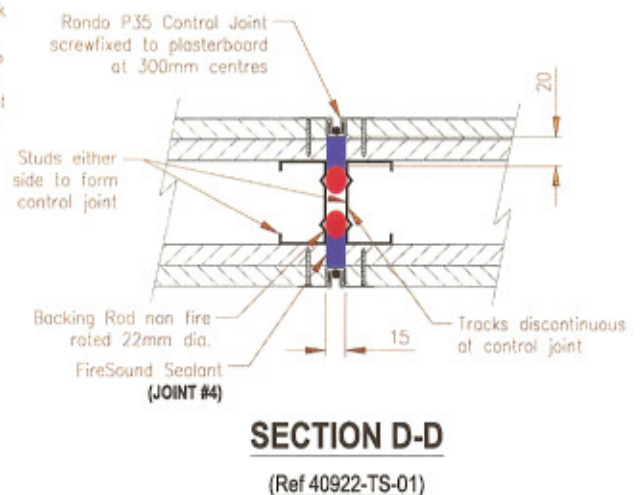
Title  
HB Fuller Company Australia P/L  
Plasterboard Wall  
Construction Details

**NOTE: Steel test frame removed for clarity**

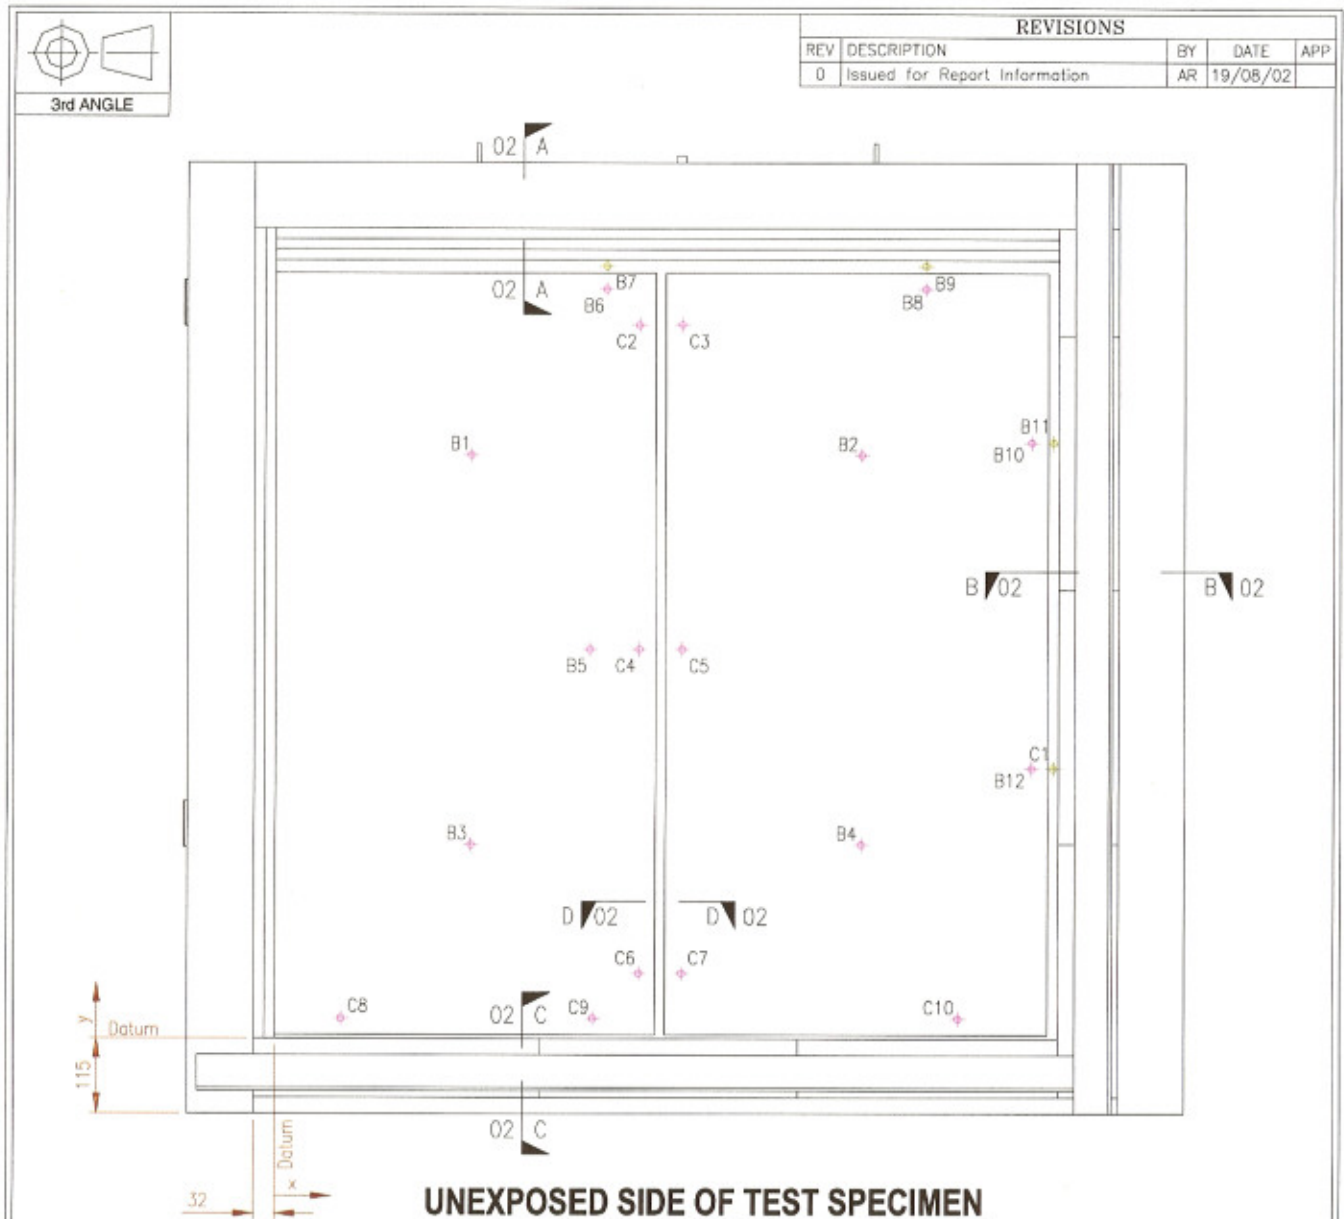
Thermocouple Positions

Thermocouple	Position		Thermocouple	Position	
	x	y		x	y
B1	295	897	B12	1139	416
B2	885	897	C1	1172	416
B3	295	299	C2	550	1096
B4	885	299	C3	615	1096
B5	475	598	C4	550	598
B6	500	1151	C5	615	598
B7	500	1186	C6	550	100
B8	980	1151	C7	615	100
B9	980	1186	C8	100	31
B10	1139	916	C9	480	31
B11	1172	916	C10	1030	31

- x Thermocouple on plasterboard  
y Thermocouple on sealant

Notes: <sup>1</sup> Positions are all shown in millimetres and are measured from the bottom western corner of the partition (See Drawing 40922-TS-03).

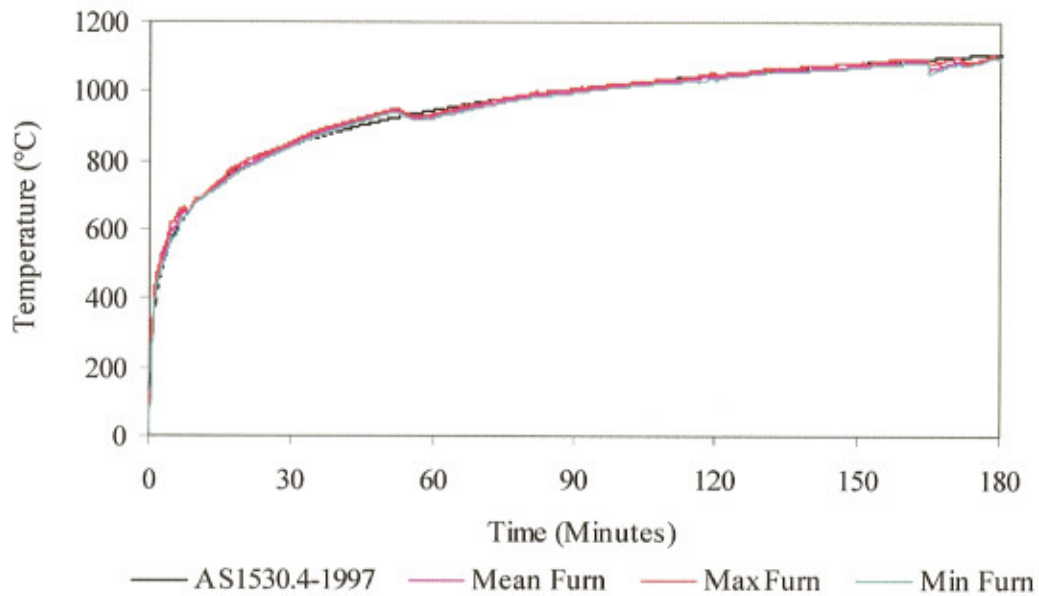
**Figure A2.1: Furnace Temperatures versus Time**

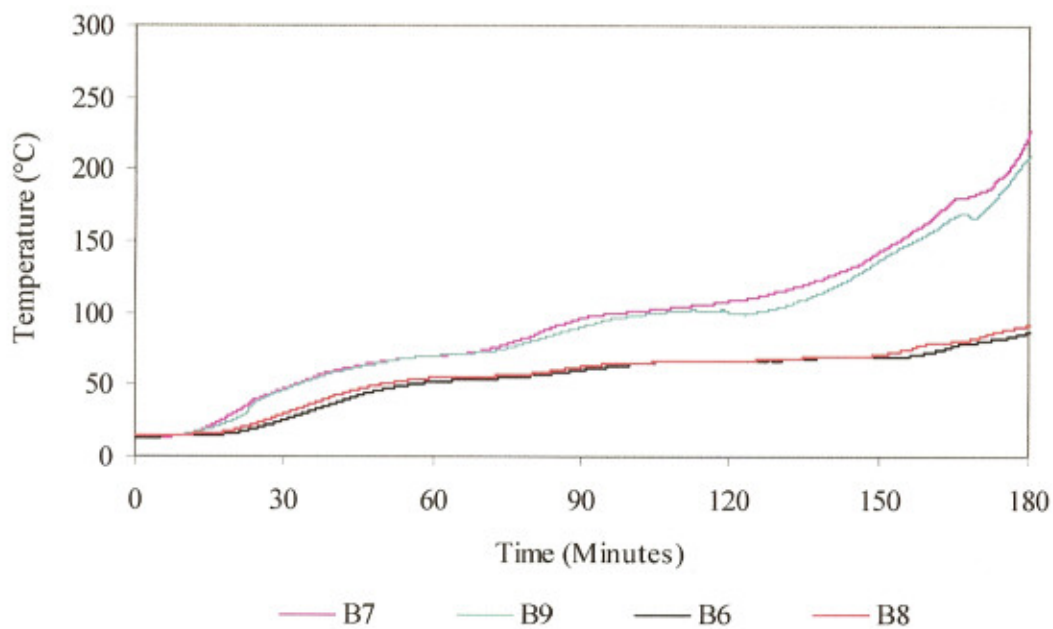
**Figure A2.2: Joint #1 Temperatures versus Time**

133	00	U	A roving thermocouple was positioned on a black spot on the top joint (Joint #1) at the western corner and was fixed in this position.
135	00	E	A triangular section of the plasterboard outer layer of approximately 150mm deep had fallen away from the top western corner of the specimen on the exposed face. The area where the control joint flange had been exposed to the furnace had been completely burnt away but the control joint appeared fully sealed on the exposed face.
140	00	E	The crazed cracking on the exposed face on the eastern side of the specimen had increased considerably.
140	00	U	There was an increase in the size of the bubbling that had occurred in Joints #1 (top joint) and Joint #2 (east side).
149	00	U	The roving thermocouple reading was 195.3°C on the position stated at 133 minutes. This equated to an 180°C rise of Joint #1. <b>Insulation failure of Joint #1 in accordance with AS1530.4-1997.</b>

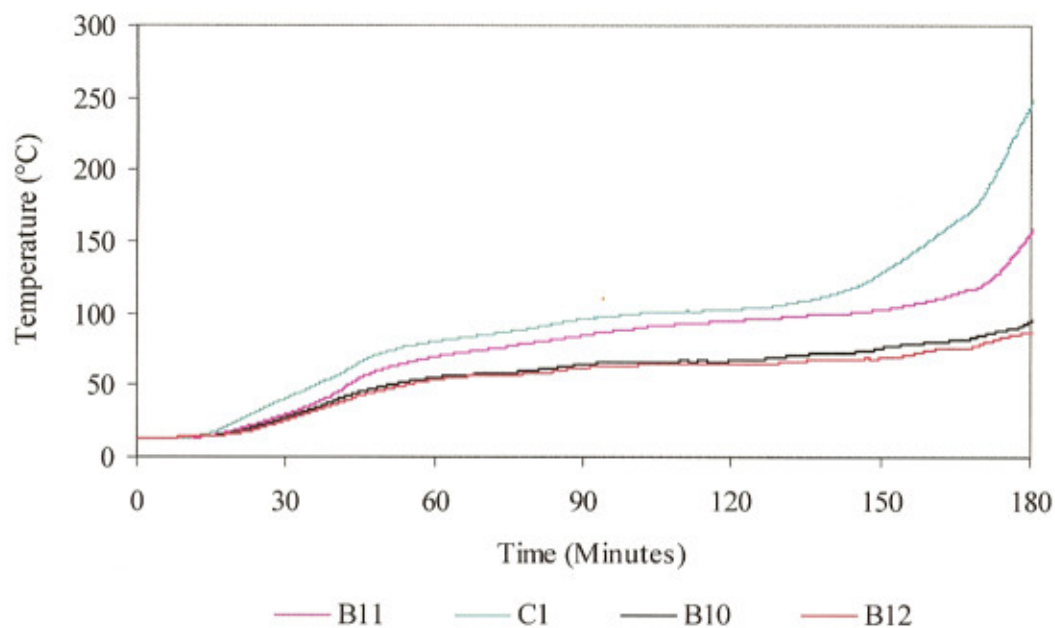
**Figure A2.3: Joint #2 Temperatures versus Time**

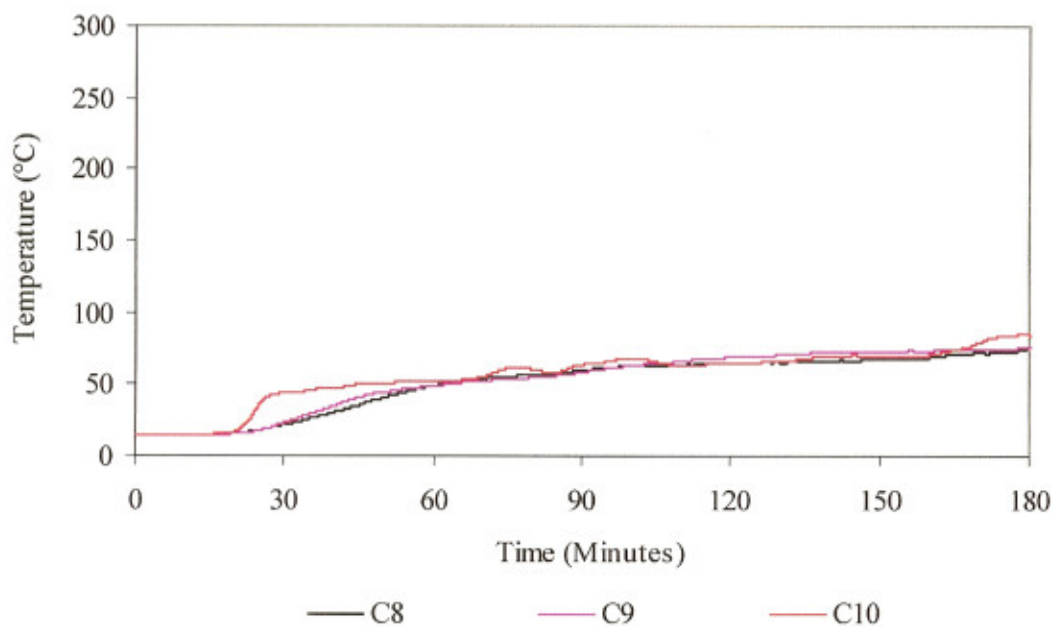
**Figure A2.4: Joint #3 Temperatures versus Time**

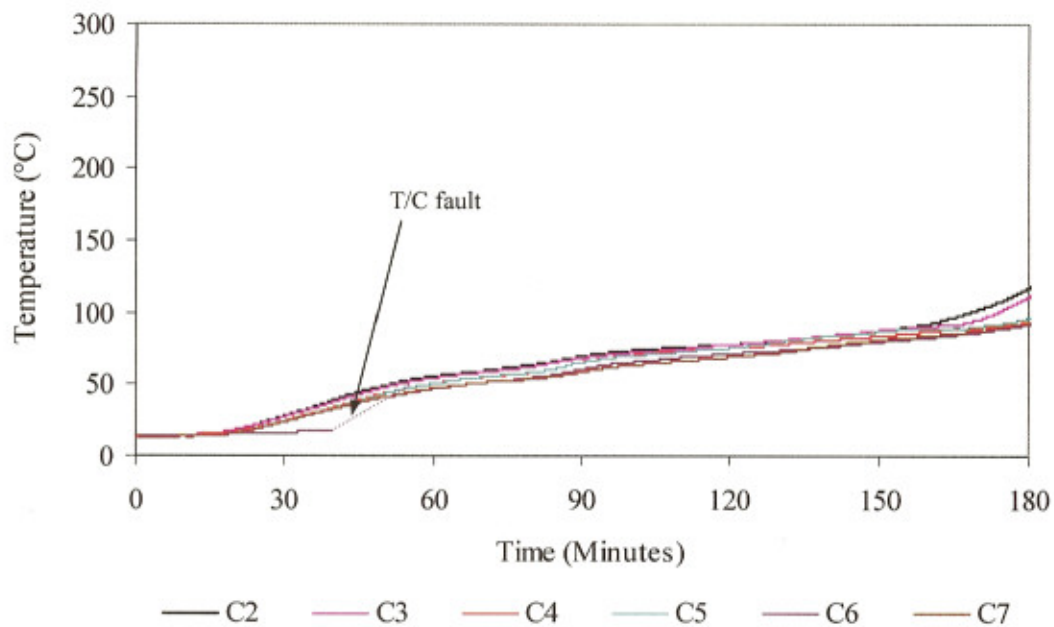
*Figure A2.5: Control Joint #4 Temperatures versus Time*

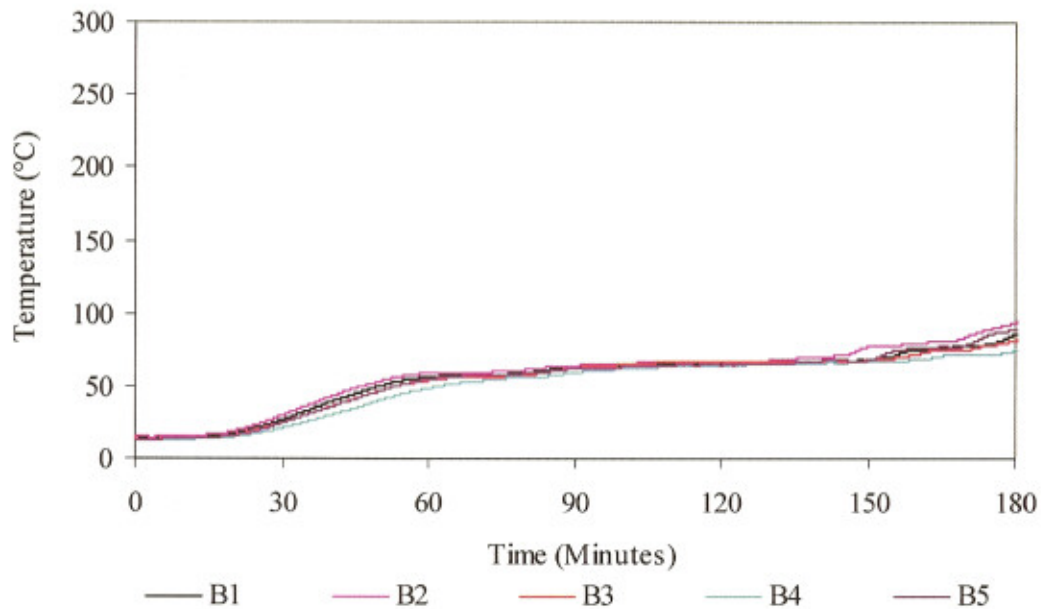
*Figure A2.6: Plasterboard partition 1/4 point Temperatures versus Time*

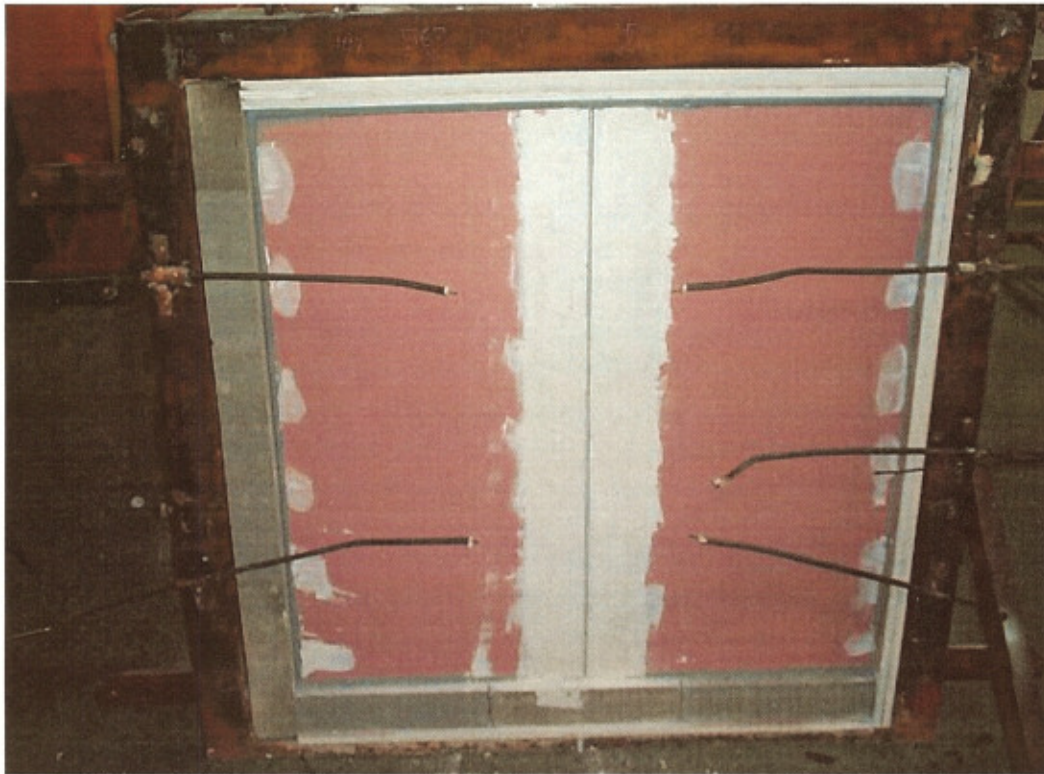
*Plate 1: Exposed face of test specimen before commencement of the fire-resistance test*

- PLATE 1: Exposed face of the test specimen before commencement of the fire-resistance test.
- PLATE 2: Unexposed face of the test specimen before commencement of the fire-resistance test.
- PLATE 3: Unexposed face of test specimen after approximately 120 minutes test duration.
- PLATE 4: Exposed face of the test specimen after completion of the fire-resistance test.

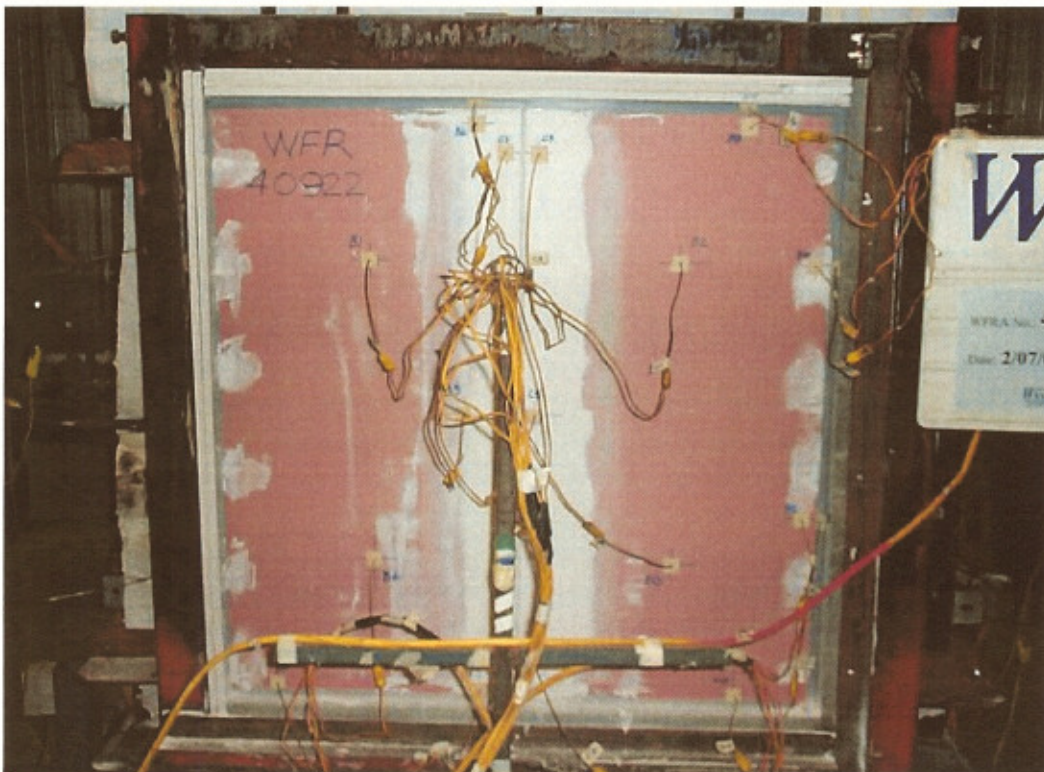
*Plate 2: Unexposed face of test specimen before commencement of the fire-resistance test*

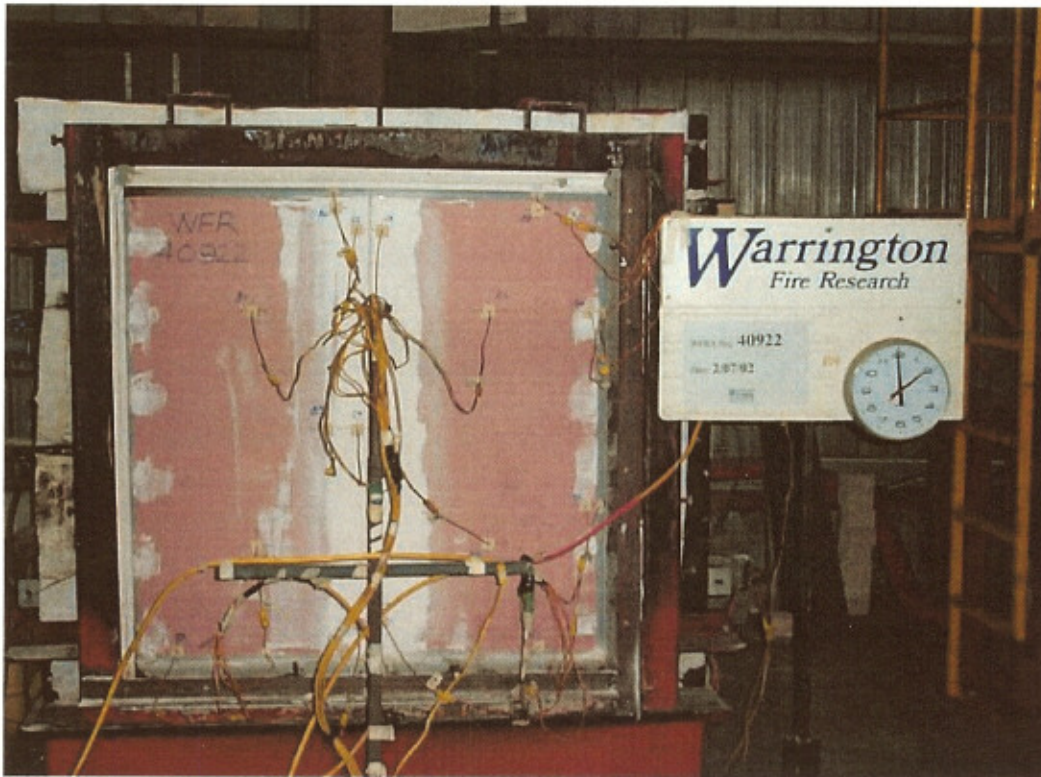
*Plate 3: Unexposed face of the test specimen after approximately 120 minutes test duration*

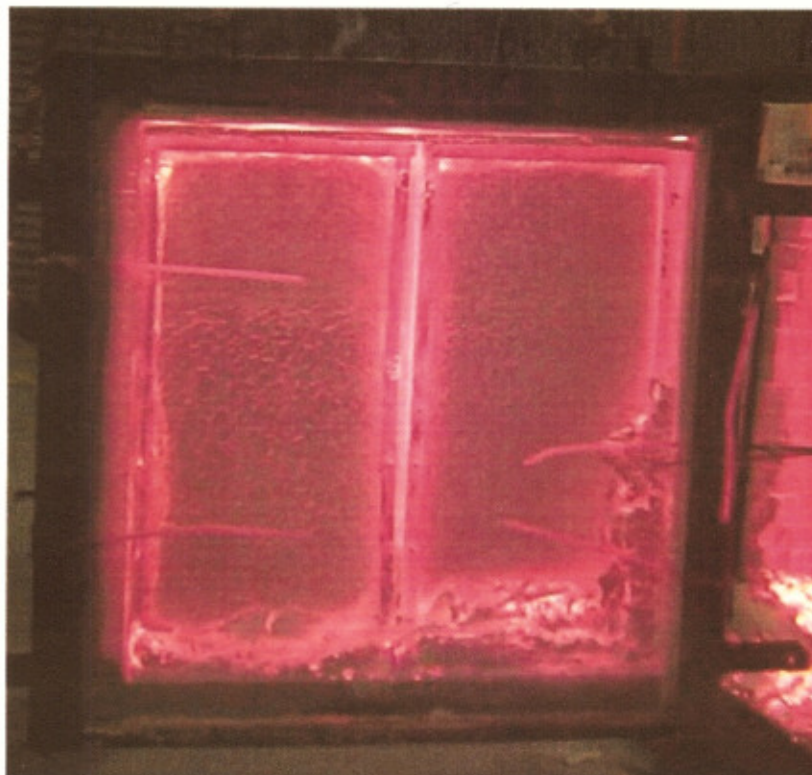
*Plate 4: Exposed face of the test specimen after completion of the fire-resistance test*

- A2.3.1 After the termination of the fire test the specimen was immediately removed from the furnace and the following observations were noted regarding the condition of the exposed and unexposed faces of the test specimen.
- (i) Both control joint (Joint #4) studs were bowed outwards, with a gap of approximately 25mm wide, buckling was evident at several localized positions along the eastern stud.
  - (ii) The control joint (Joint #4) material was intact on the exposed face for about 250mm above the bottom of the joint.
  - (iii) The control joint (Joint #4) material was intact for the unexposed control joint however, where the stud had bowed outwards there was a gap of approximately 5mm.
