# FIRE TEST REPORT

## FP21481-02-1

**THE FIRE RESISTANCE IN ACCORDANCE WITH  
AS 1530.4:2014 OF SIX DOUBLE CAULKED CONTROL  
JOINTS INSTALLED IN A 120 MM THICK CONCRETE  
FLOOR SLAB**

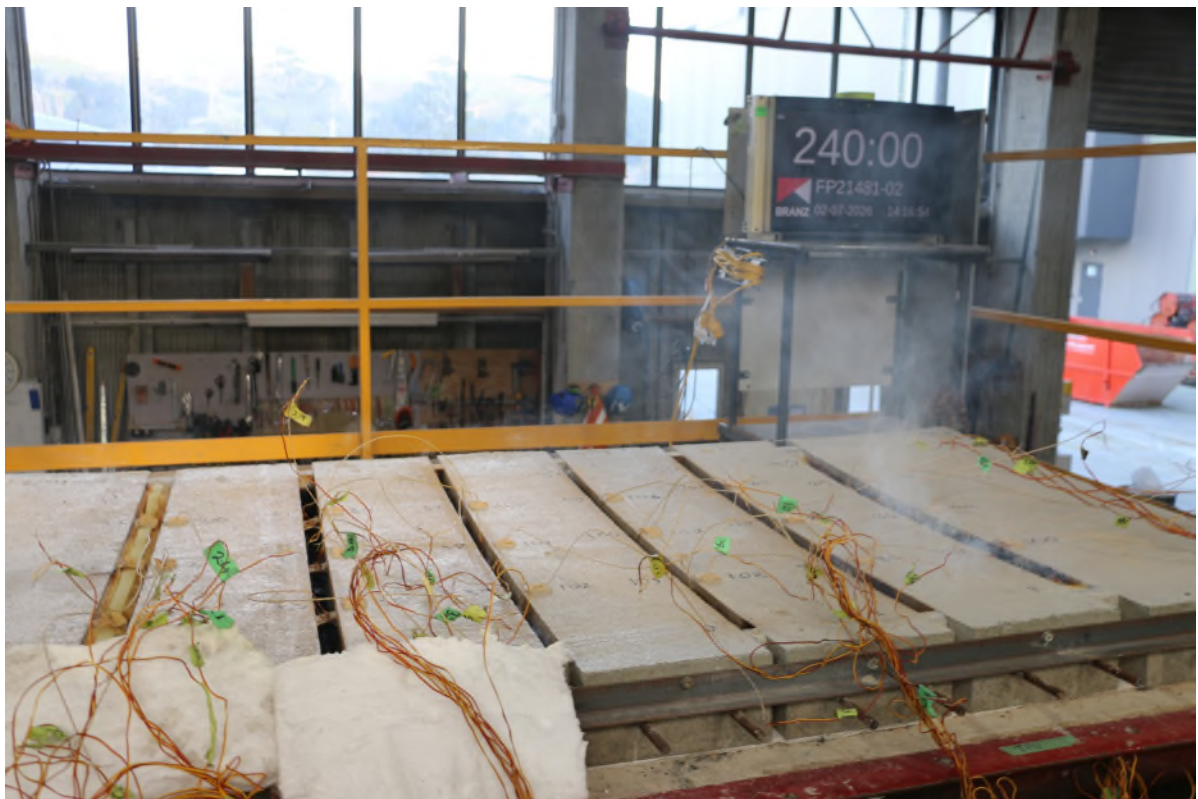
**Photo 5: The Unexposed Face of the Test Assembly After a Duration of 240 Minutes**

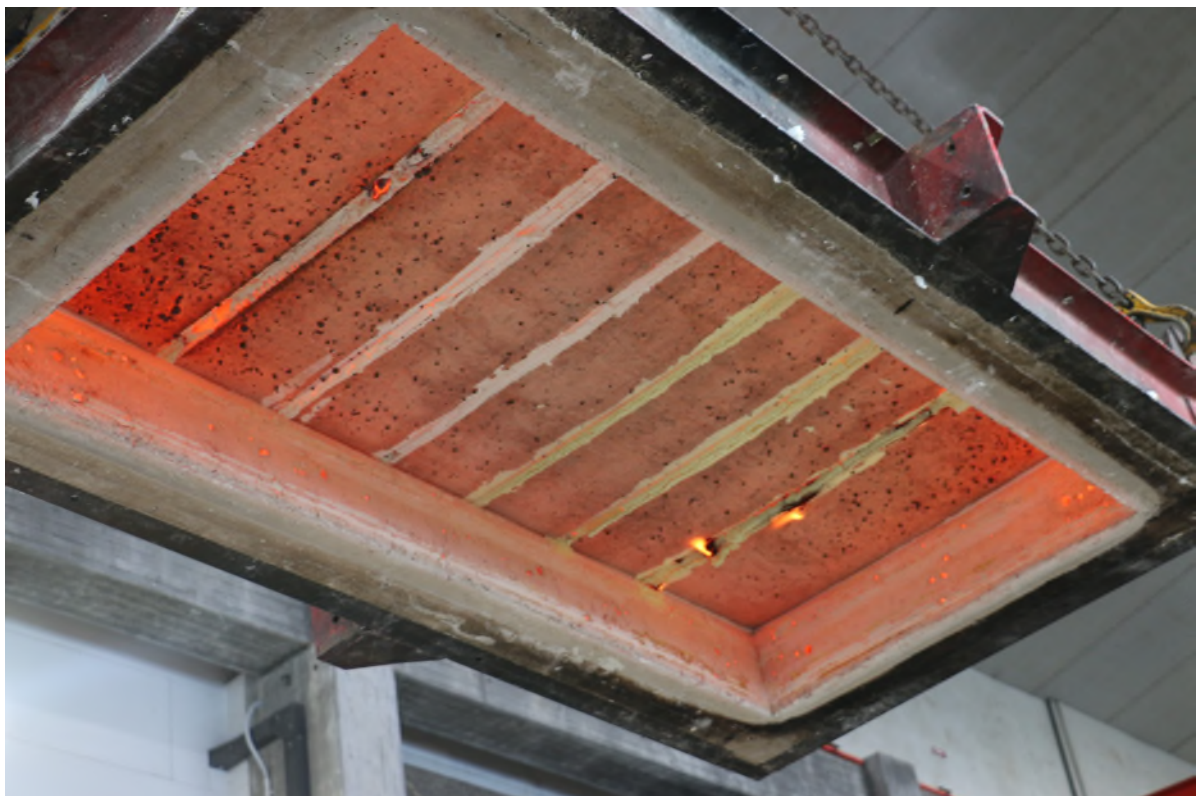
**Photo 6: The Exposed Face of the Test Assembly Immediately After Testing**

The test was terminated after the specimen had been exposed to the standard fire resistance conditions for 245 minutes.
